HISTORIC PRESERVATION COMMISSION MEETING

Wednesday, June 8th, 2016 at 7:00 p.m.
Municipal Building, 35 Cabarrus Avenue, West

Certificate of Appropriateness Request : H-12-16

Staff Report prepared by: Starla A. Rogers, Sr. Planner

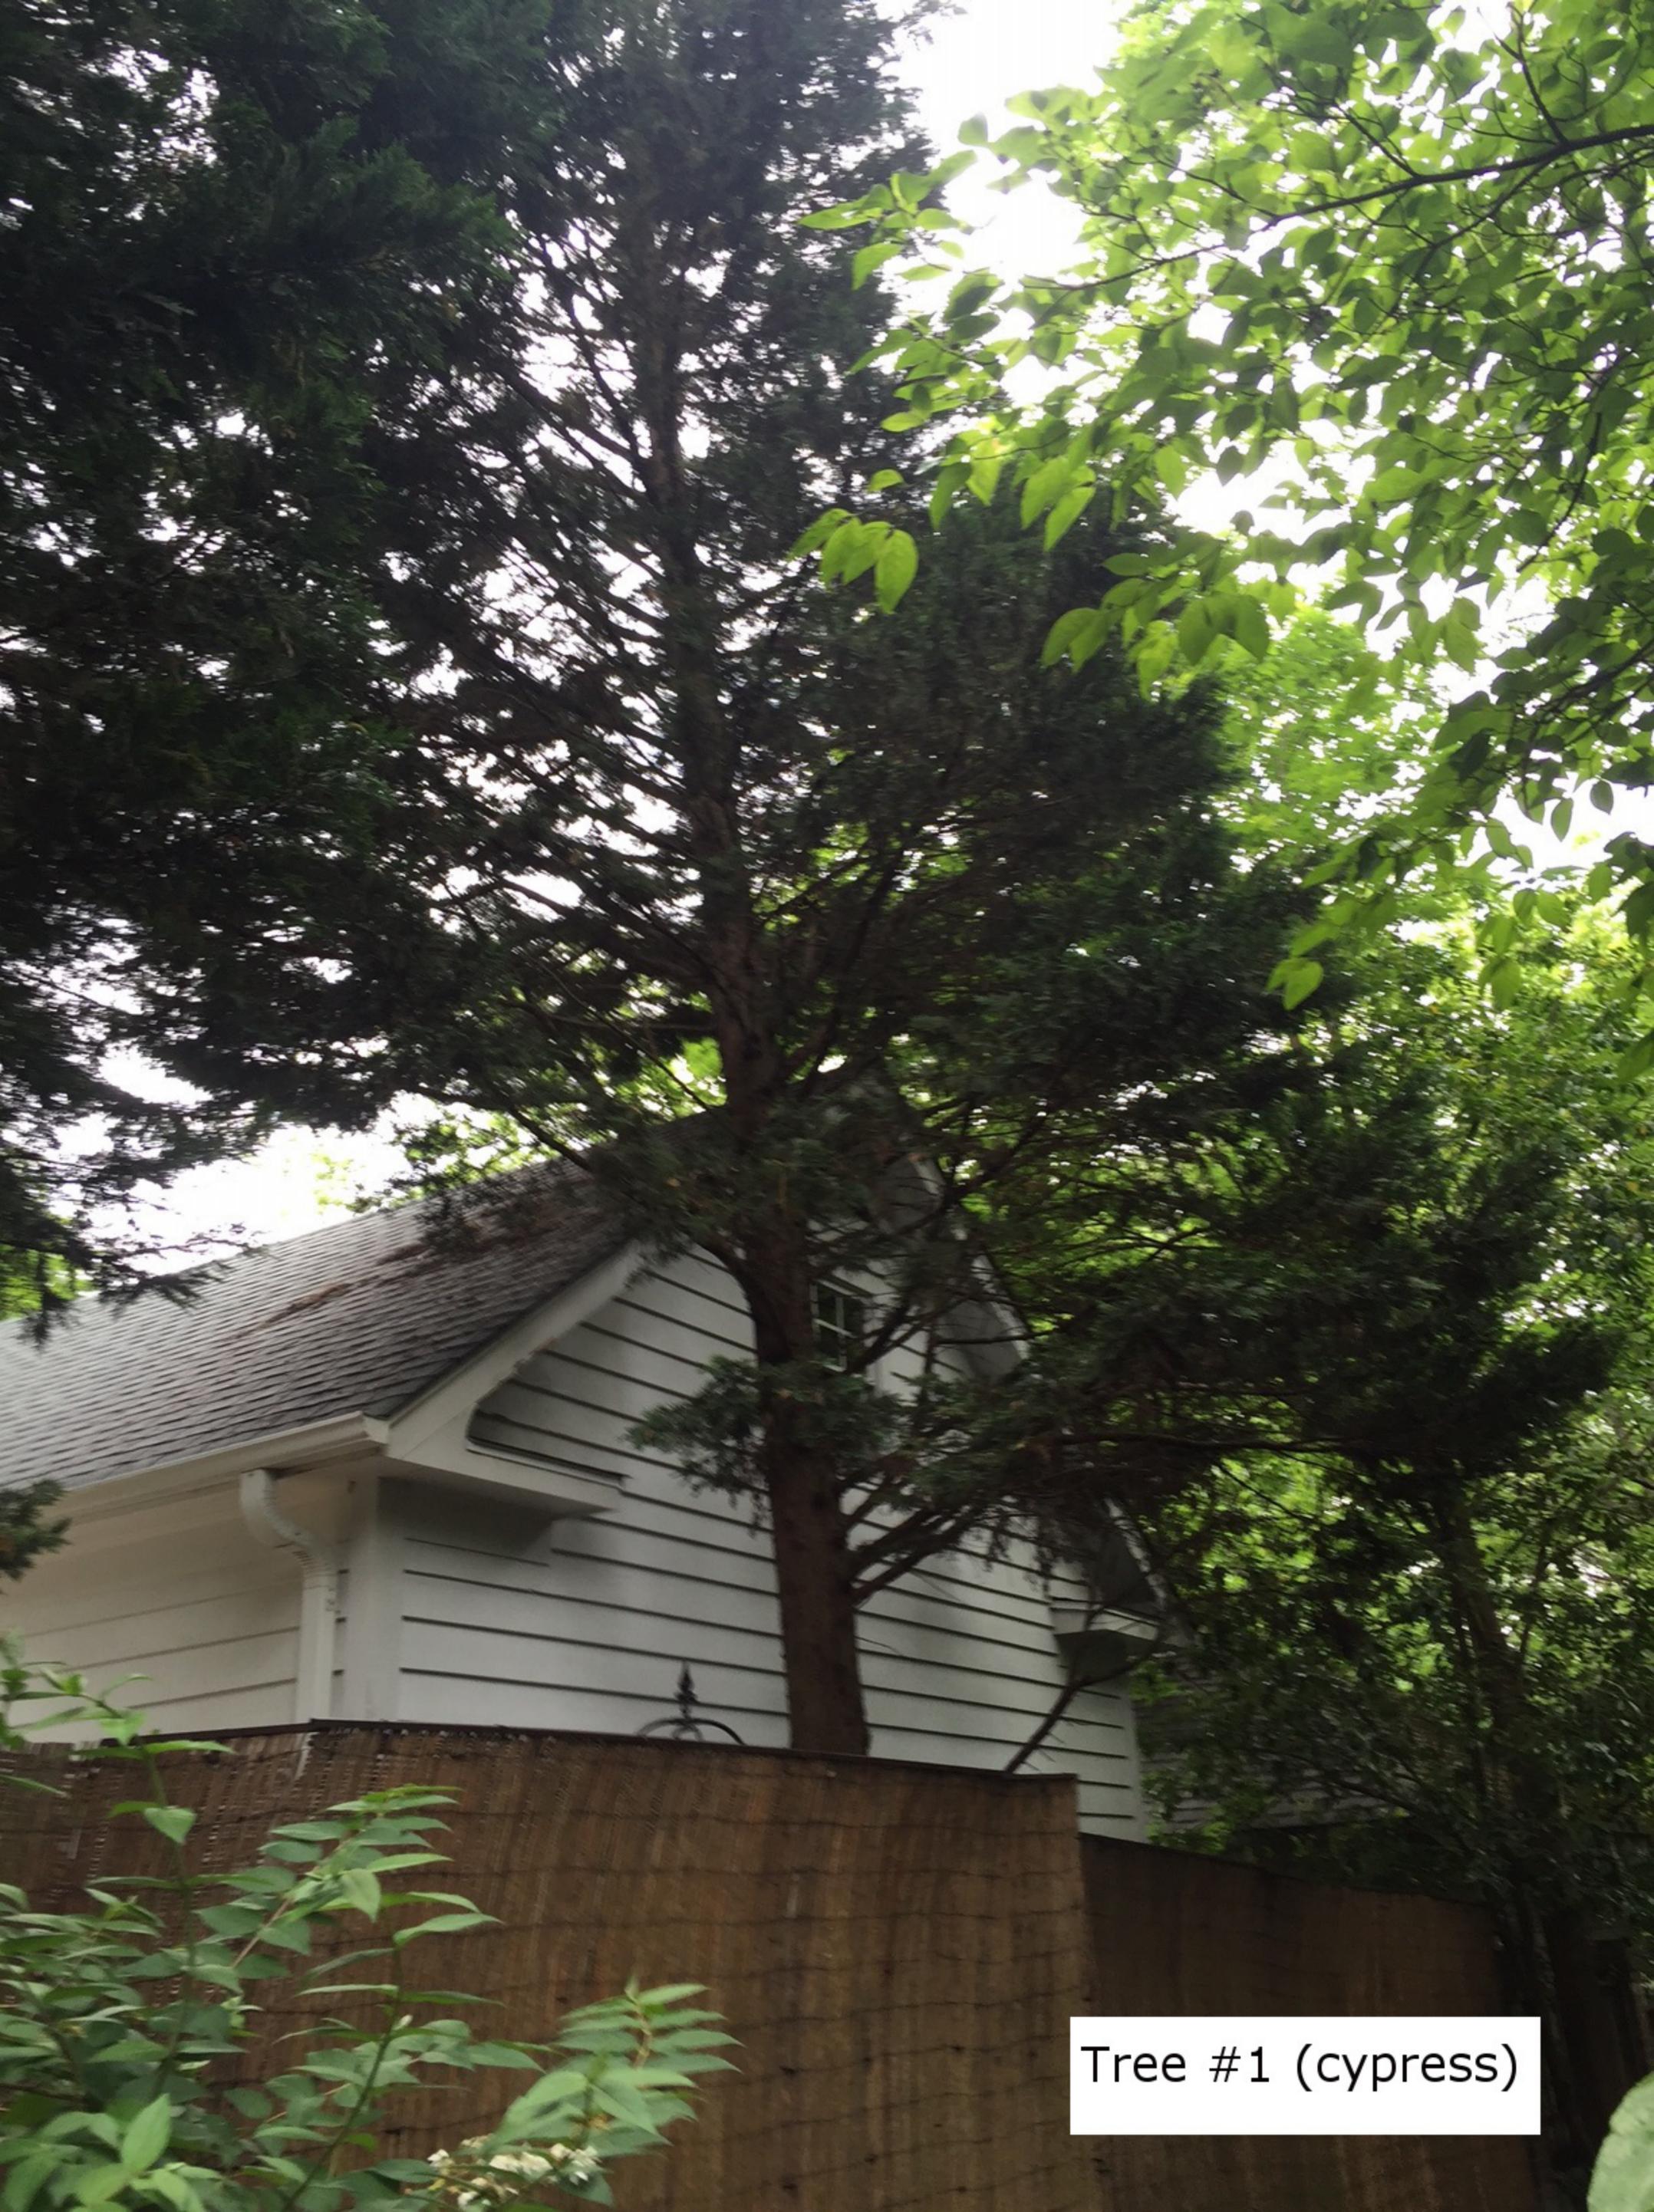
Tree #1 (cypress)

This tree has out grown its location and is causing damage to the roof line of the detached garage. This tree has no defects or risks beyond the normal for this species. *Bill Leake*

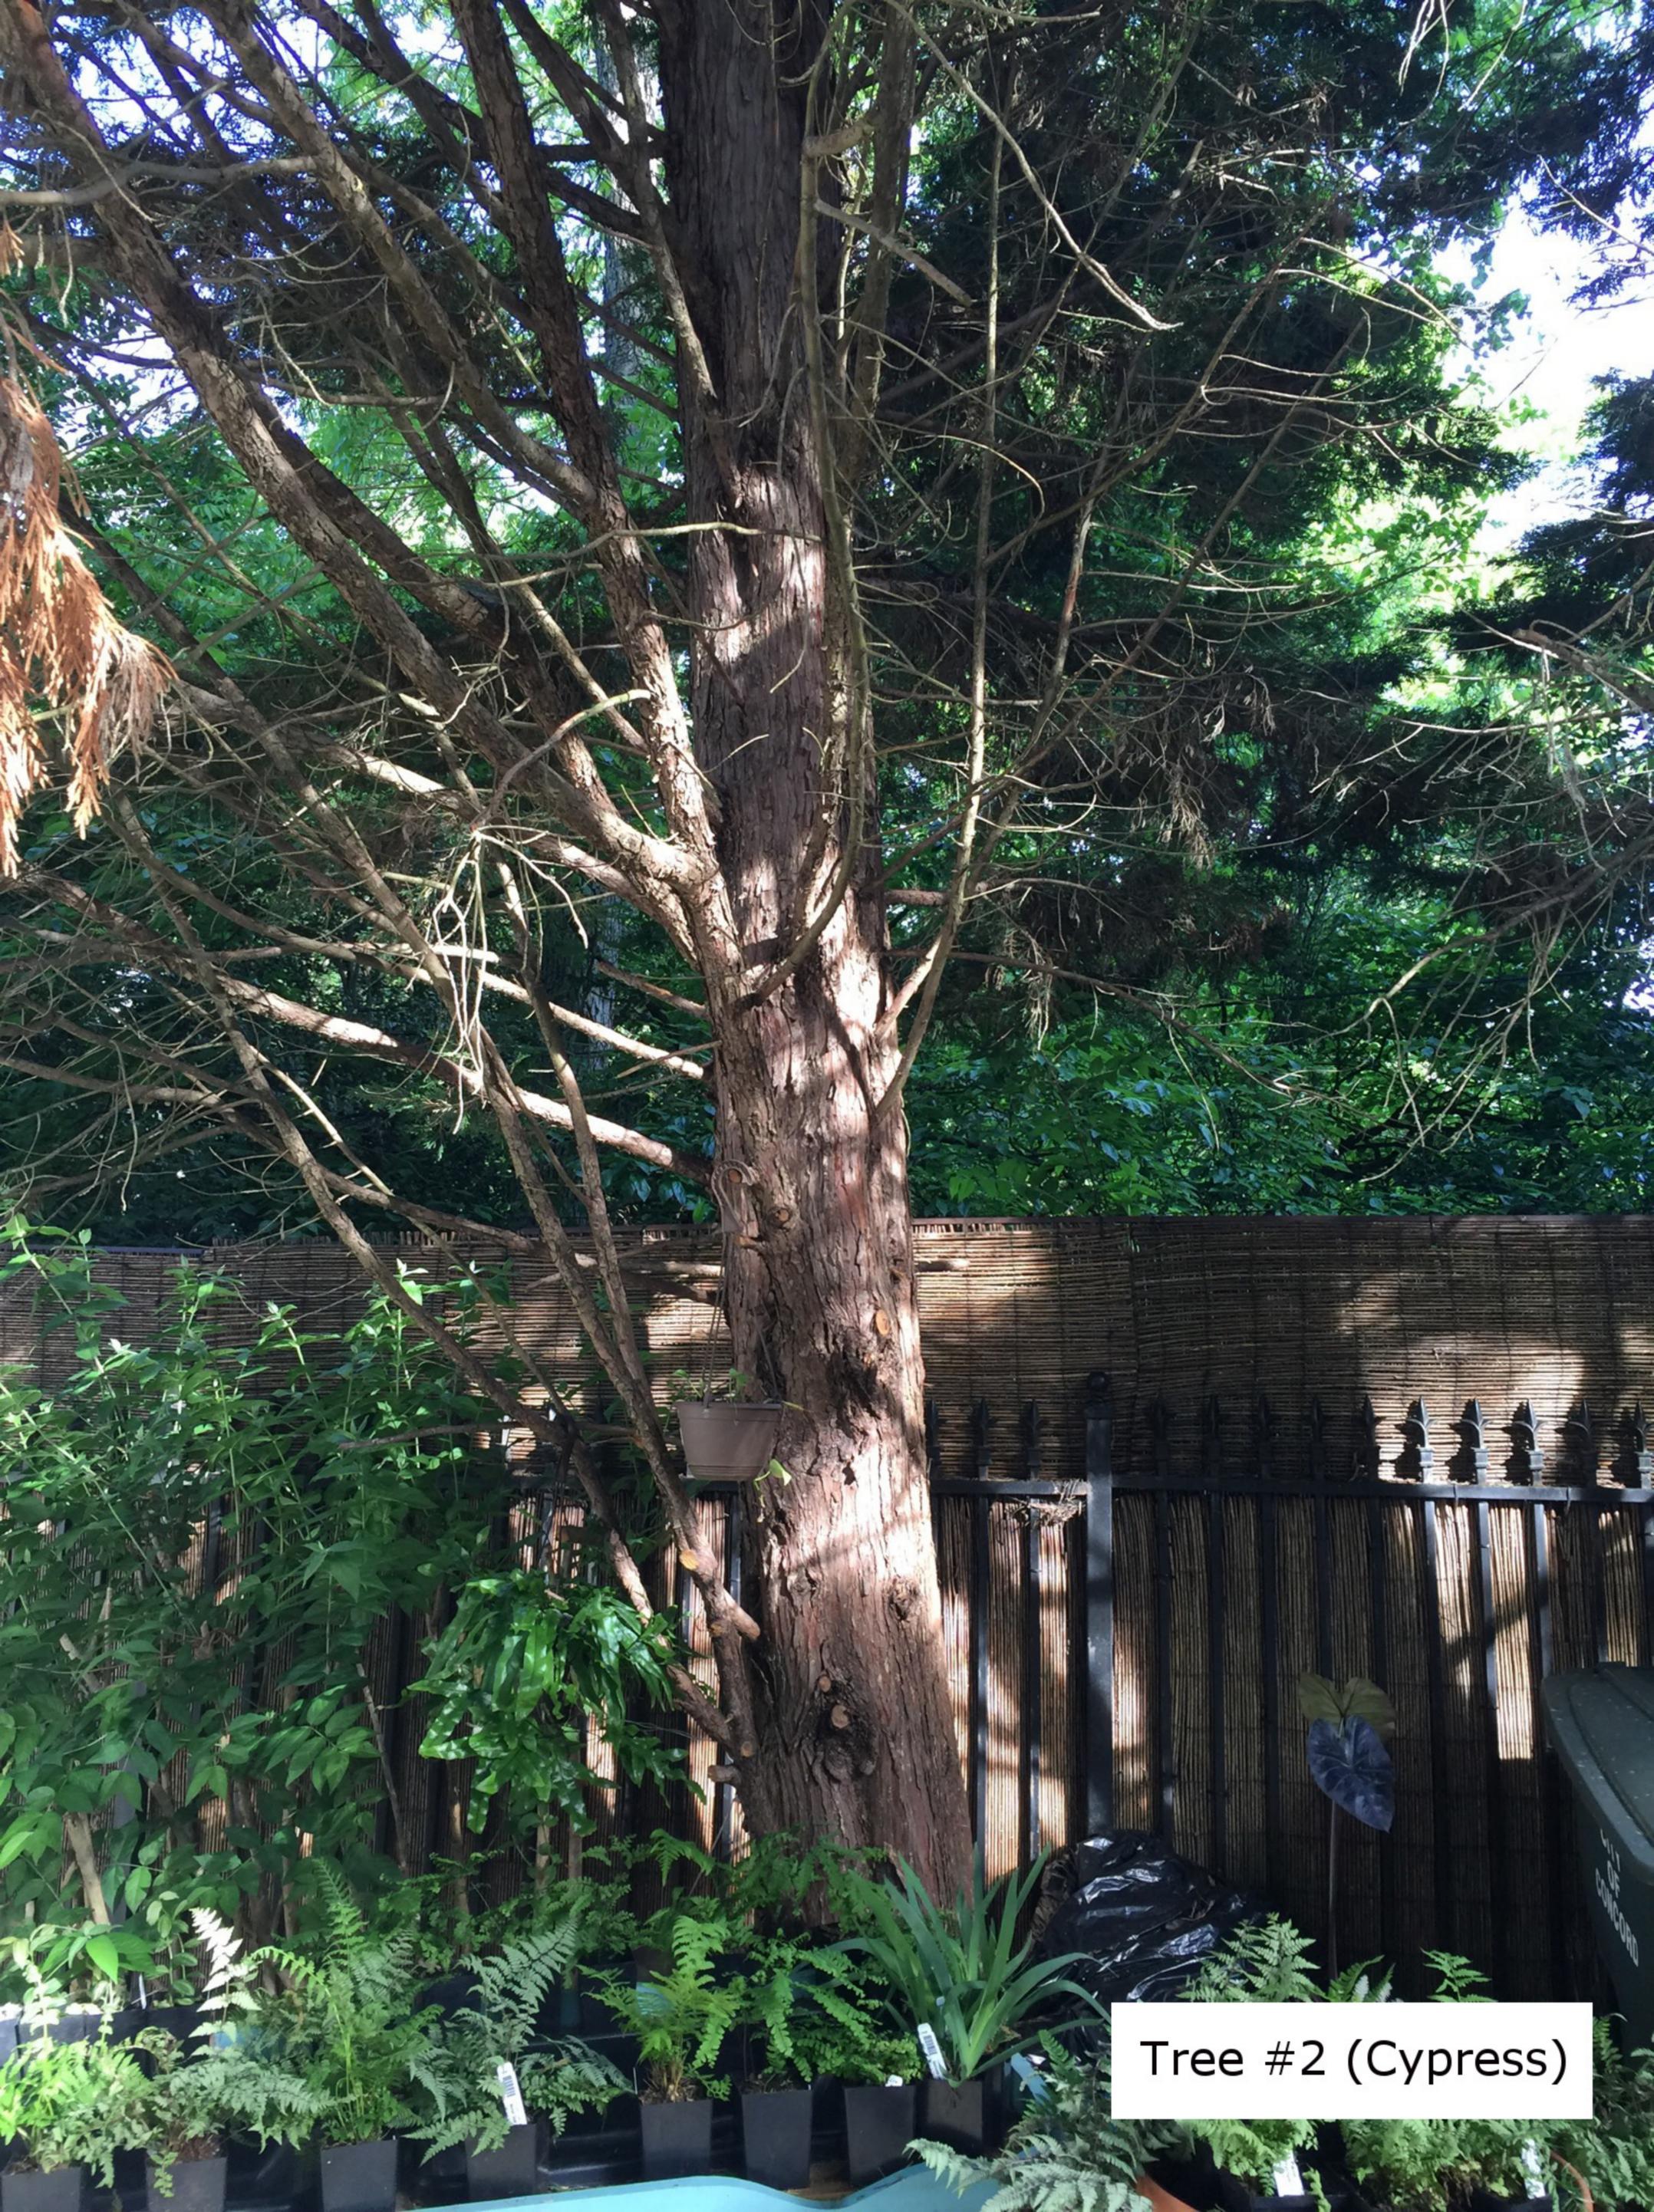
Tree #2 (Cypress)

This tree has out grown its location. This tree has no defects or risks beyond the normal for this species. *Bill Leake*

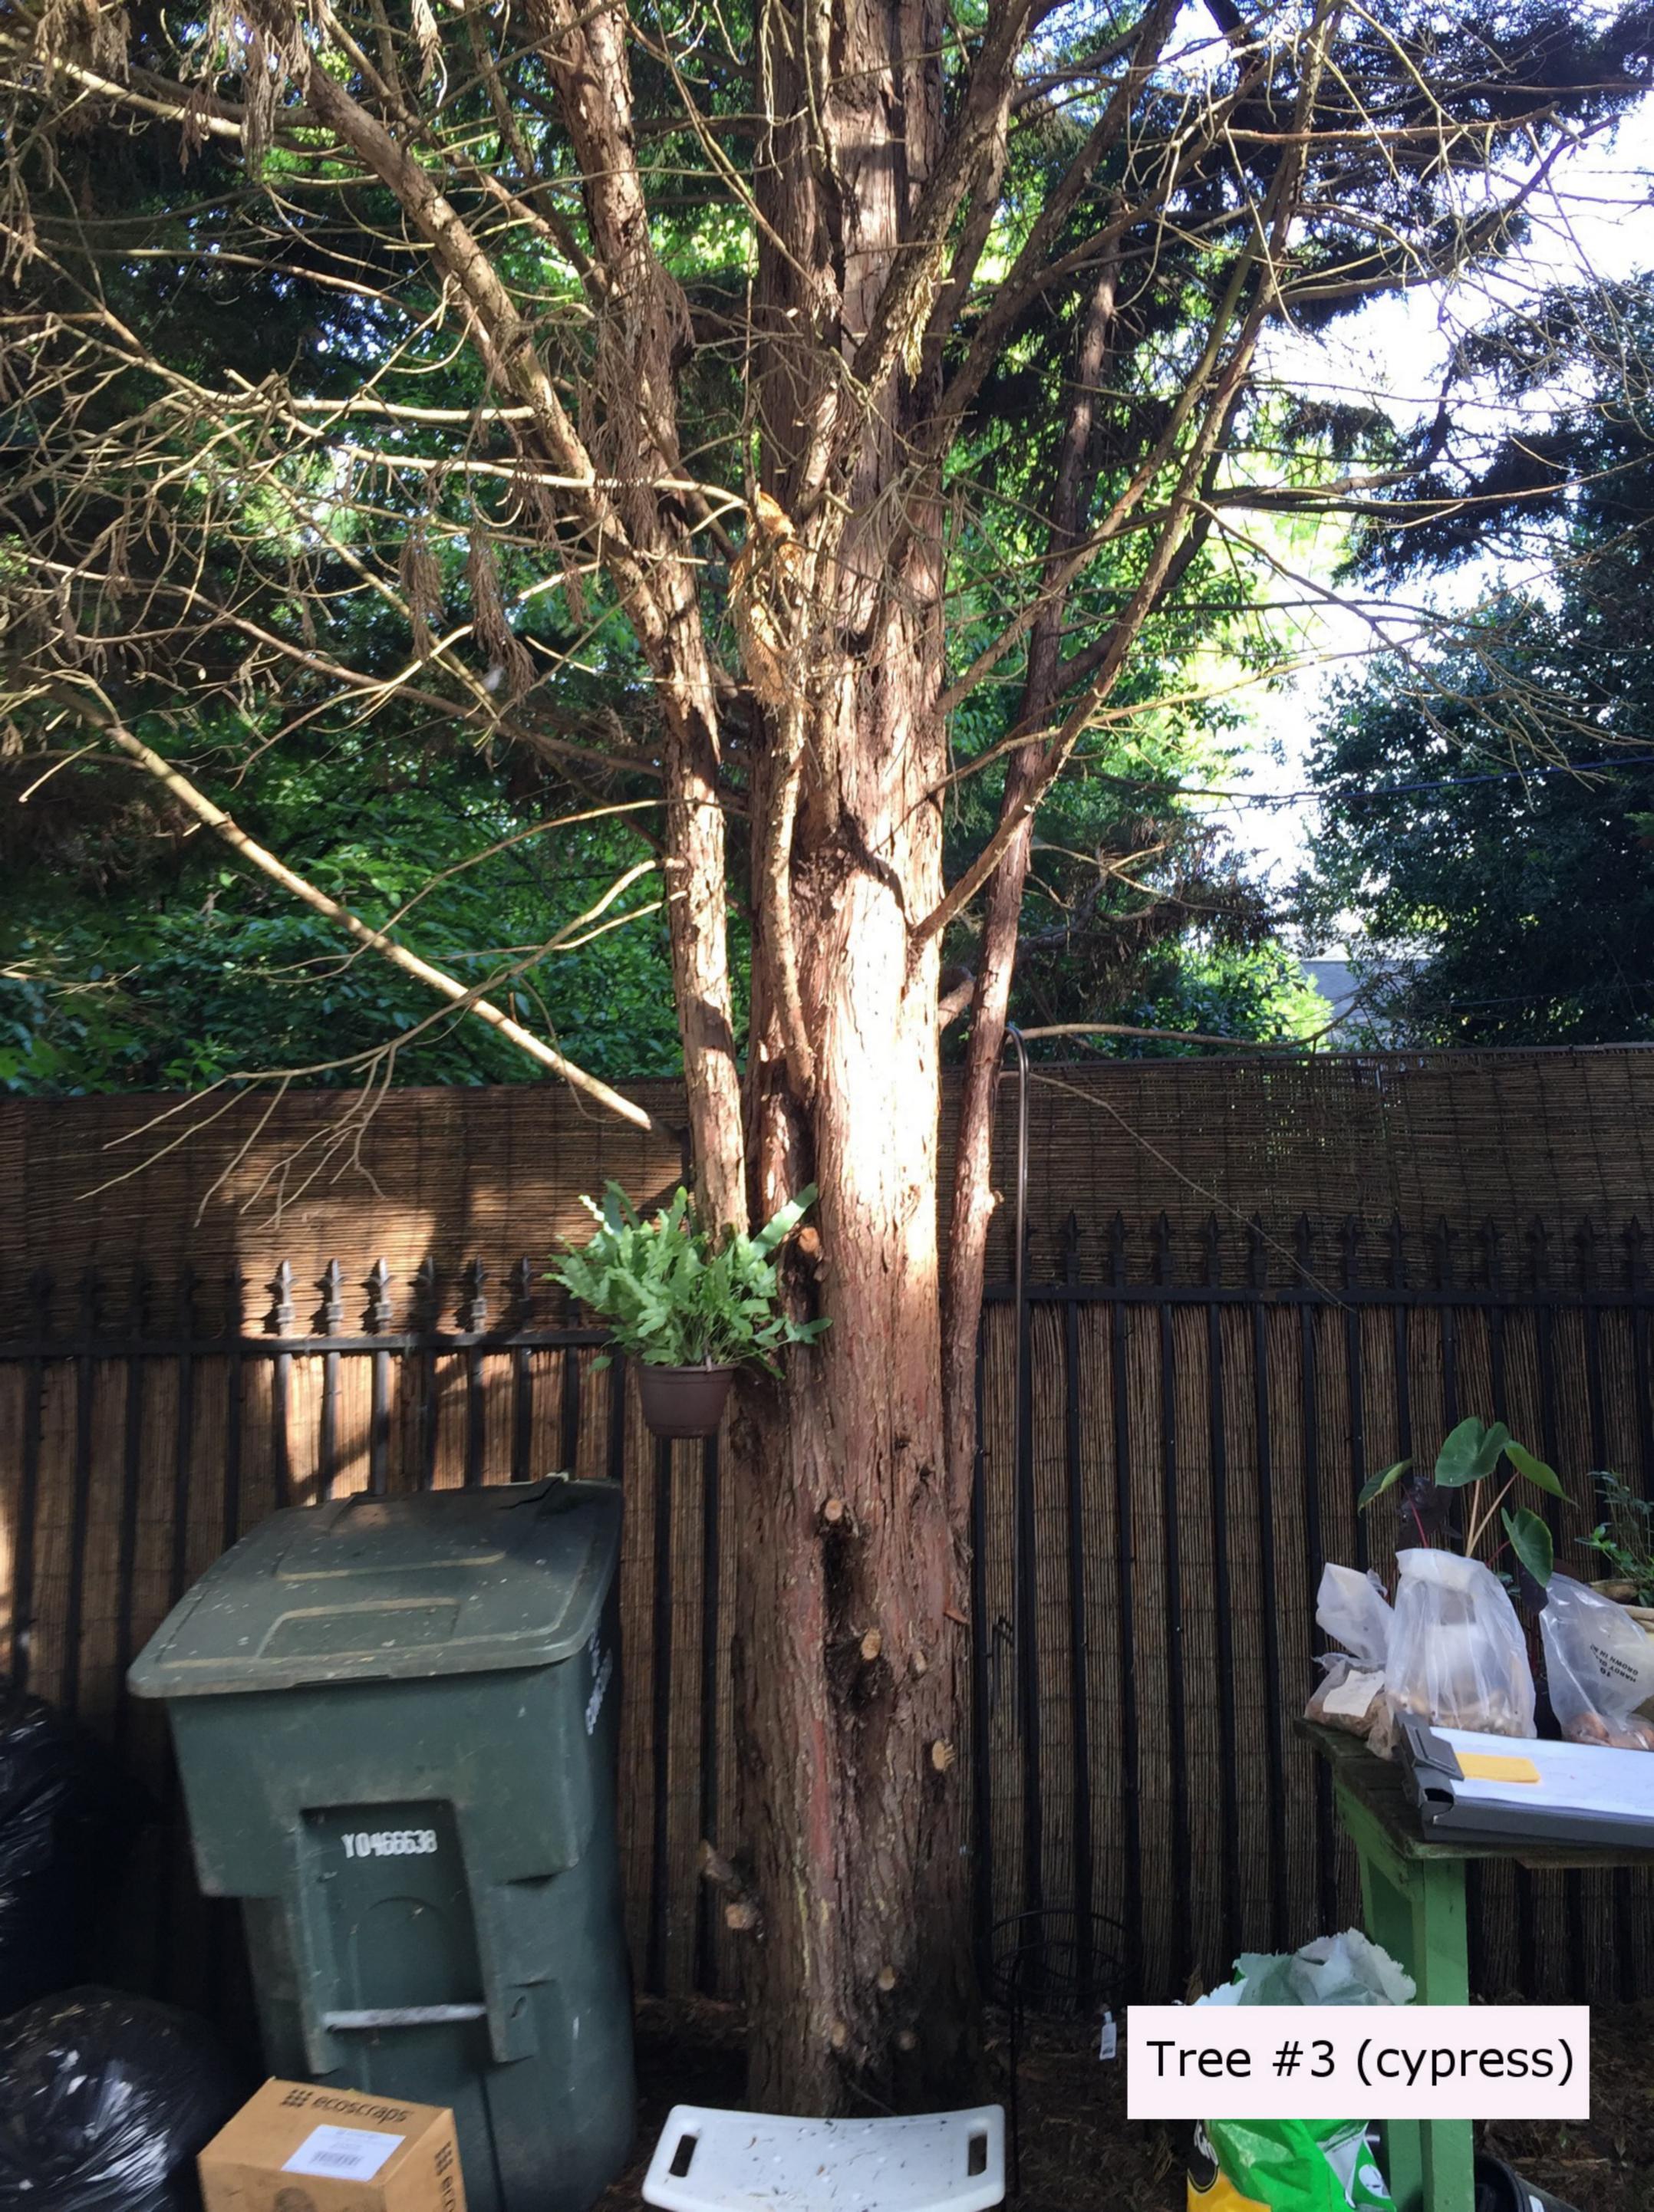
Tree #3 (cypress)

This tree has out grown its location and foliage is heavy in direction of lean. This tree has no defects or risks beyond the normal for this species. *Bill Leake*

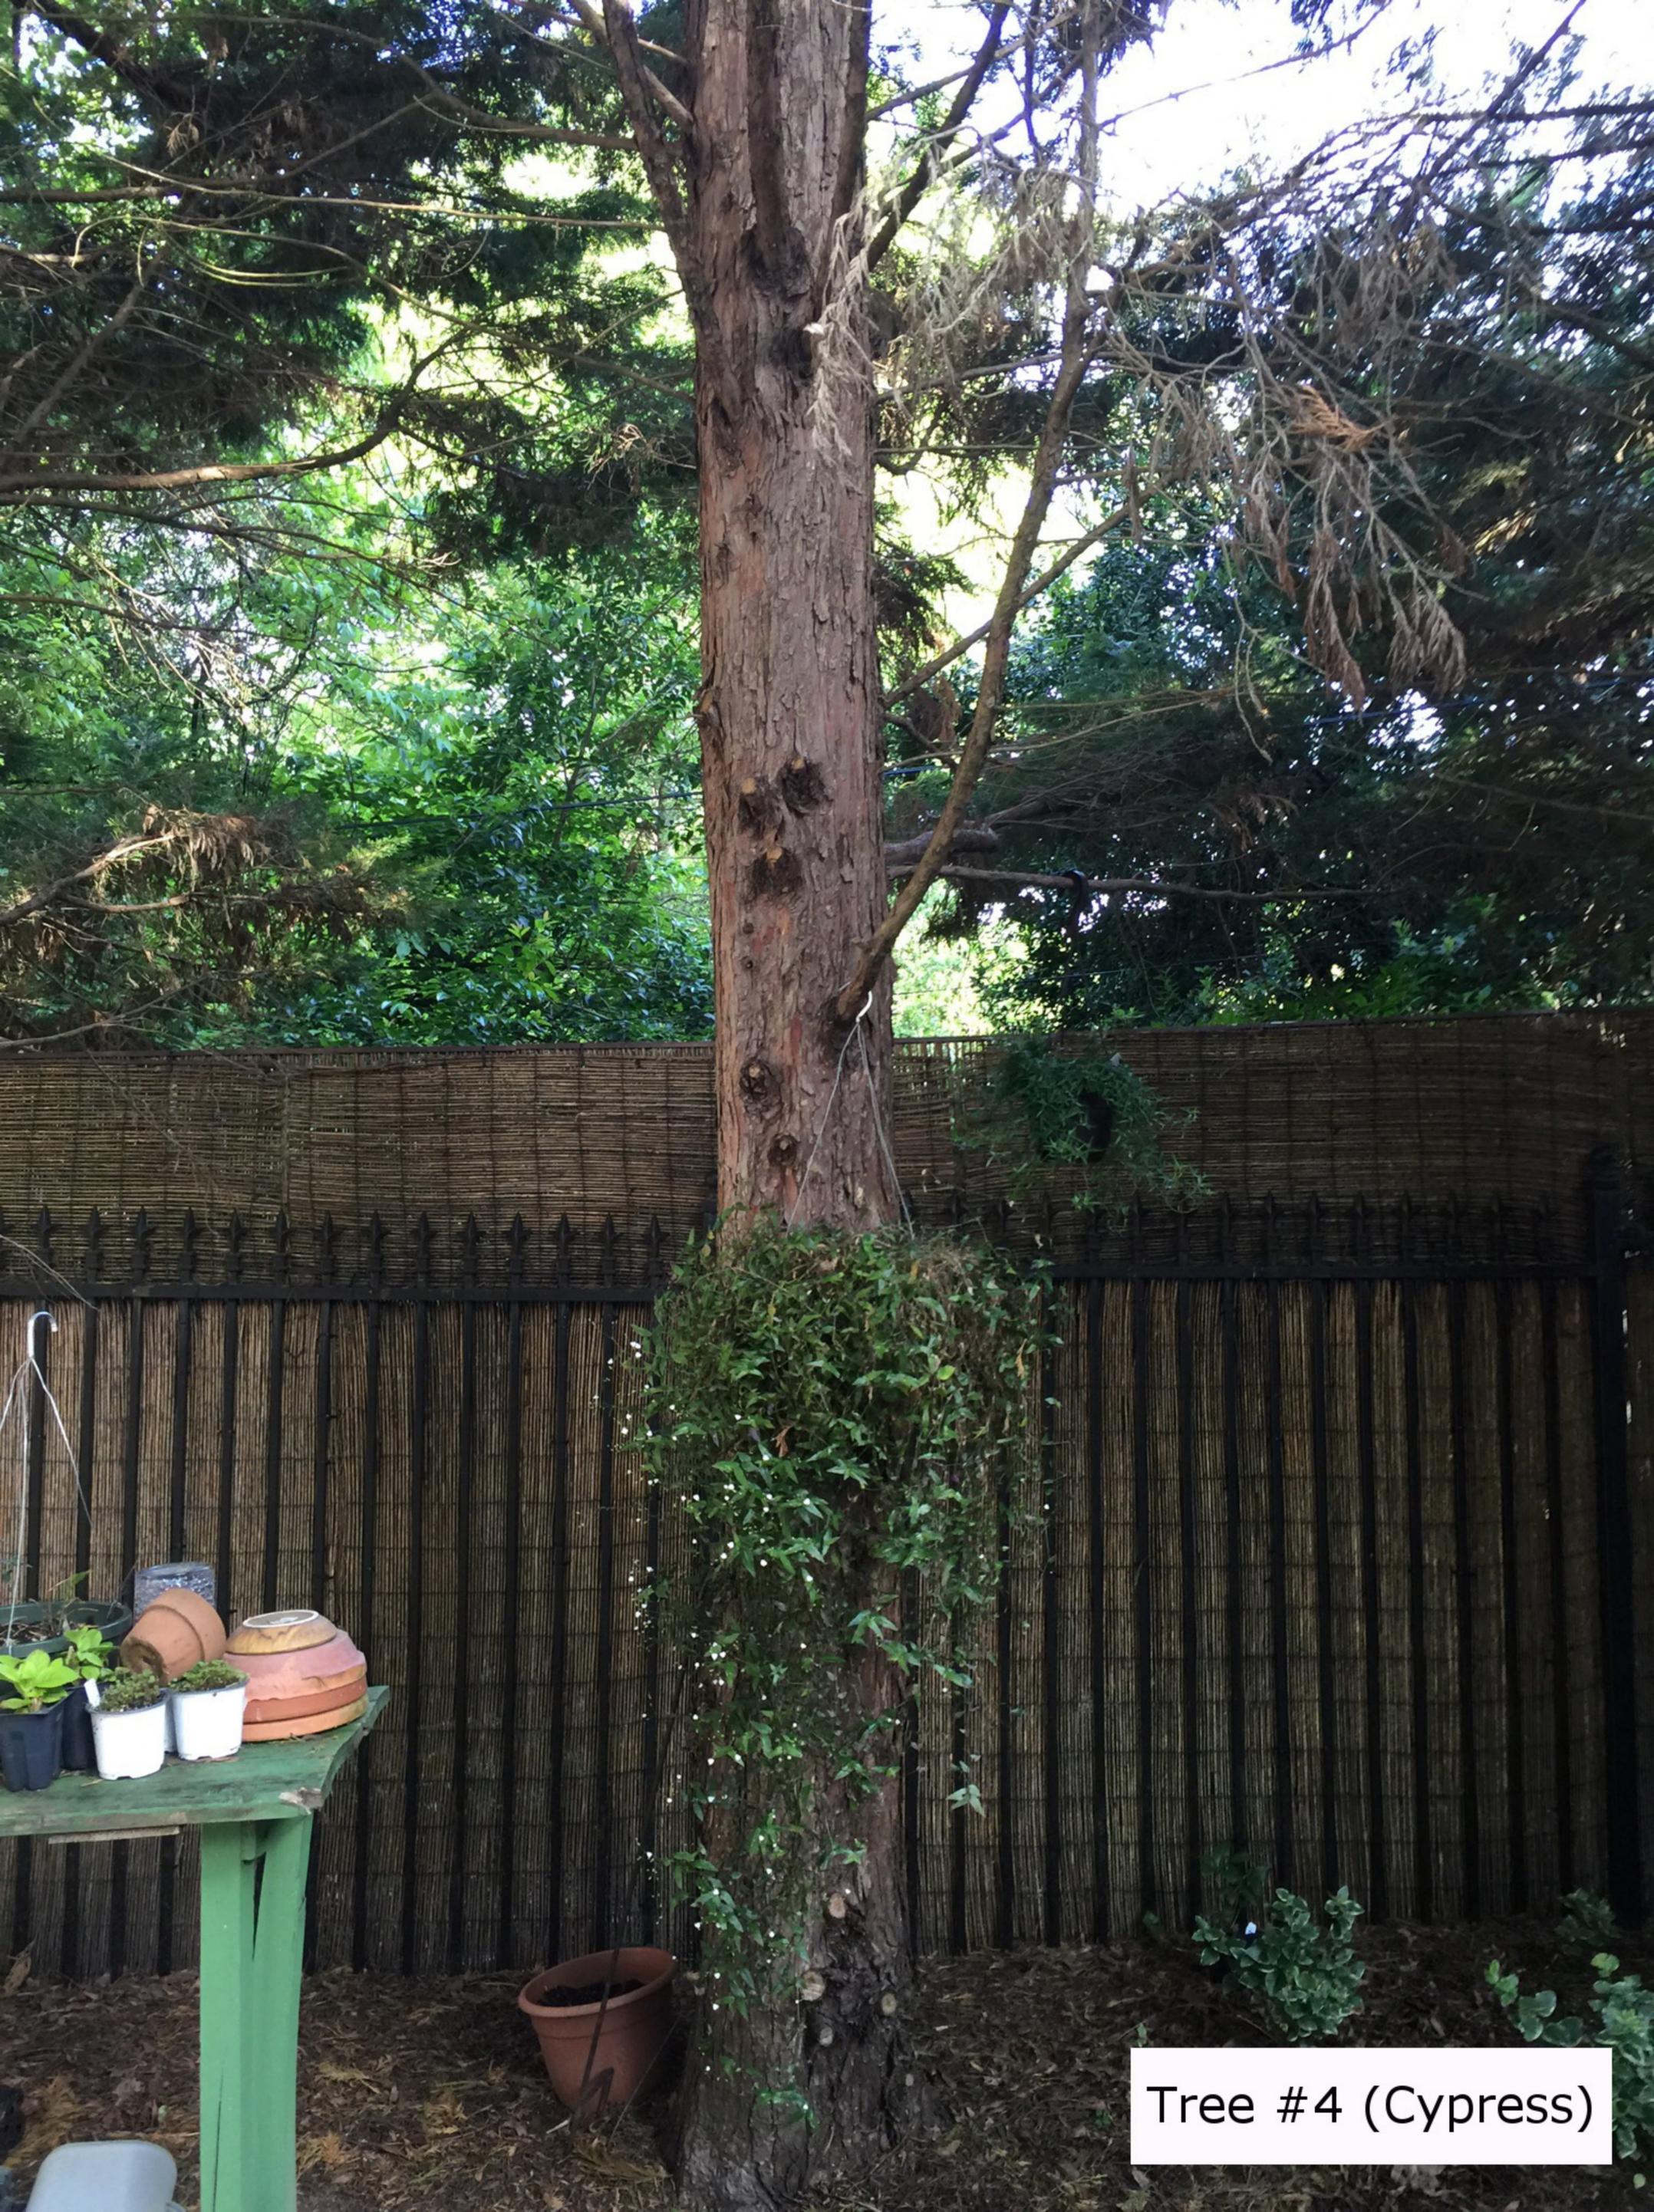
Tree #4 (Cypress)

This tree has out grown its location and foliage is heavy in direction of lean. This tree has no defects or risks beyond the normal for this species. *Bill Leake*

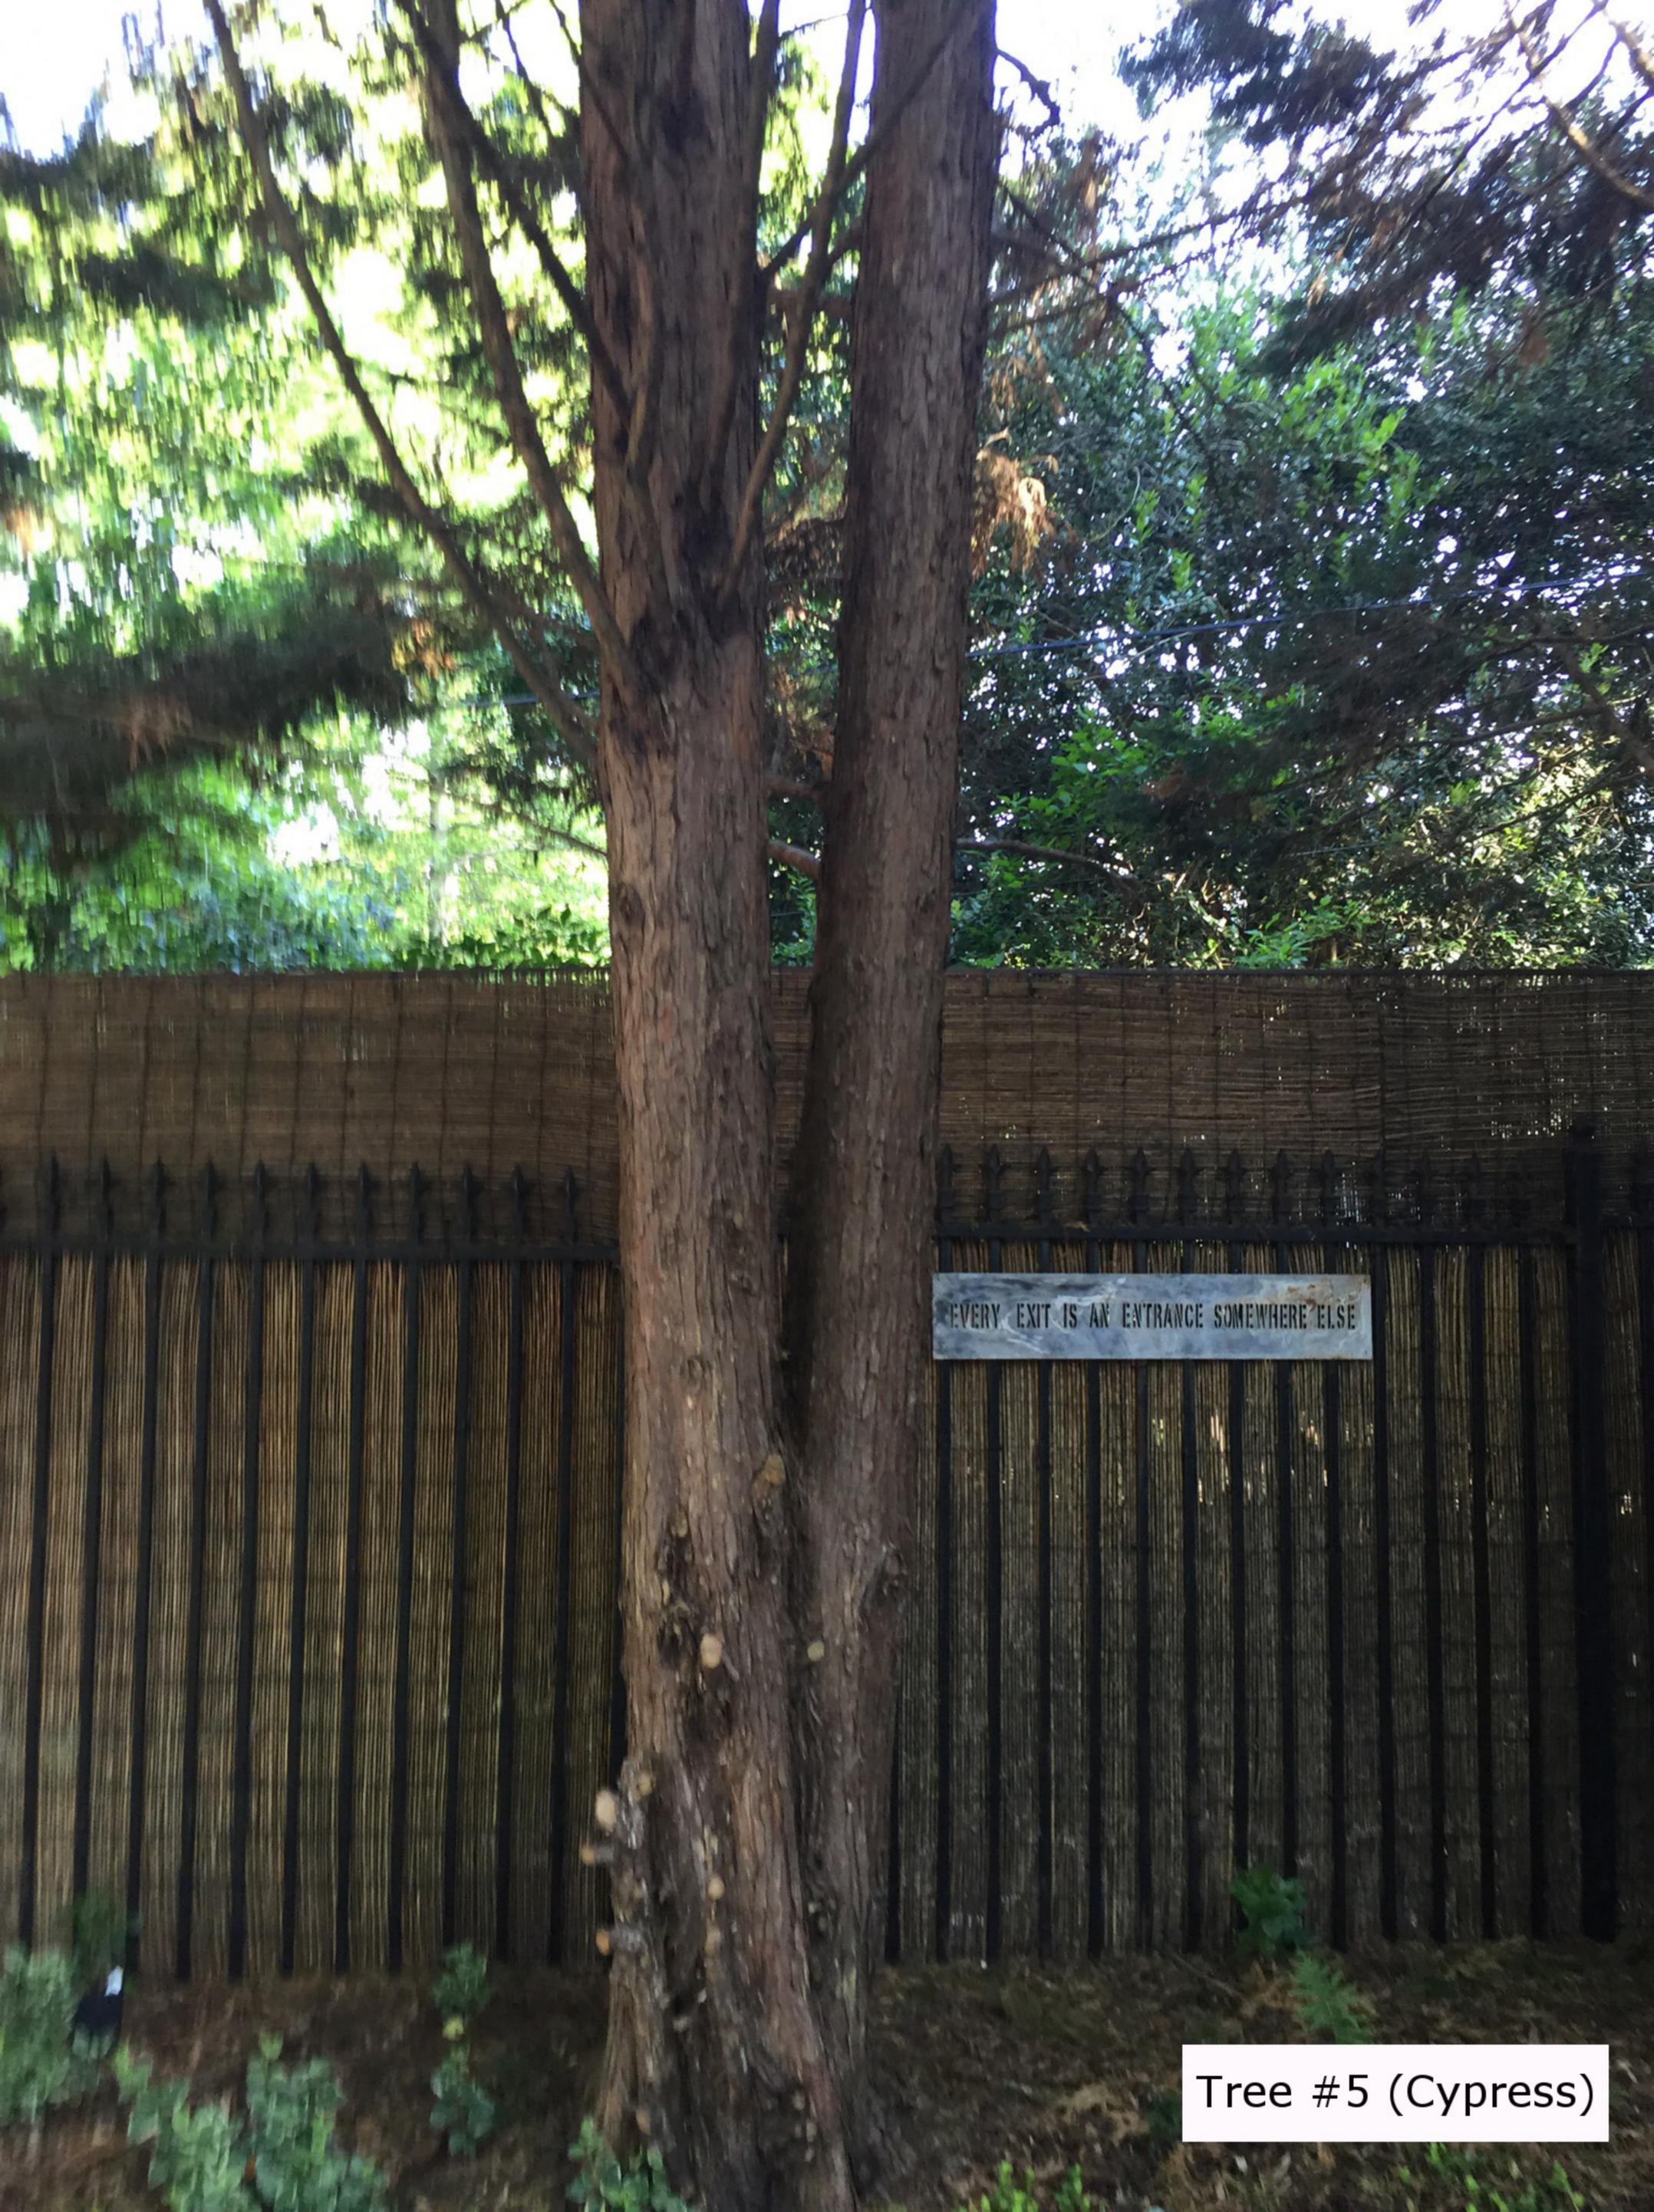
Tree #5 (Cypress)

This tree has out grown its location and foliage is heavy in direction of lean. This tree has no defects or risks beyond the normal for this species. *Bill Leake*

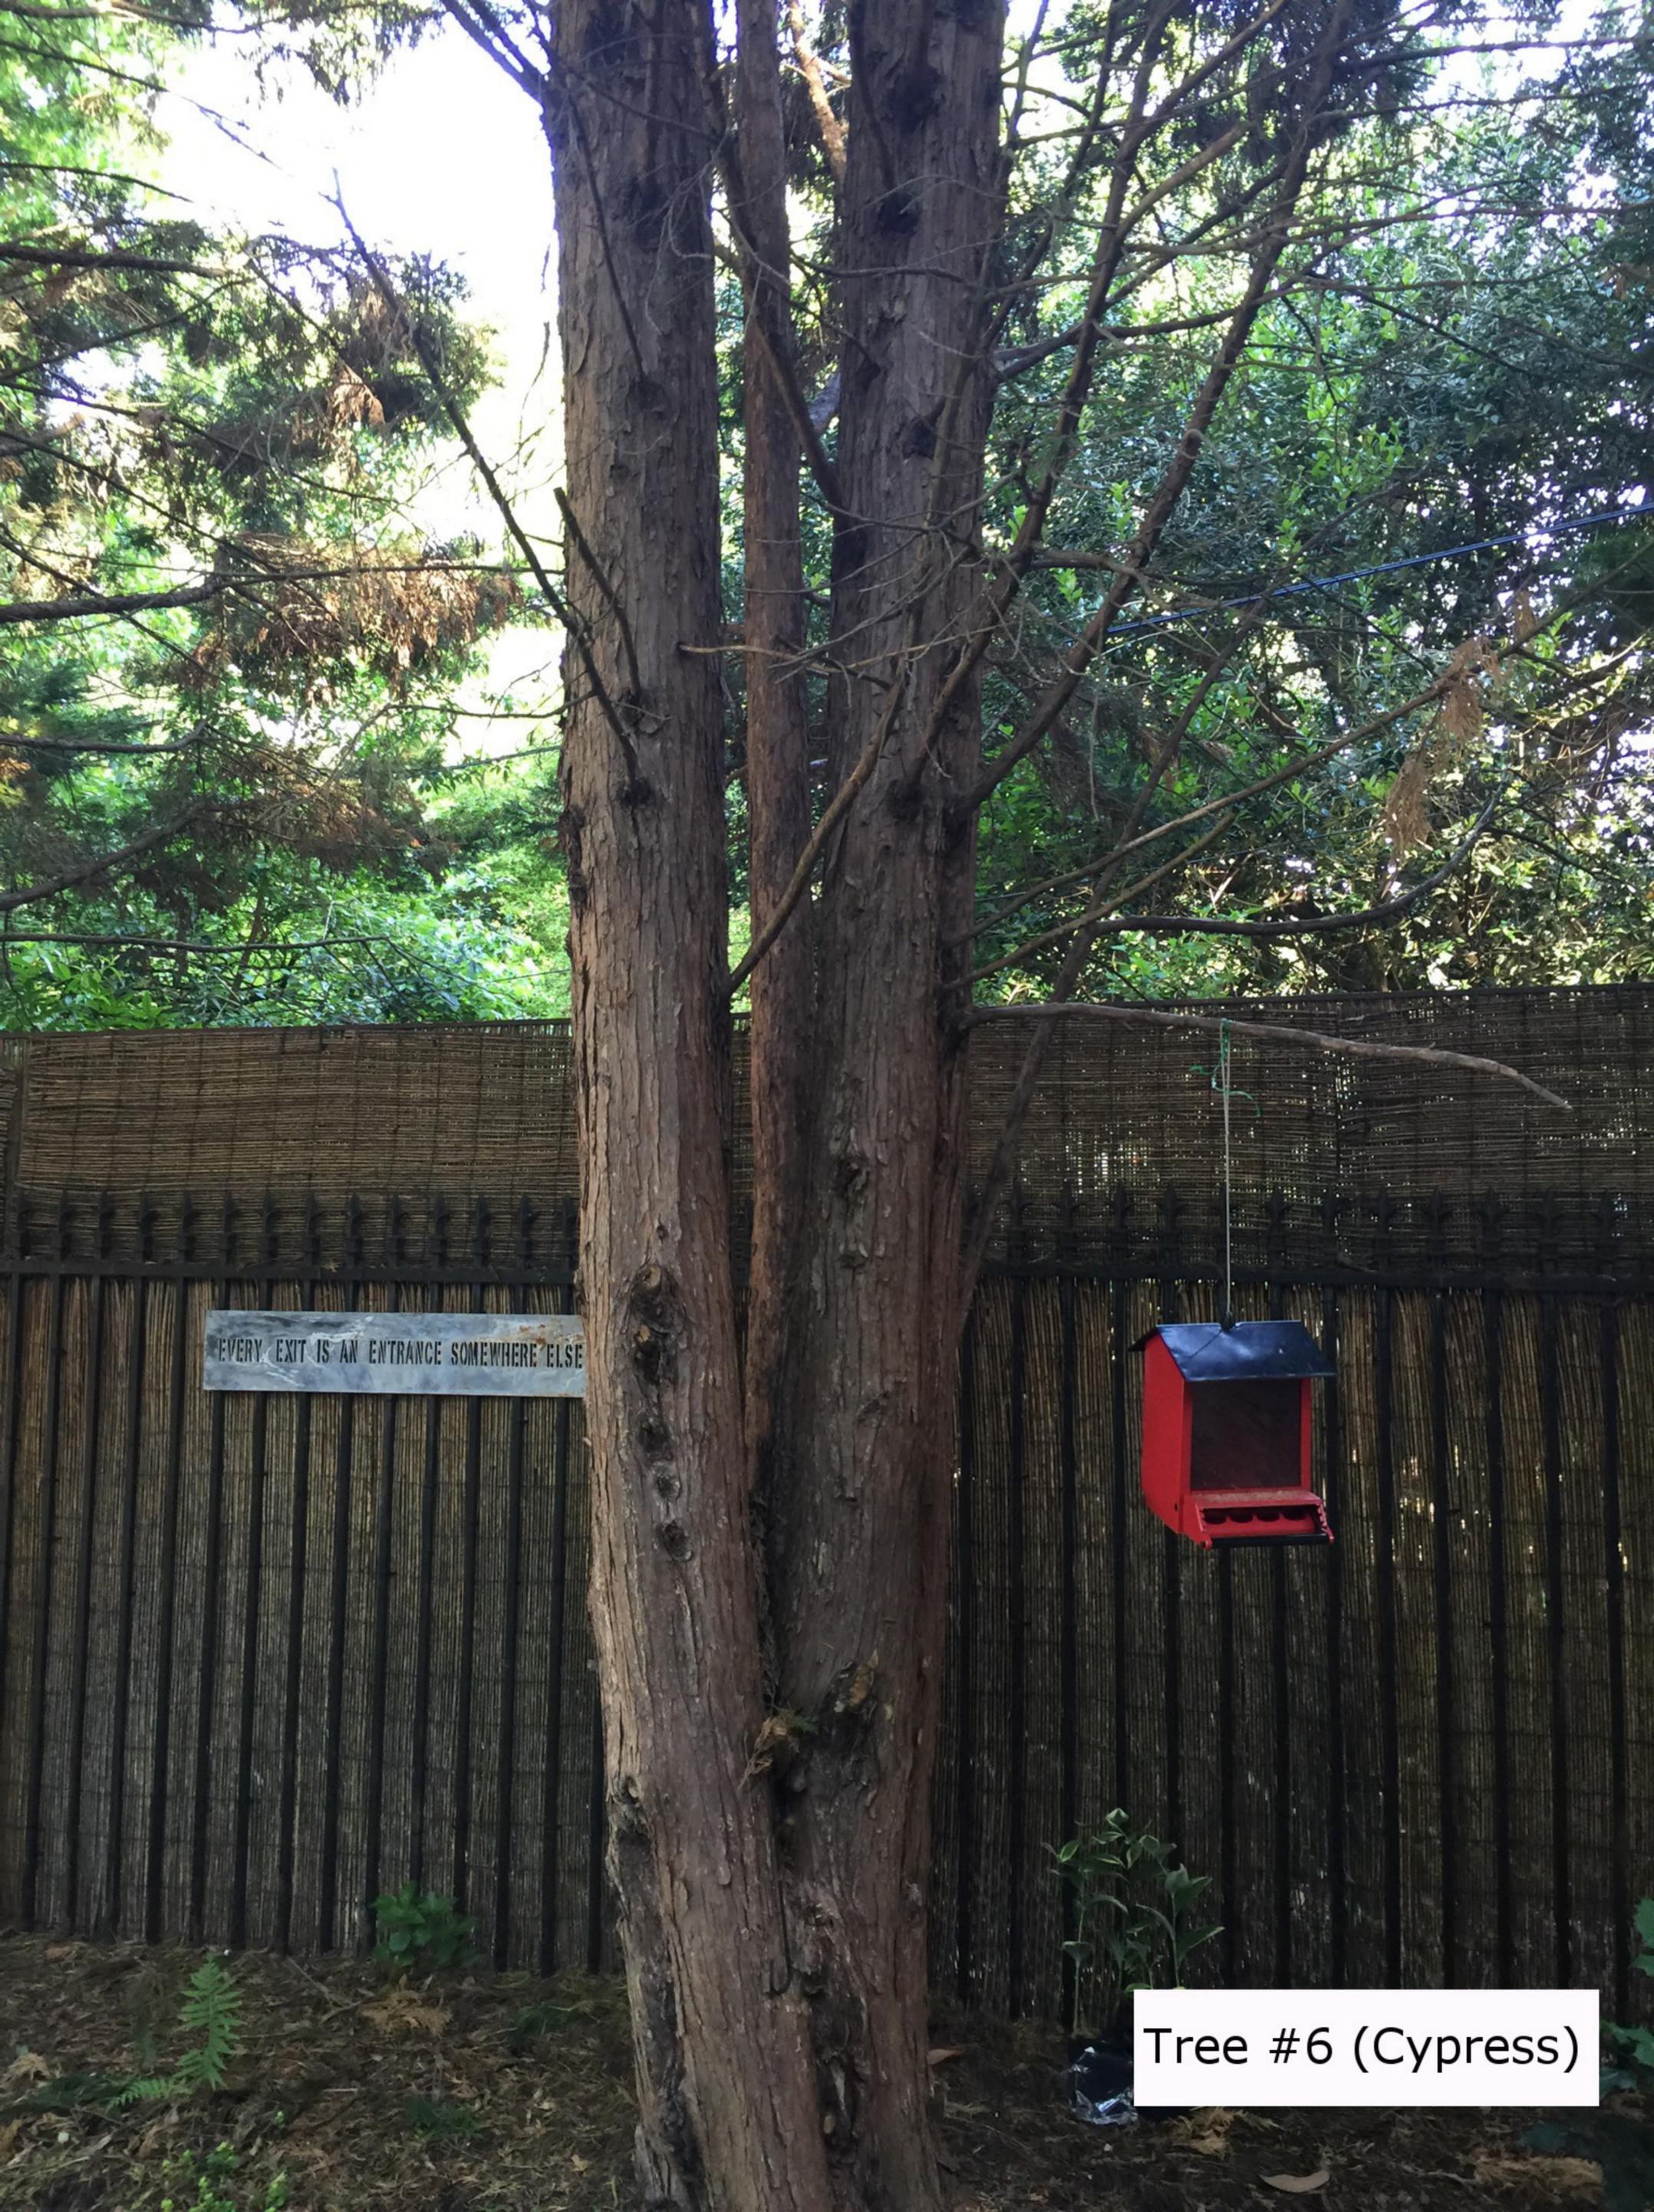
Tree #6 (Cypress)

This tree has out grown its location and foliage is heavy in direction of lean. This tree has no defects or risks beyond the normal for this species. *Bill Leake*
