HISTORIC PRESERVATION COMMISSION MEETING

Wednesday, June 8th, 2016 at 7:00 p.m.
Municipal Building, 35 Cabarrus Avenue, West

Certificate of Appropriateness Request : H-12-16

Staff Report prepared by: Starla A. Rogers, Sr. Planner

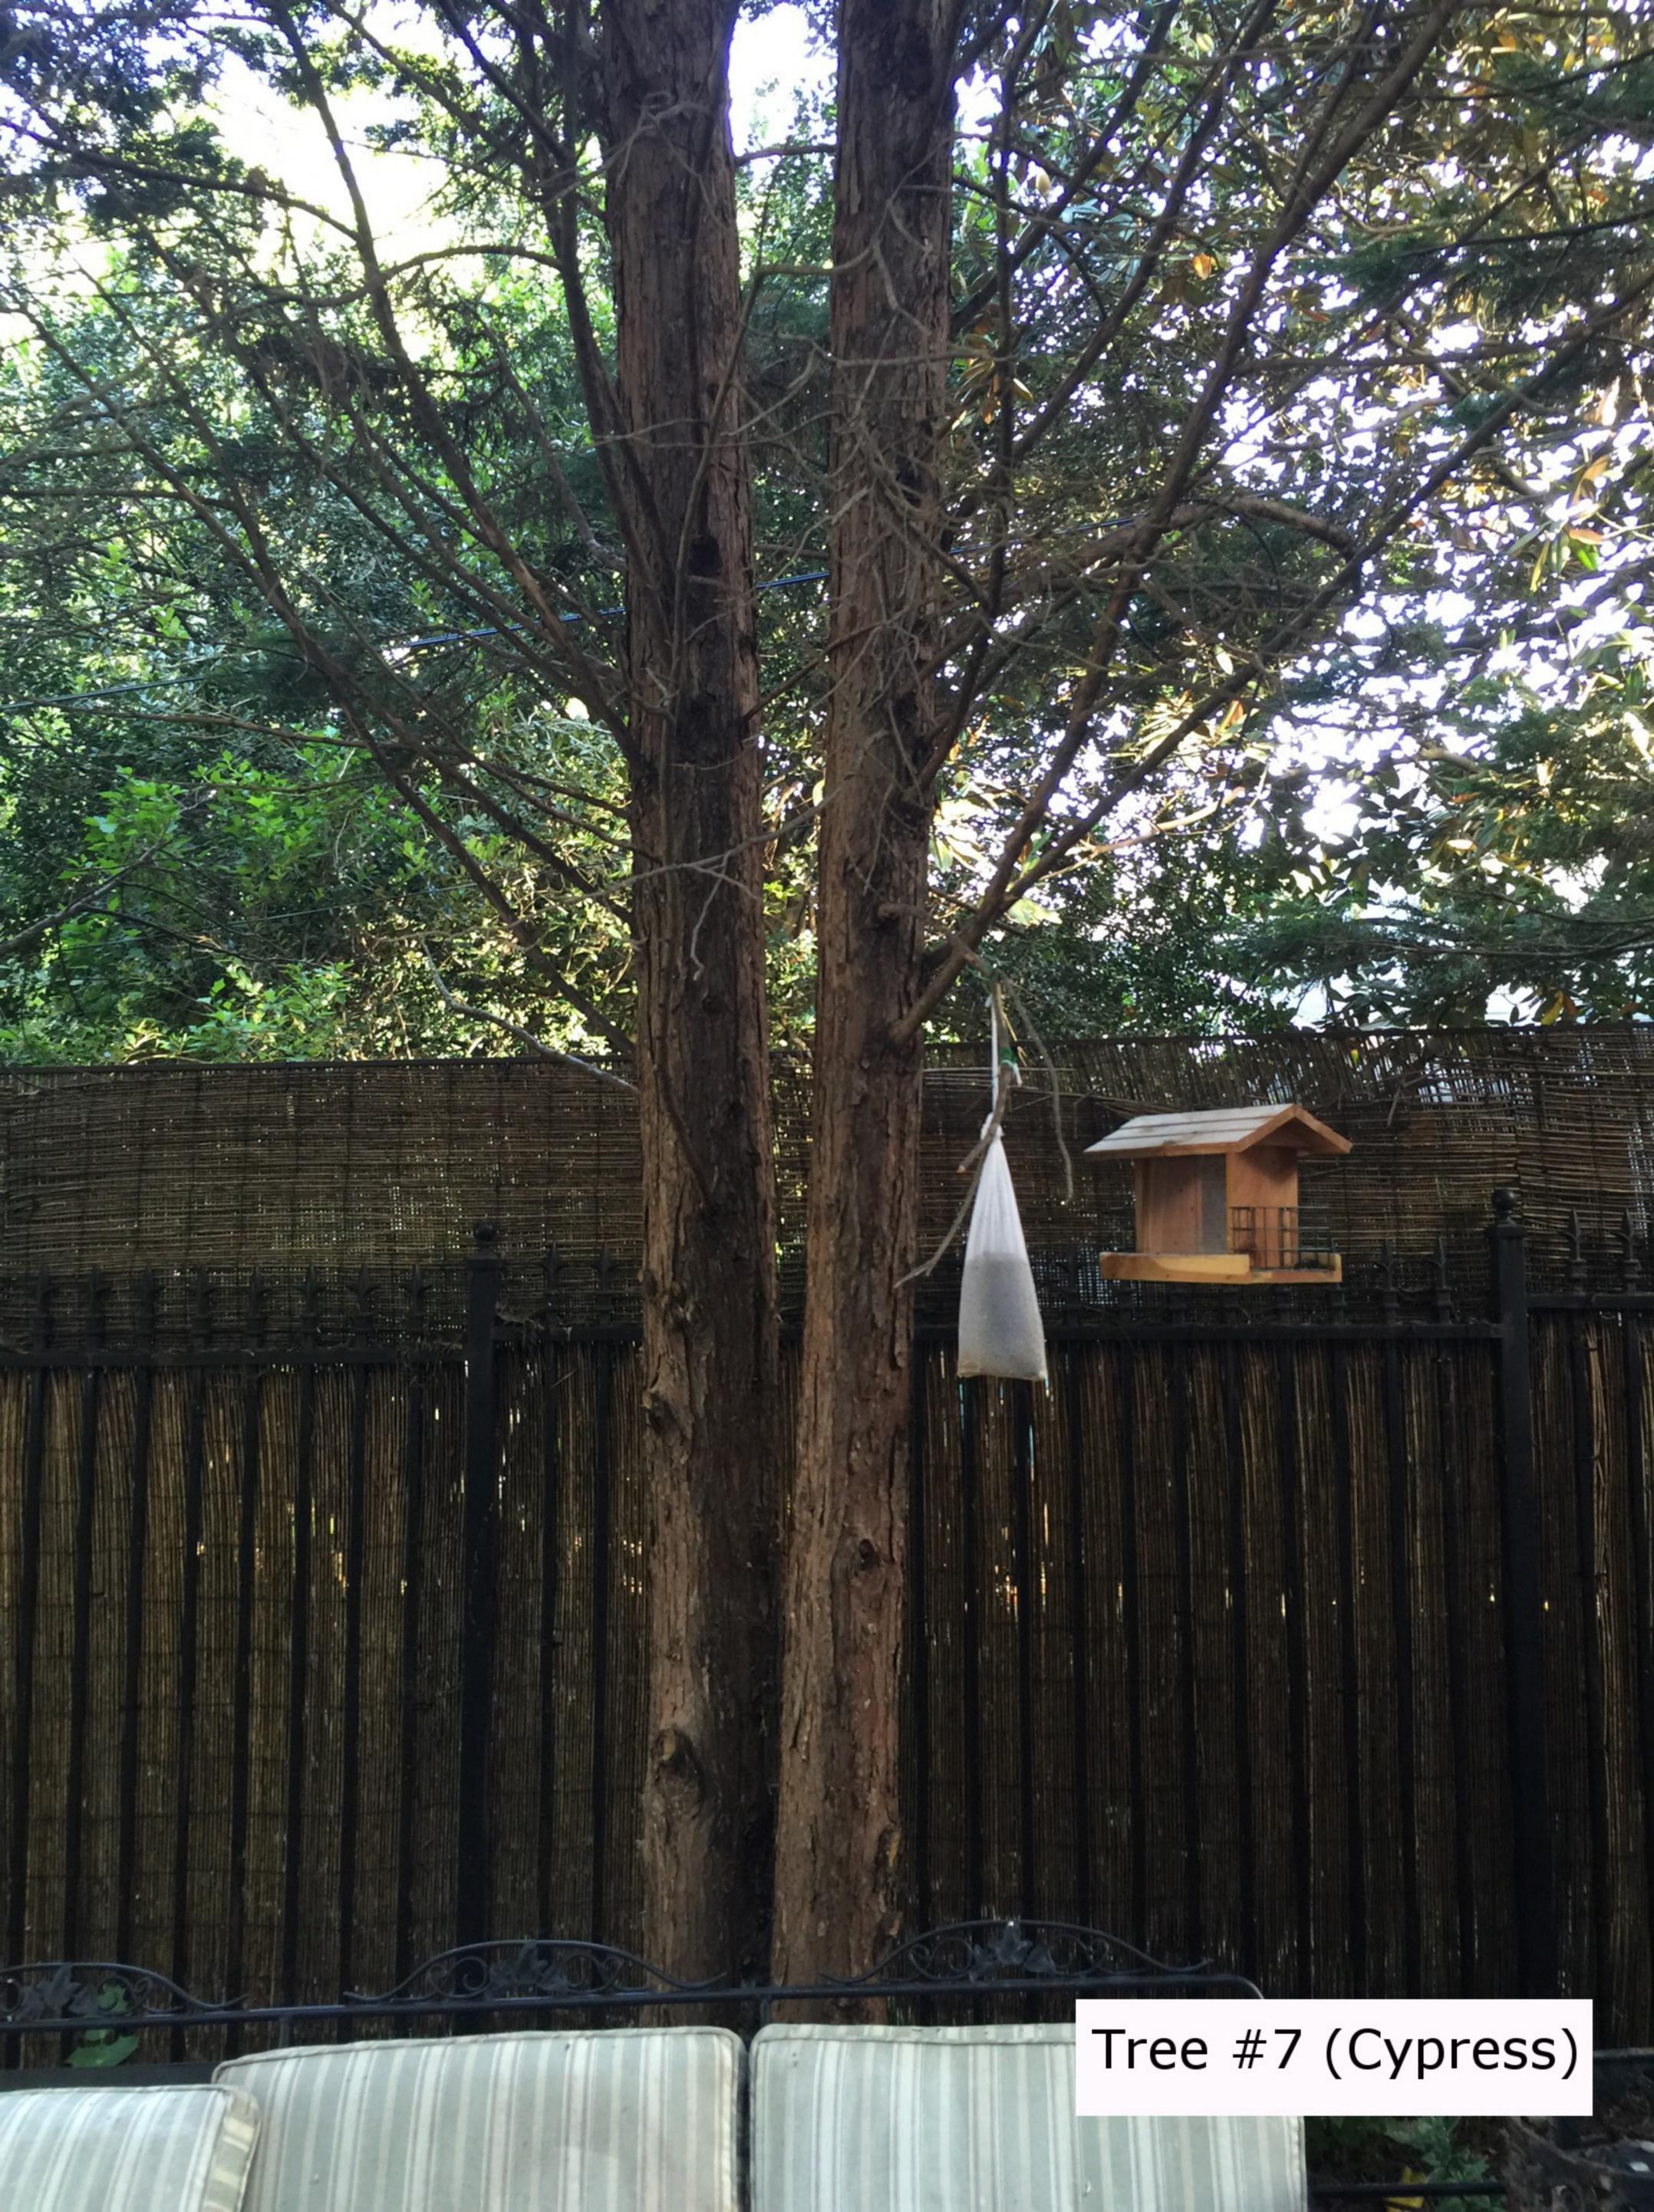
Tree #7 (Cypress)

This tree has out grown its location and limbs are contacting edge of roof line. This tree has no defects or risks beyond the normal for this species. *Bill Leake*

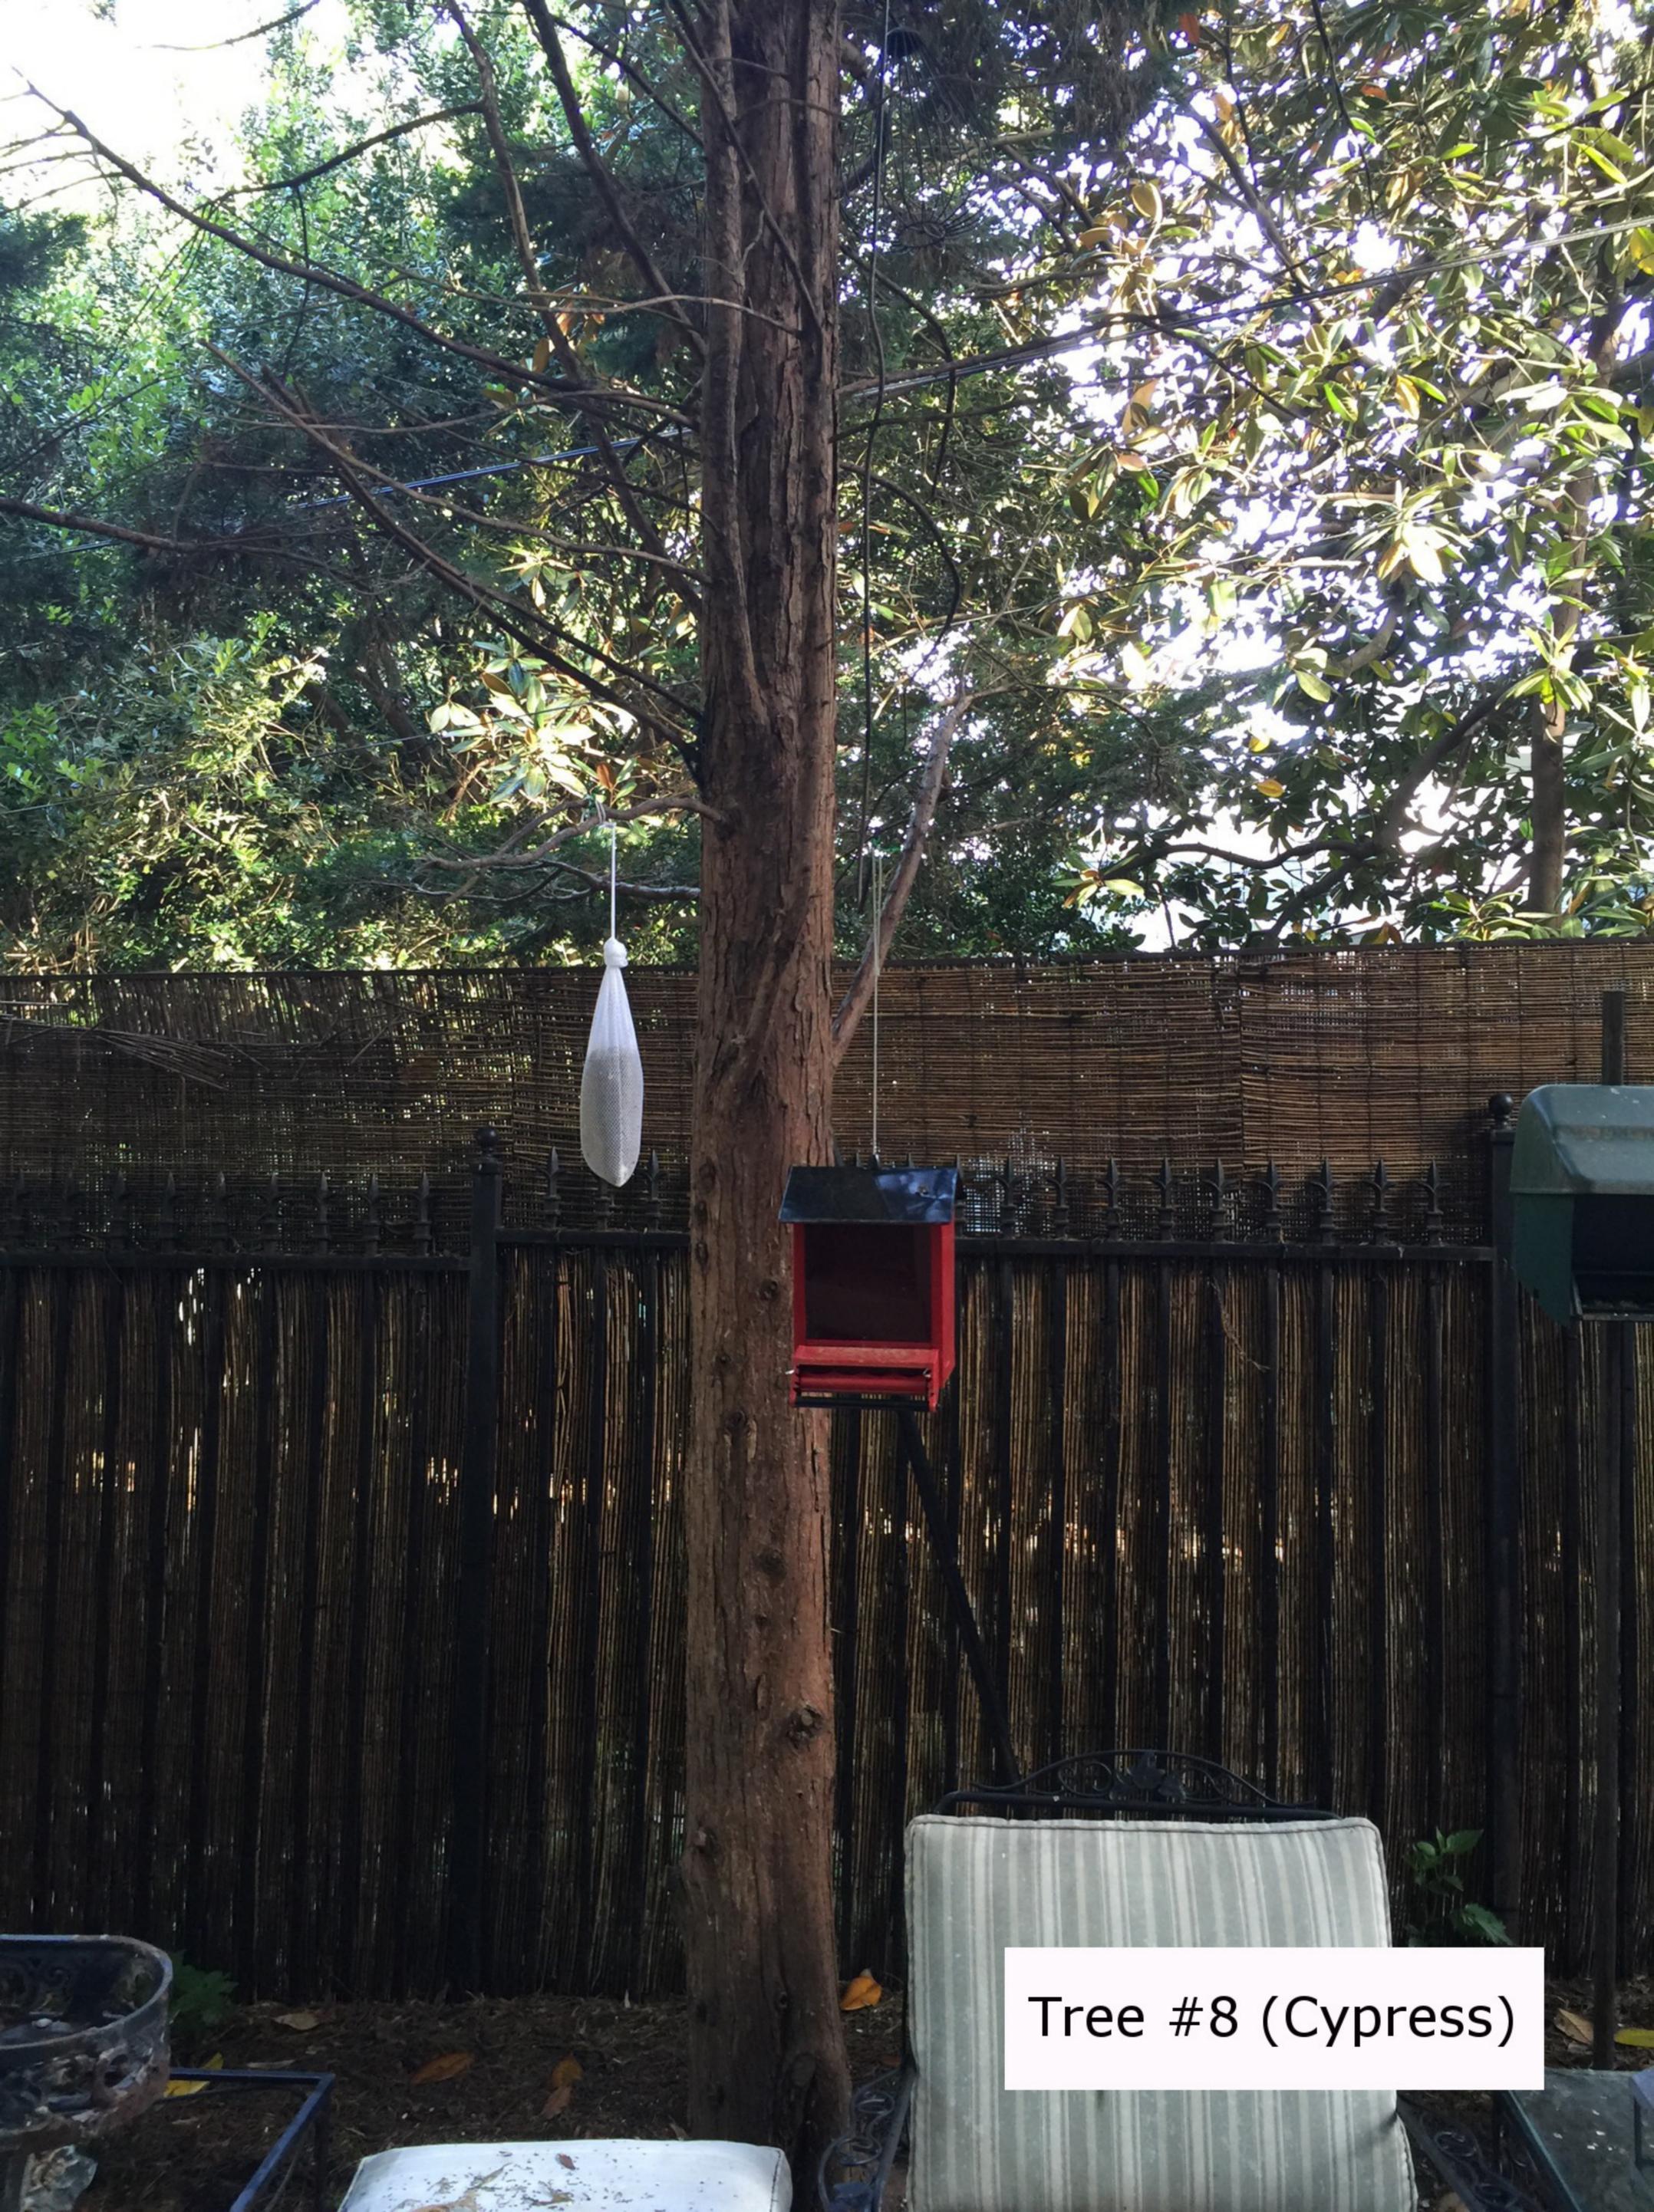
Tree #8 (Cypress)

This tree has out grown its location and limbs are contacting edge of roof line. This tree has no defects or risks beyond the normal for this species. *Bill Leake*

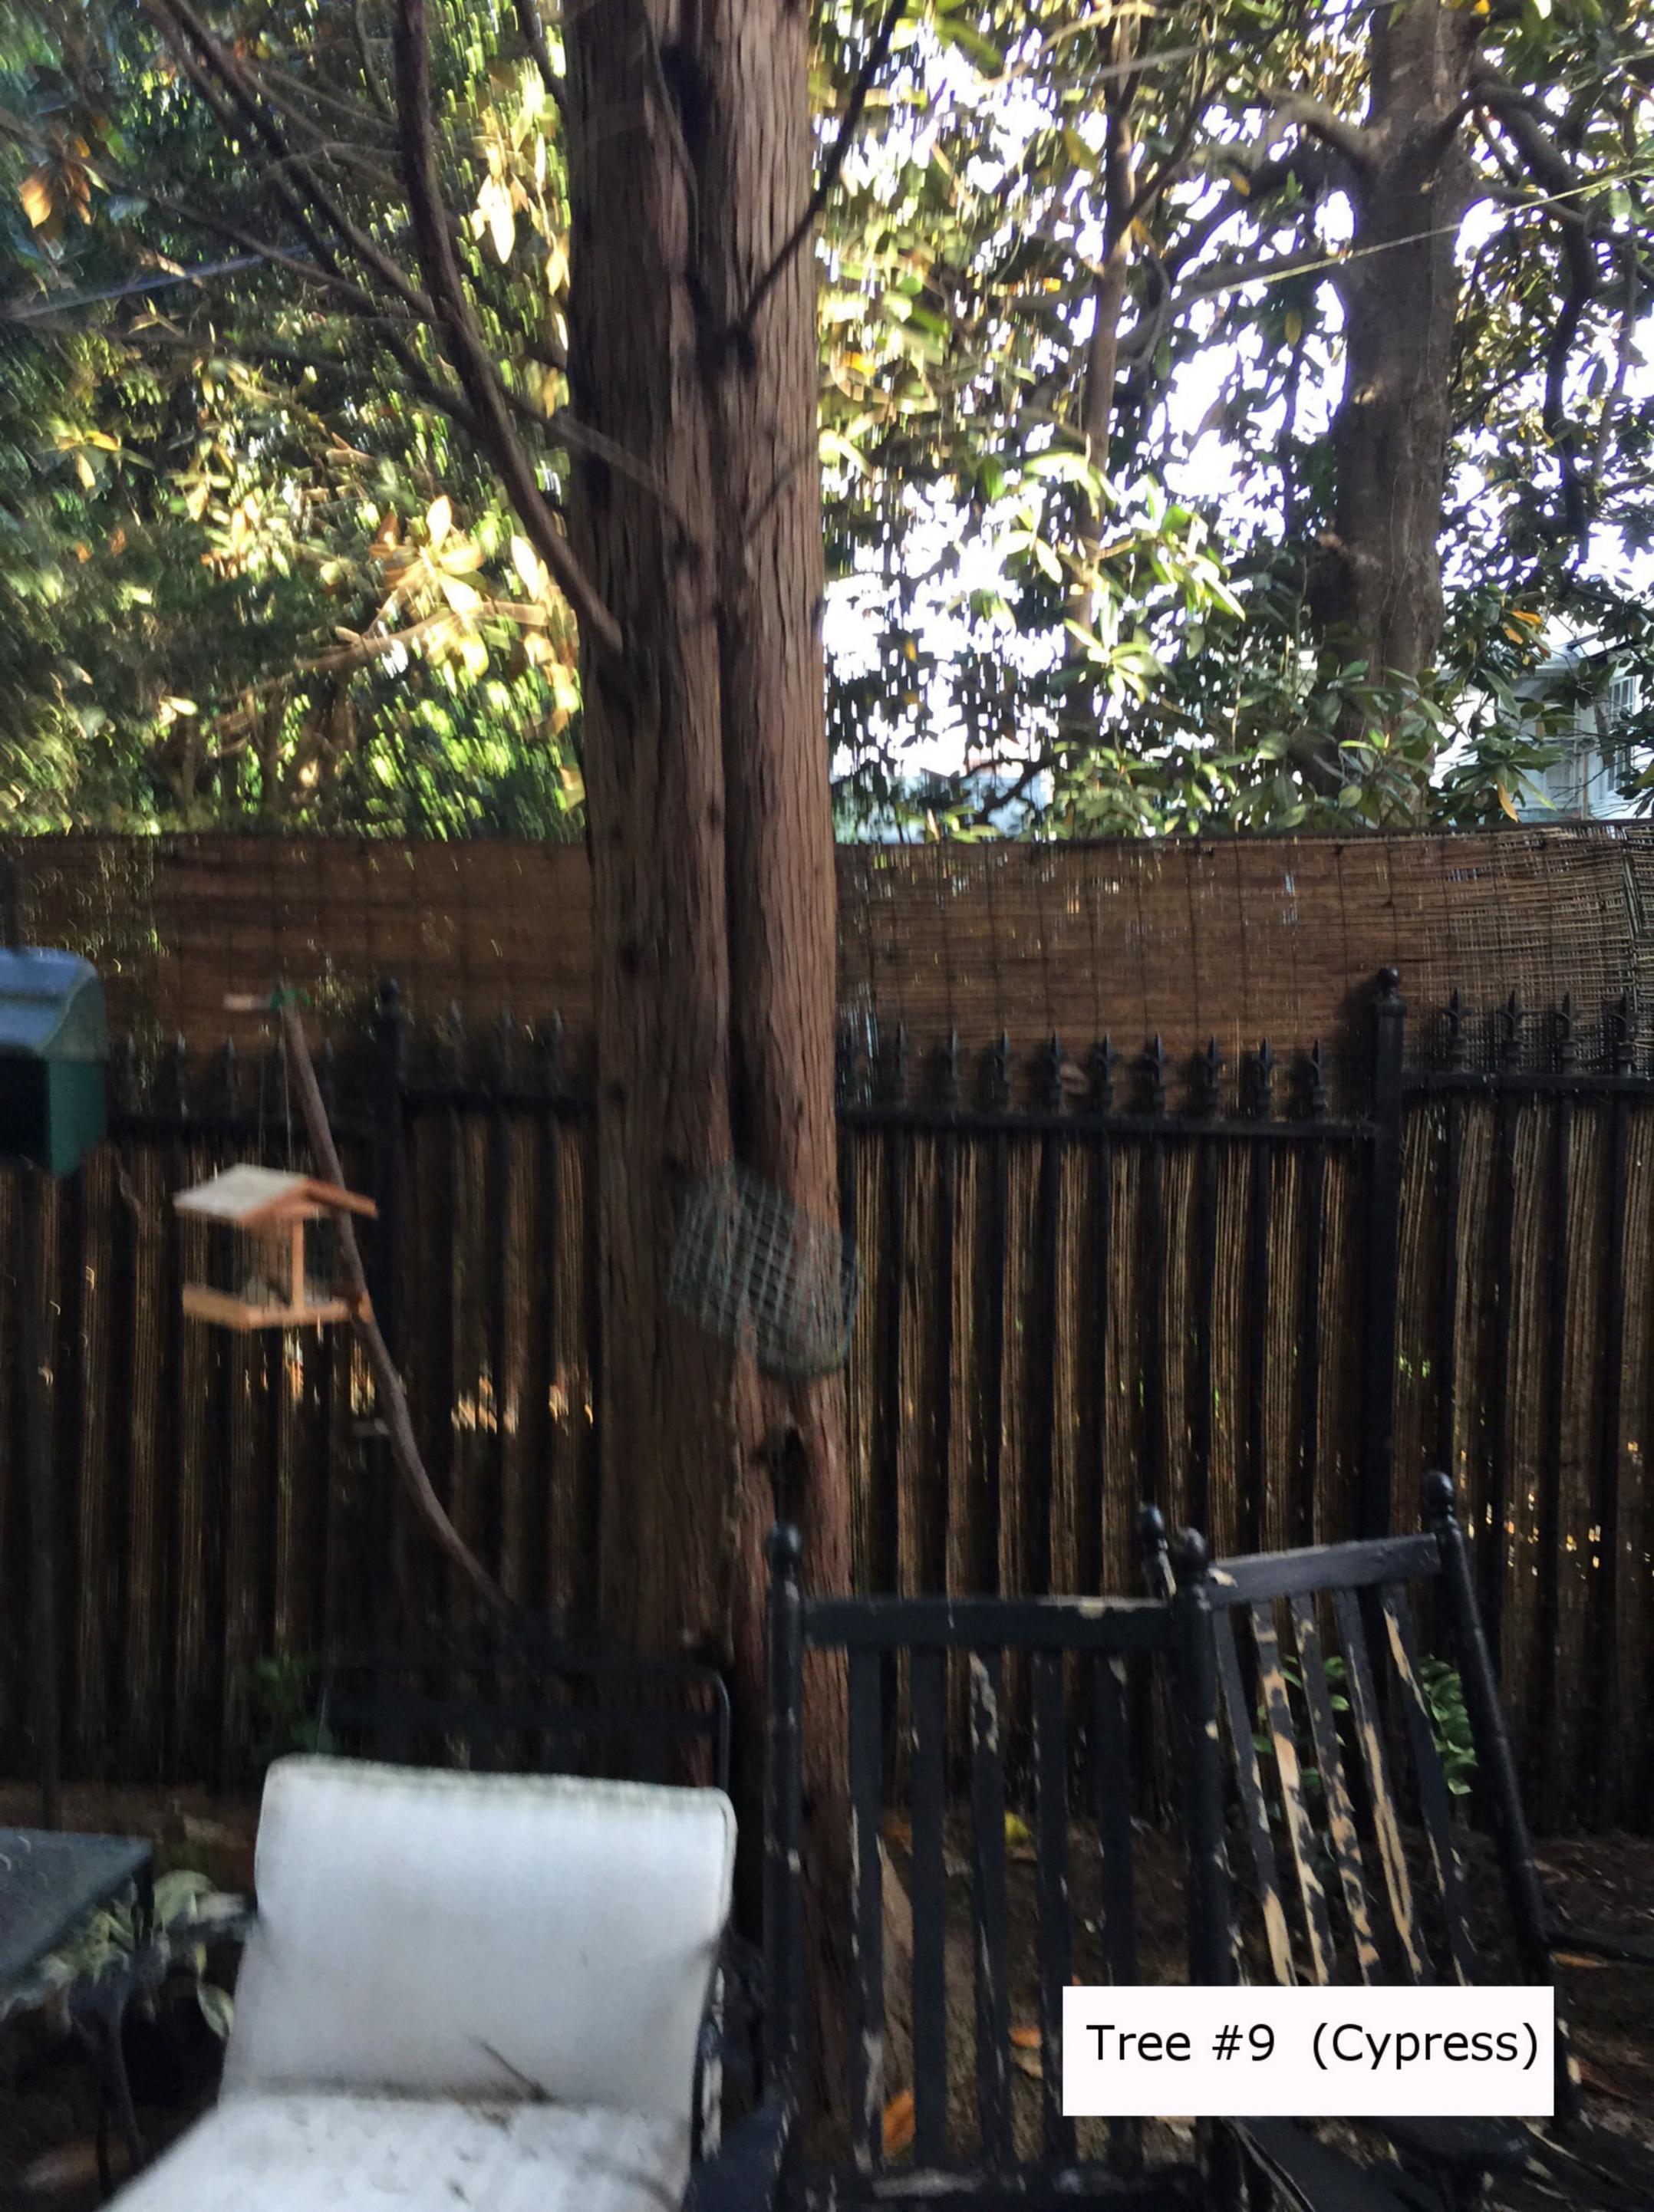
Tree #9 (Cypress)

This tree has out grown its location and limbs are contacting edge of roof line. This tree has no defects or risks beyond the normal for this species. *Bill Leake*

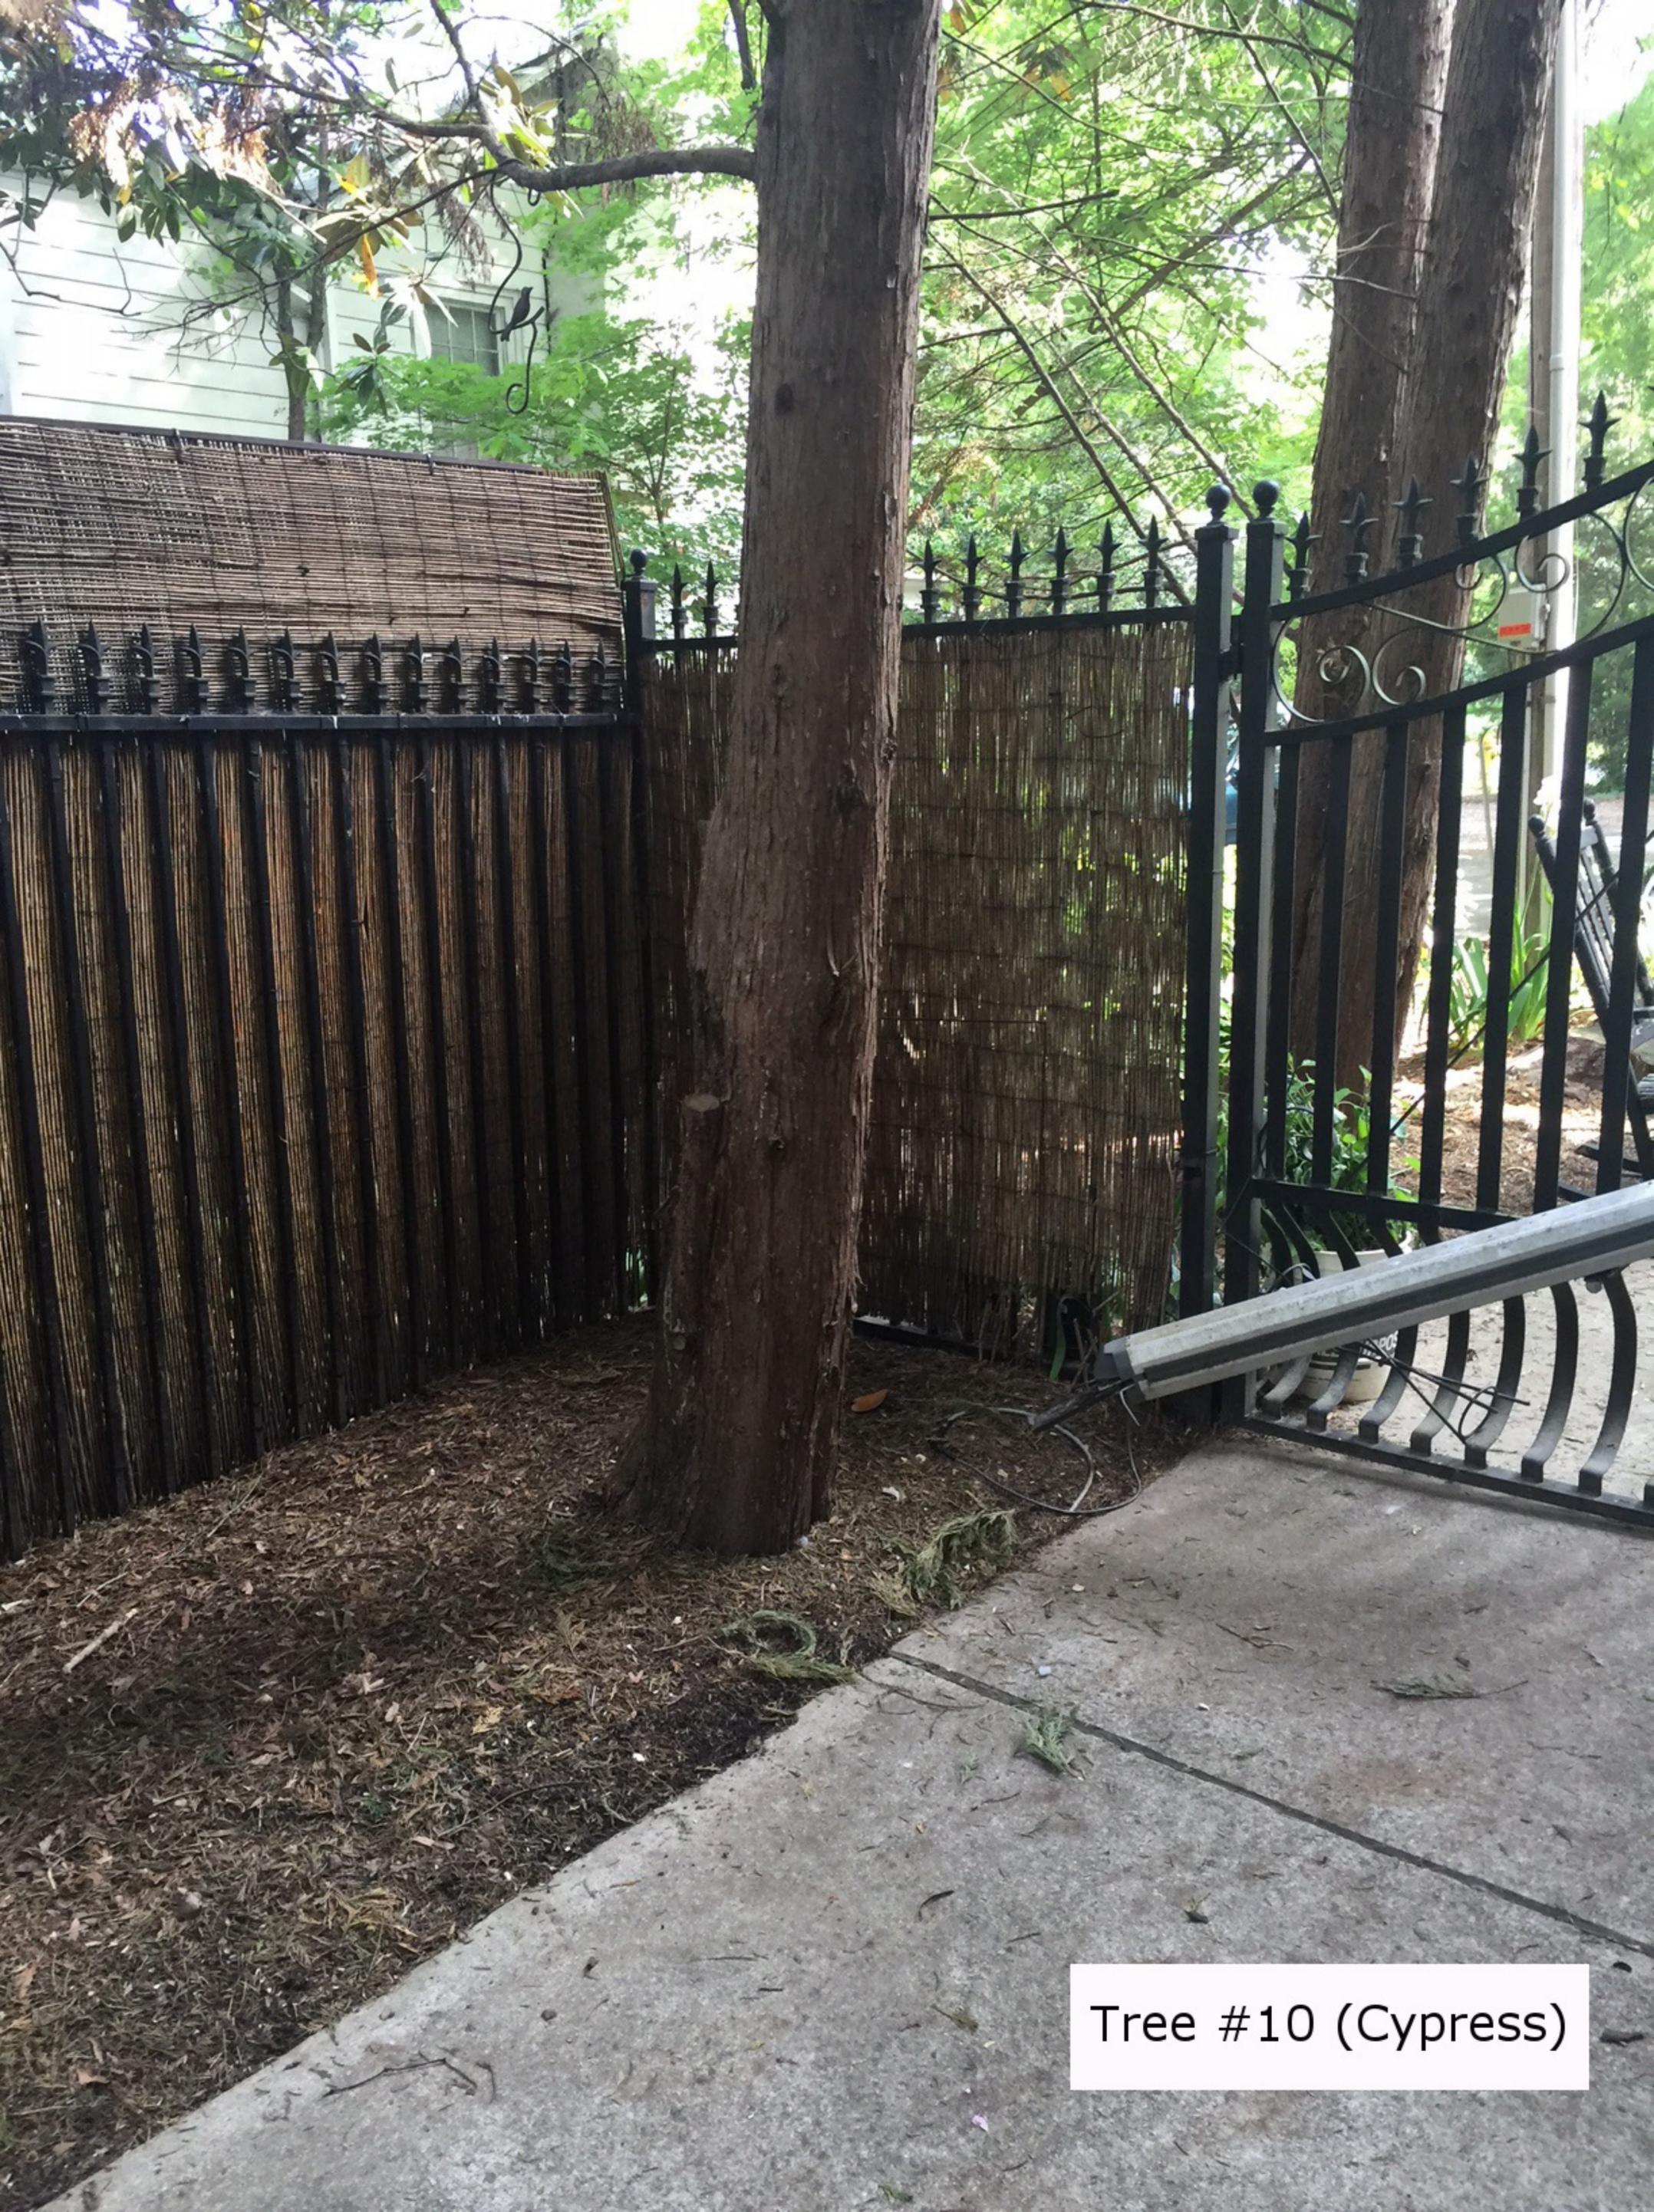
Tree #10 (Cypress)

This tree has out grown its location. This tree has no defects or risks beyond the normal for this species. *Bill Leake*

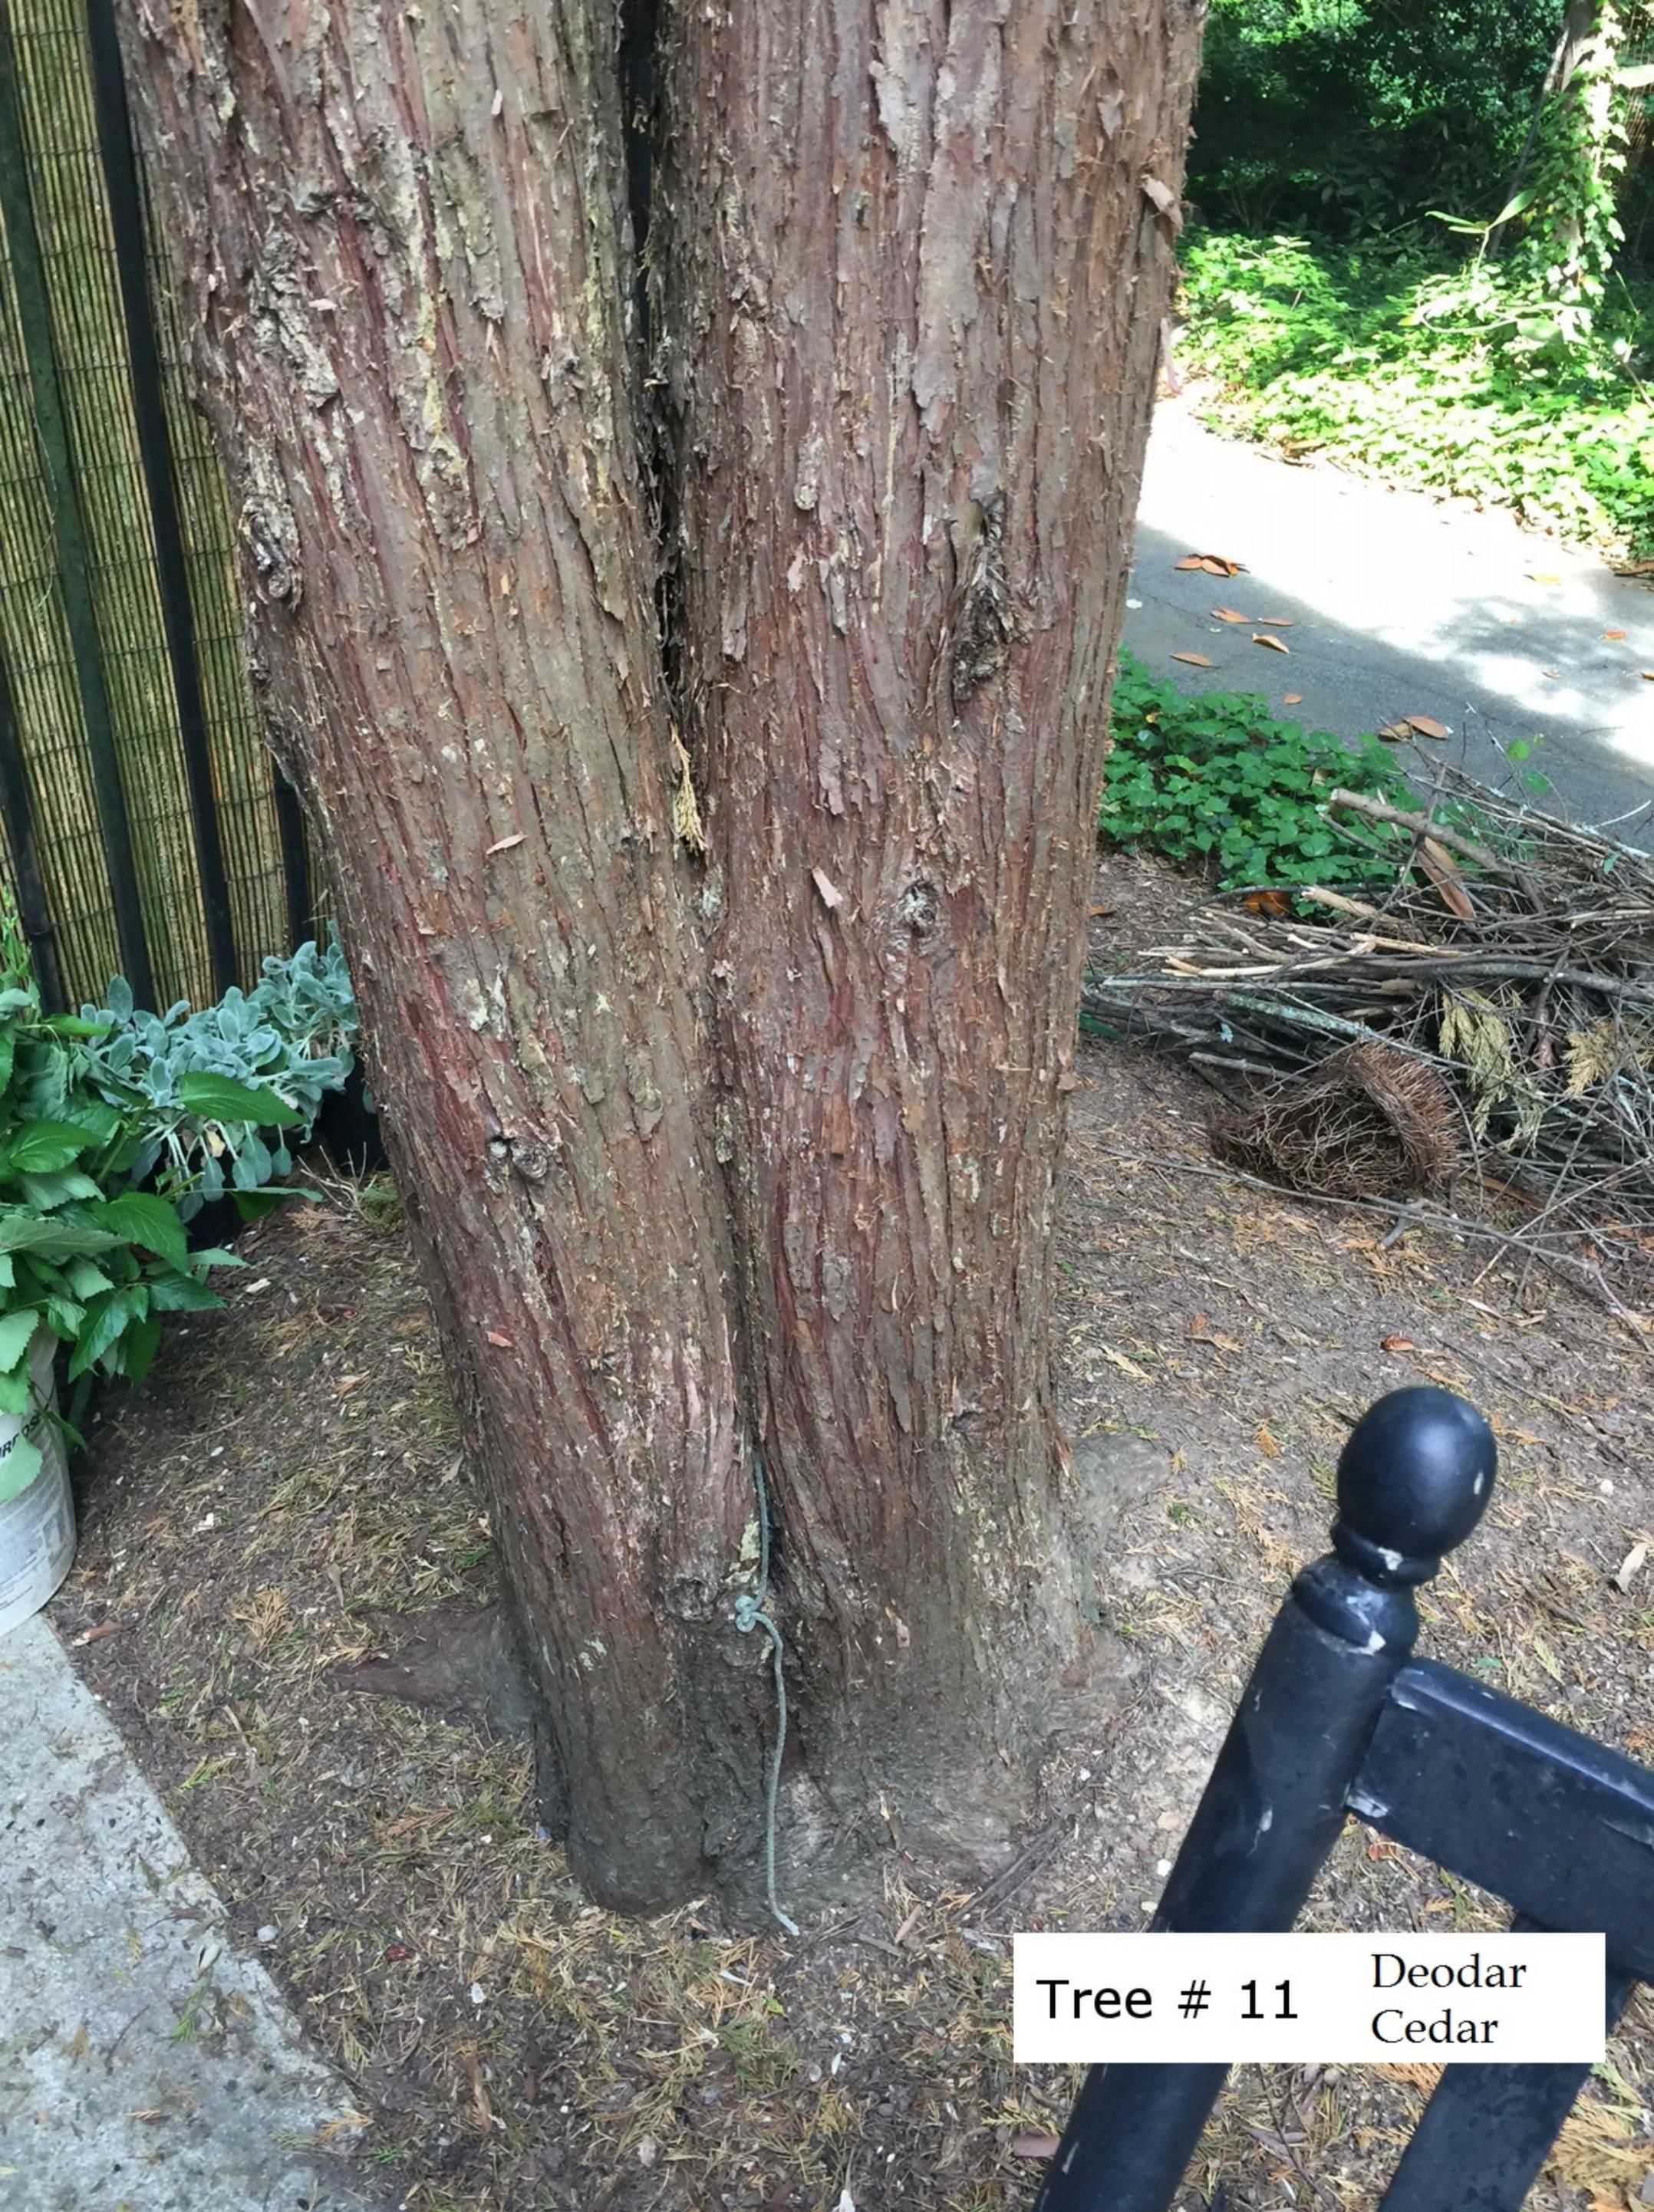
Tree # 11 Deodar Cedar

This tree has out grown its location. The co-dominate trunks do increase the probability of trunk failure impacting the adjacent property.
