HISTORIC PRESERVATION COMMISSION MEETING

Wednesday, June 8th, 2016 at 7:00 p.m.
Municipal Building, 35 Cabarrus Avenue, West

Certificate of Appropriateness Request : H-12-16

Staff Report prepared by: Starla A. Rogers, Sr. Planner

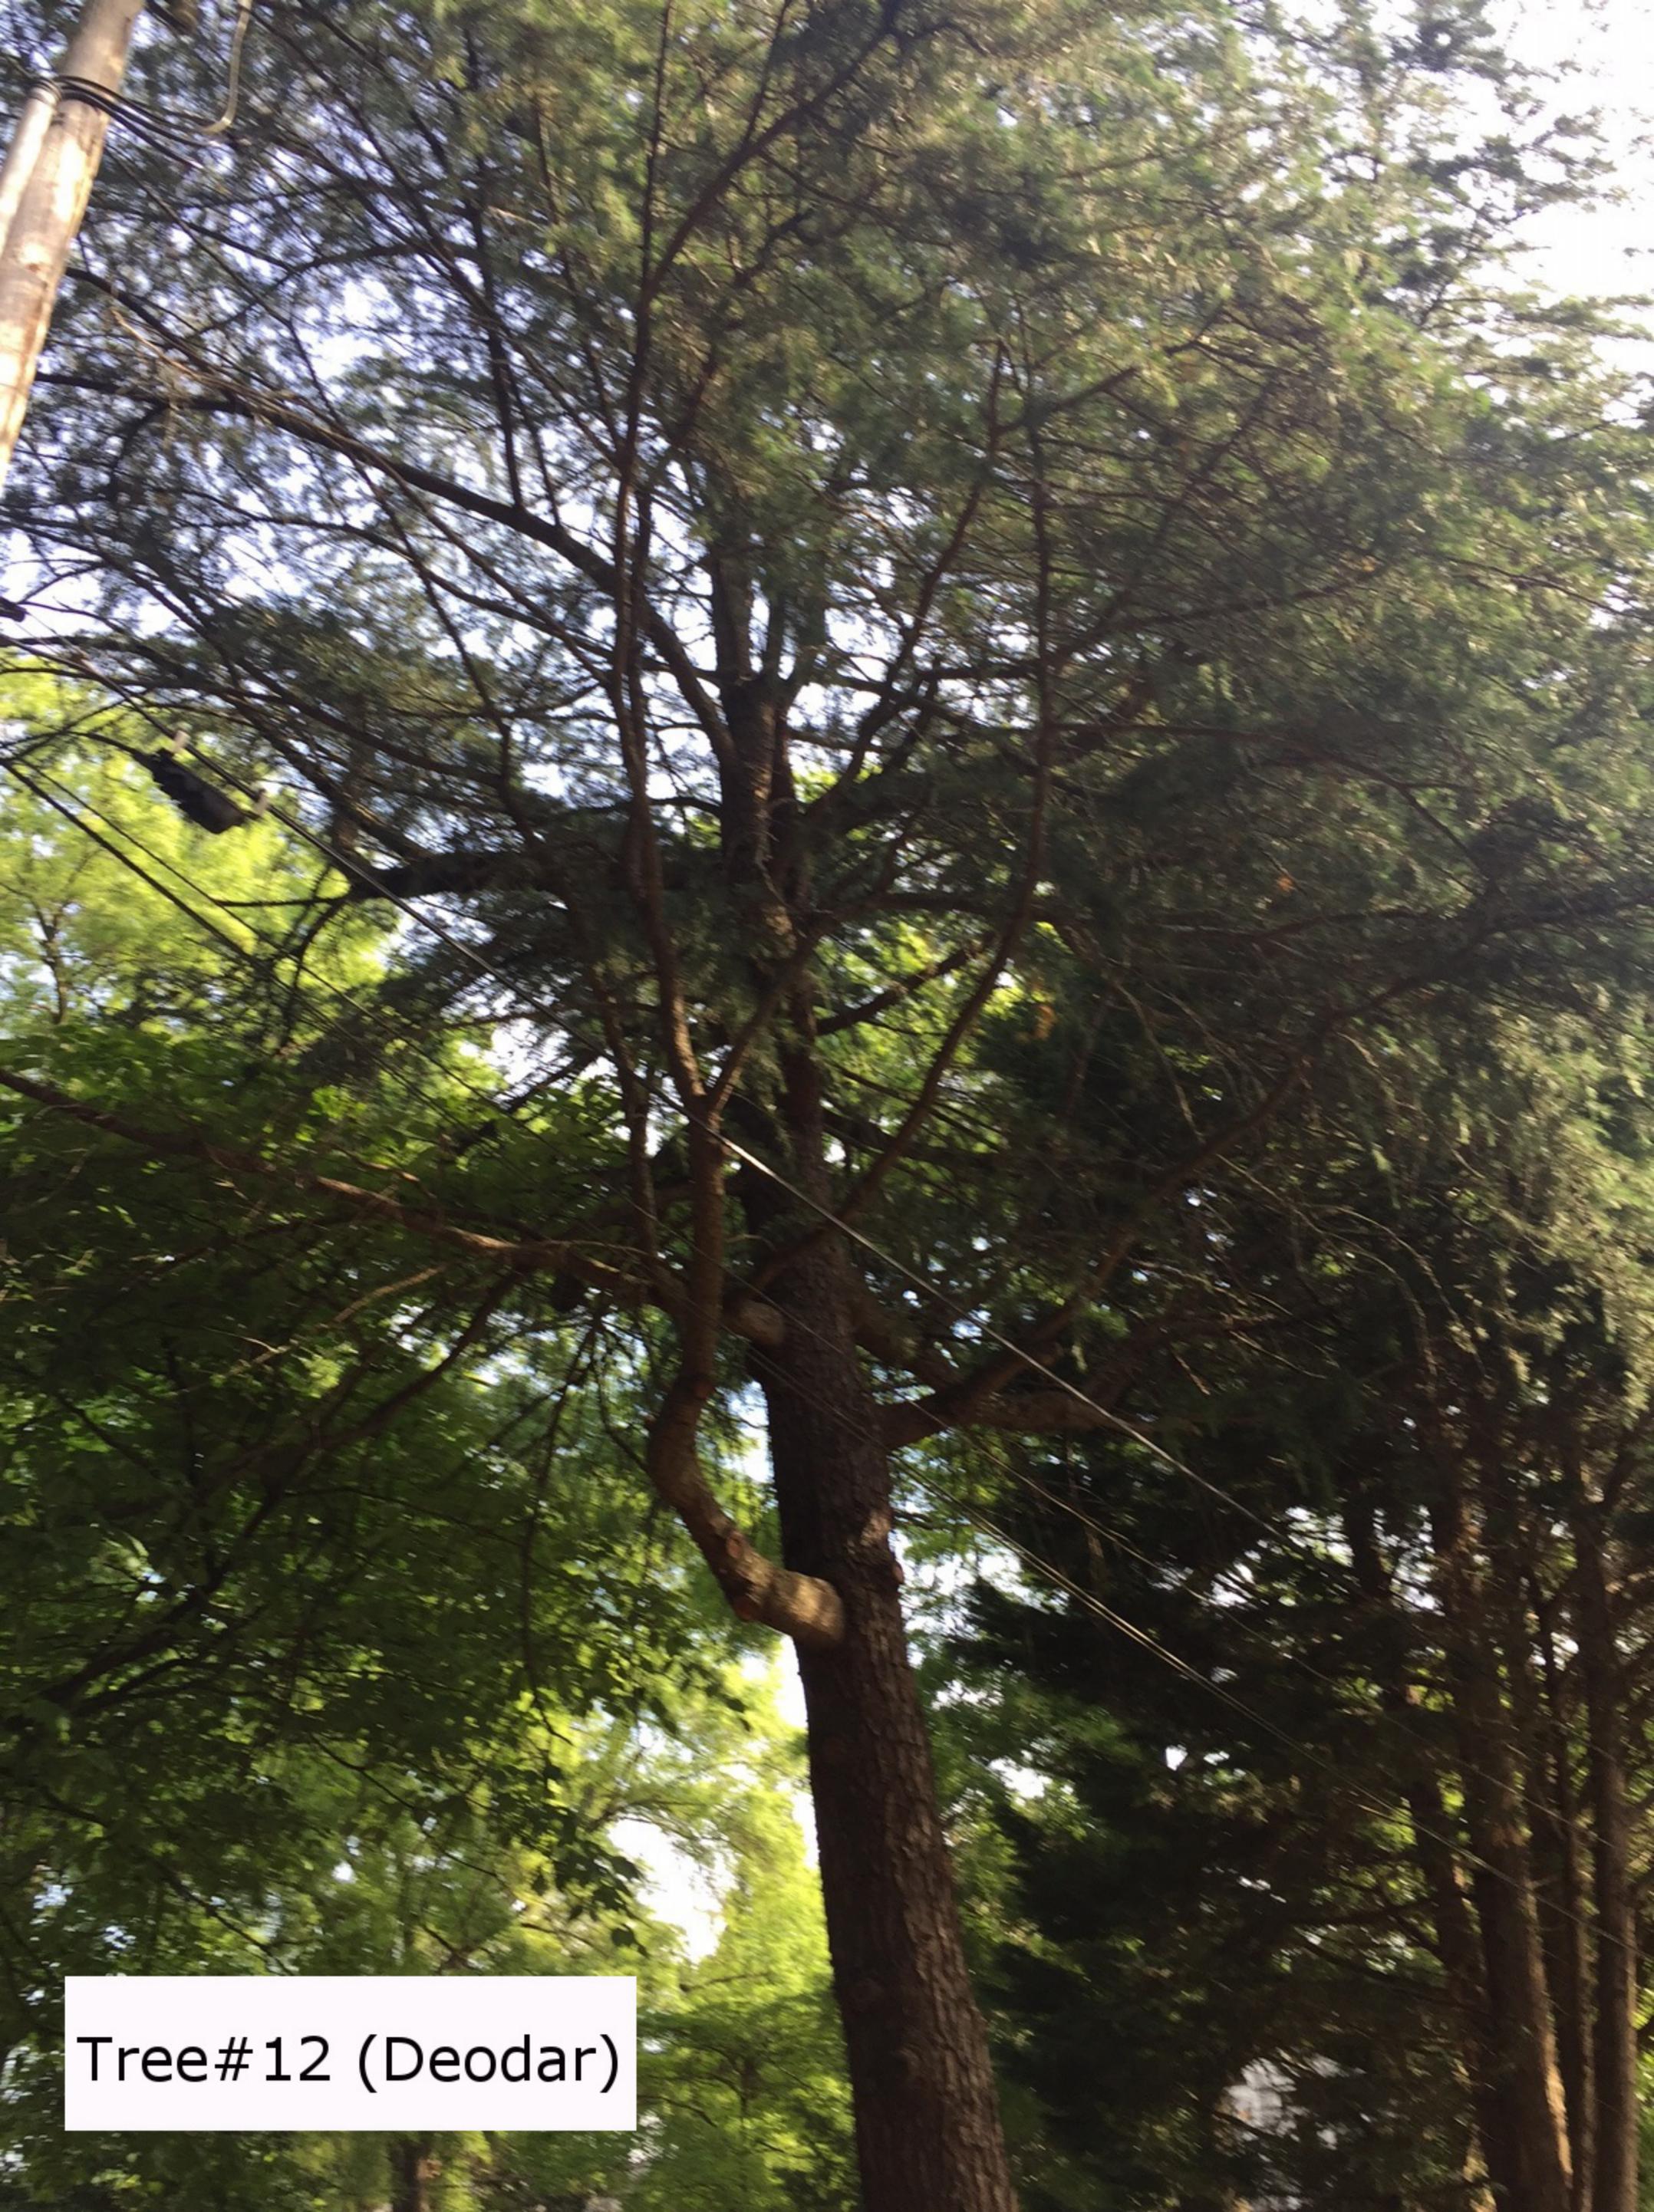
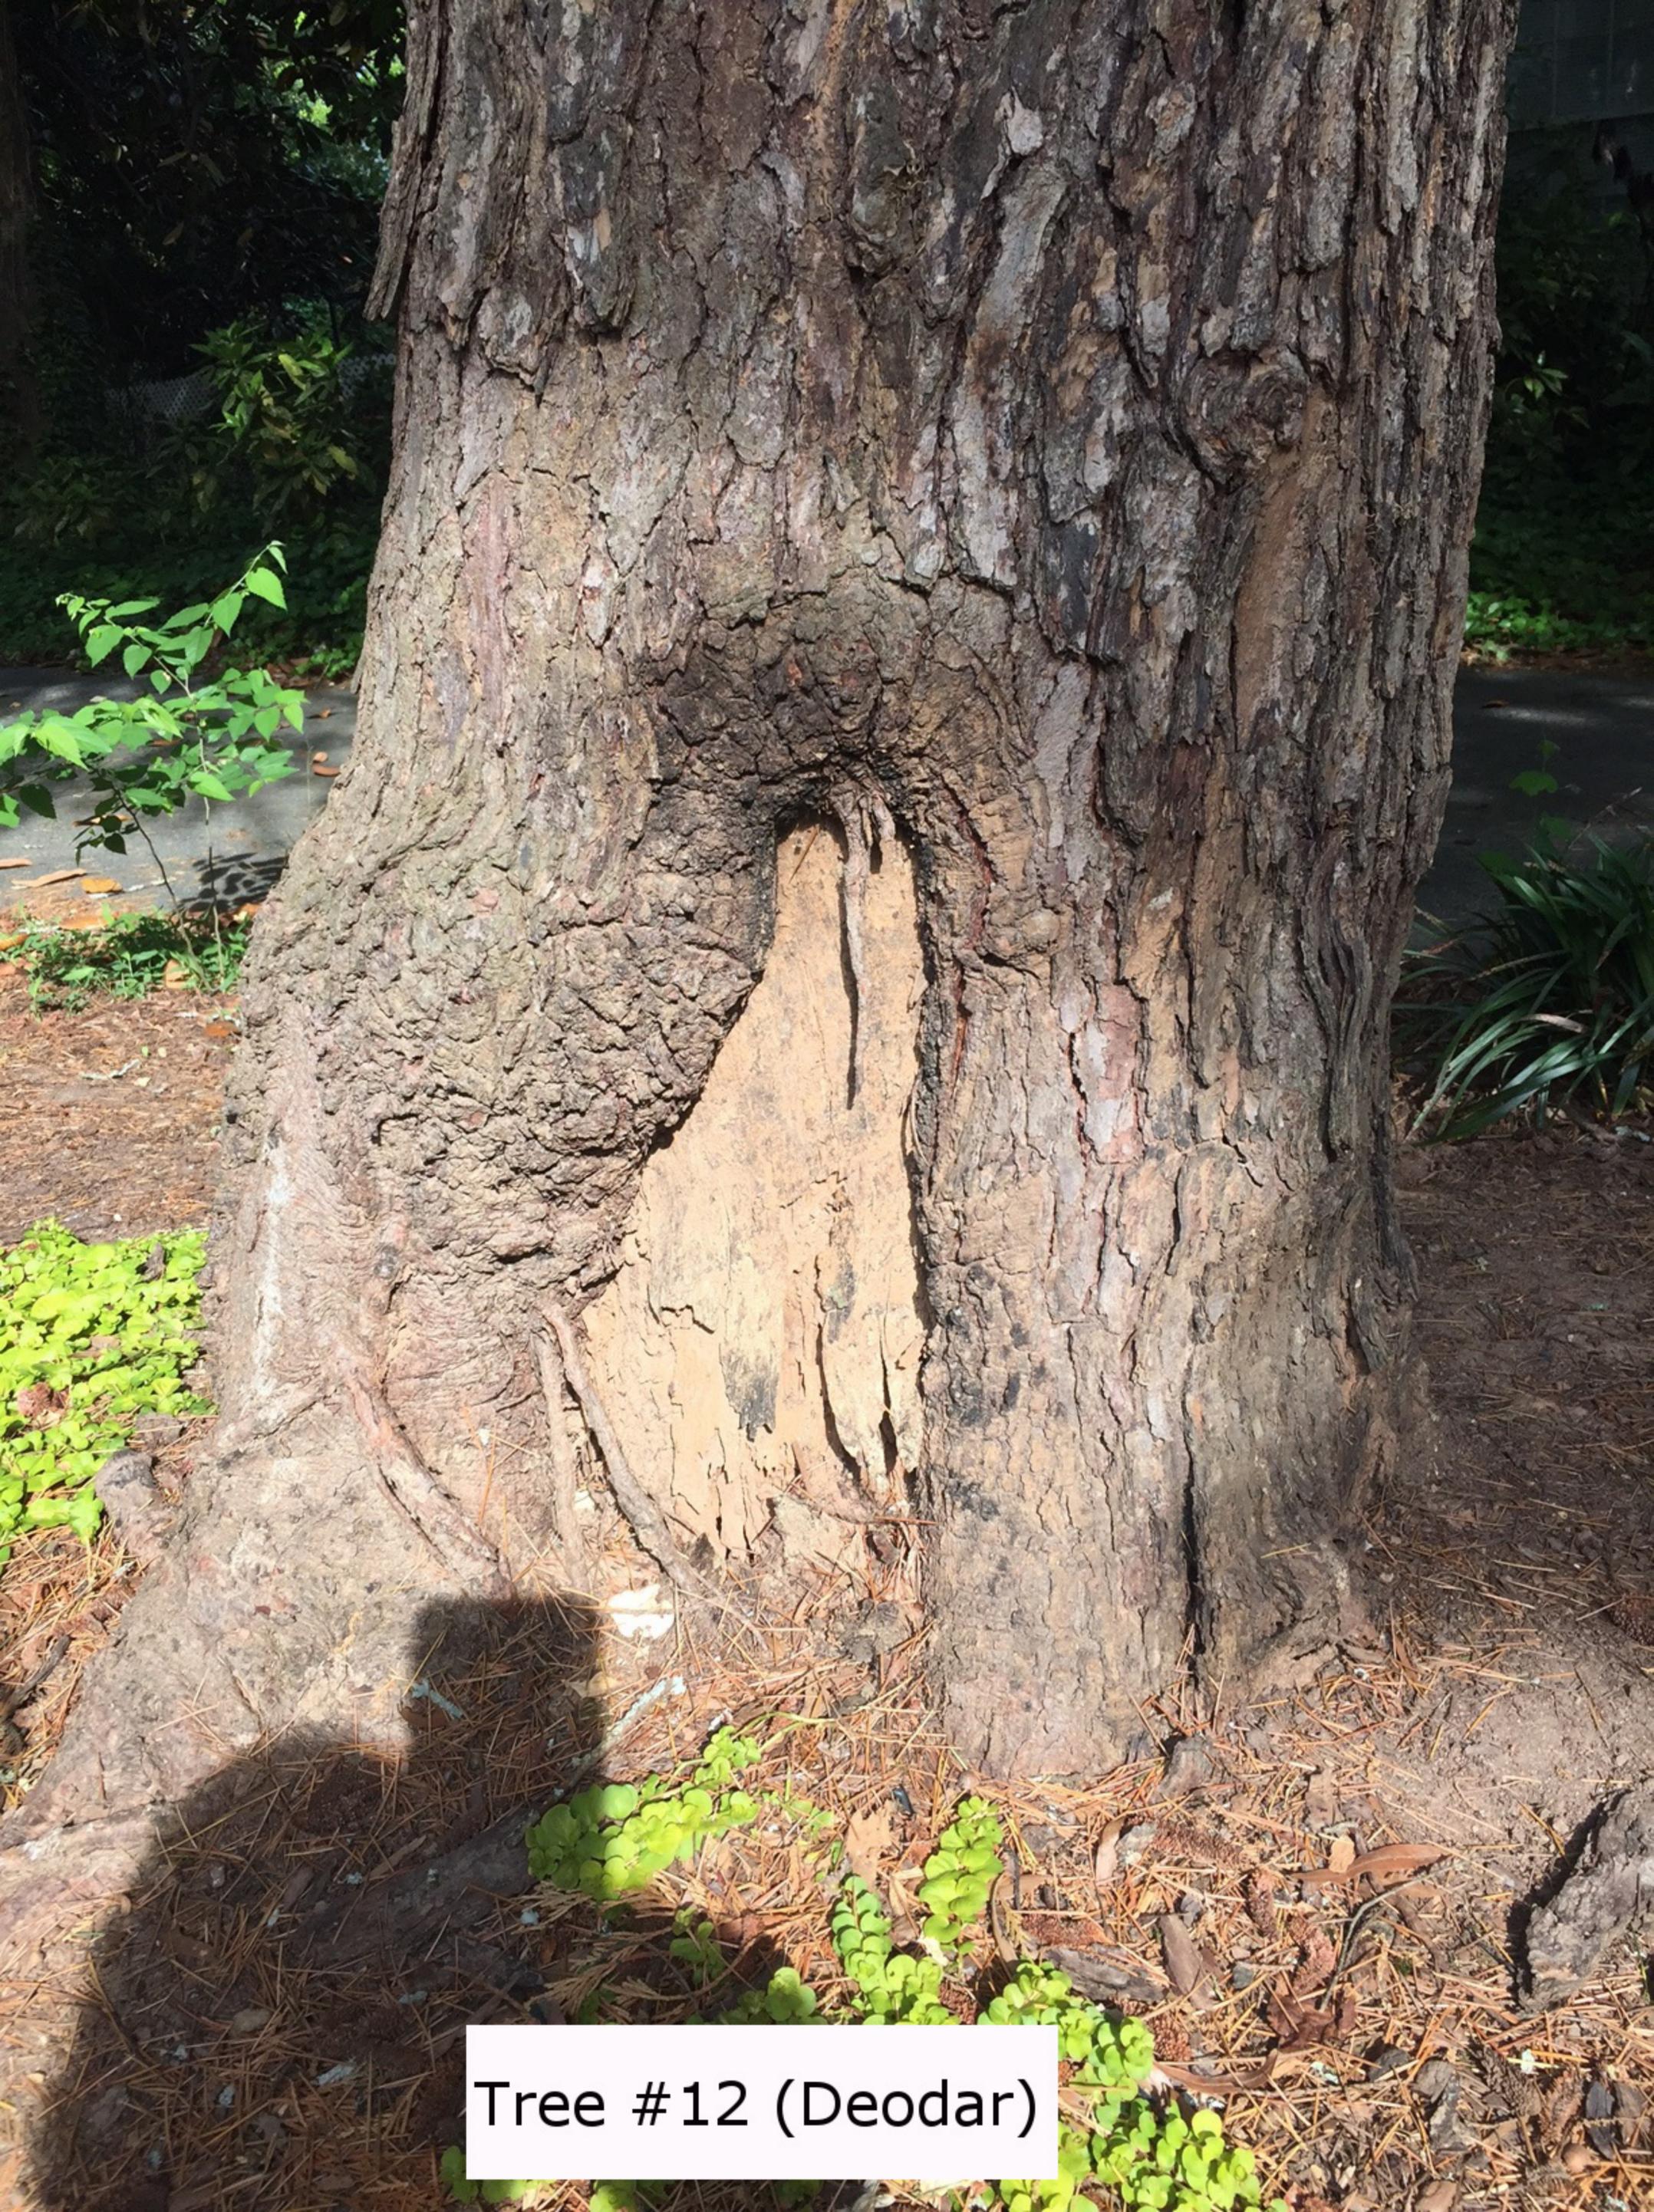
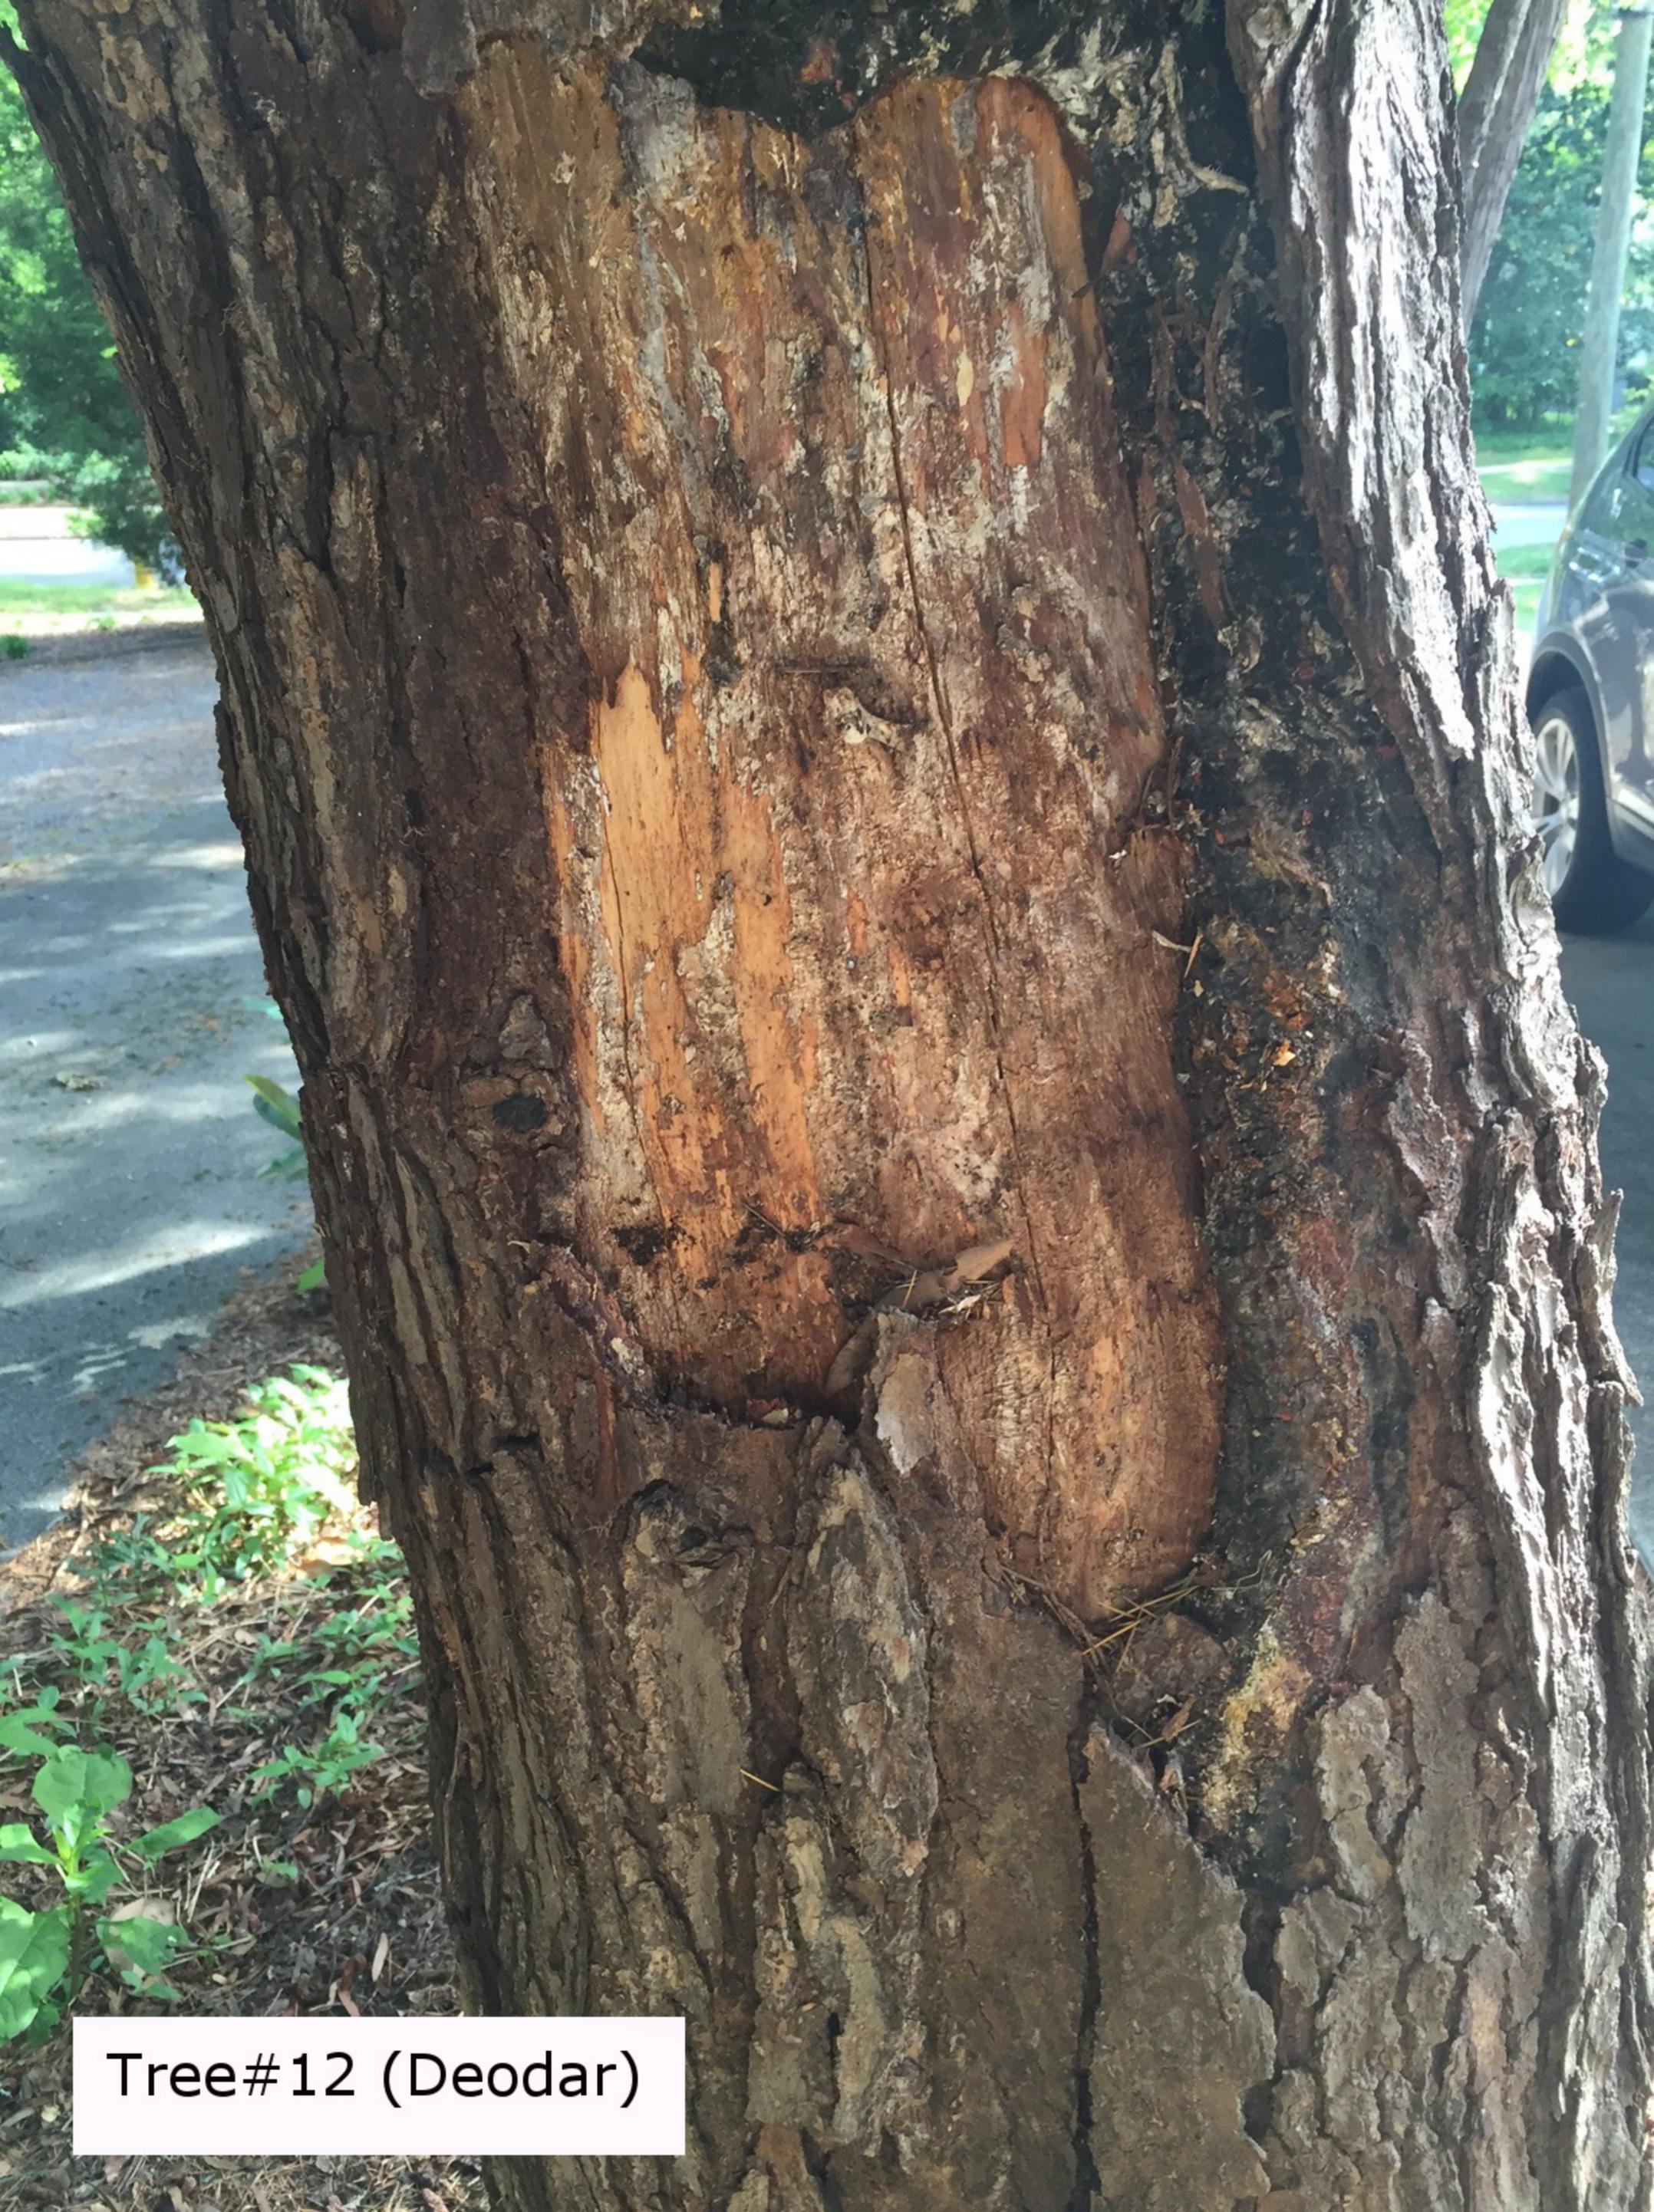
Tree# 12 (Deodar)

This tree has considerable decay in the lower trunk, leans towards the adjacent property, and is entangled in utility lines. I recommend removal. *Bill Leake*

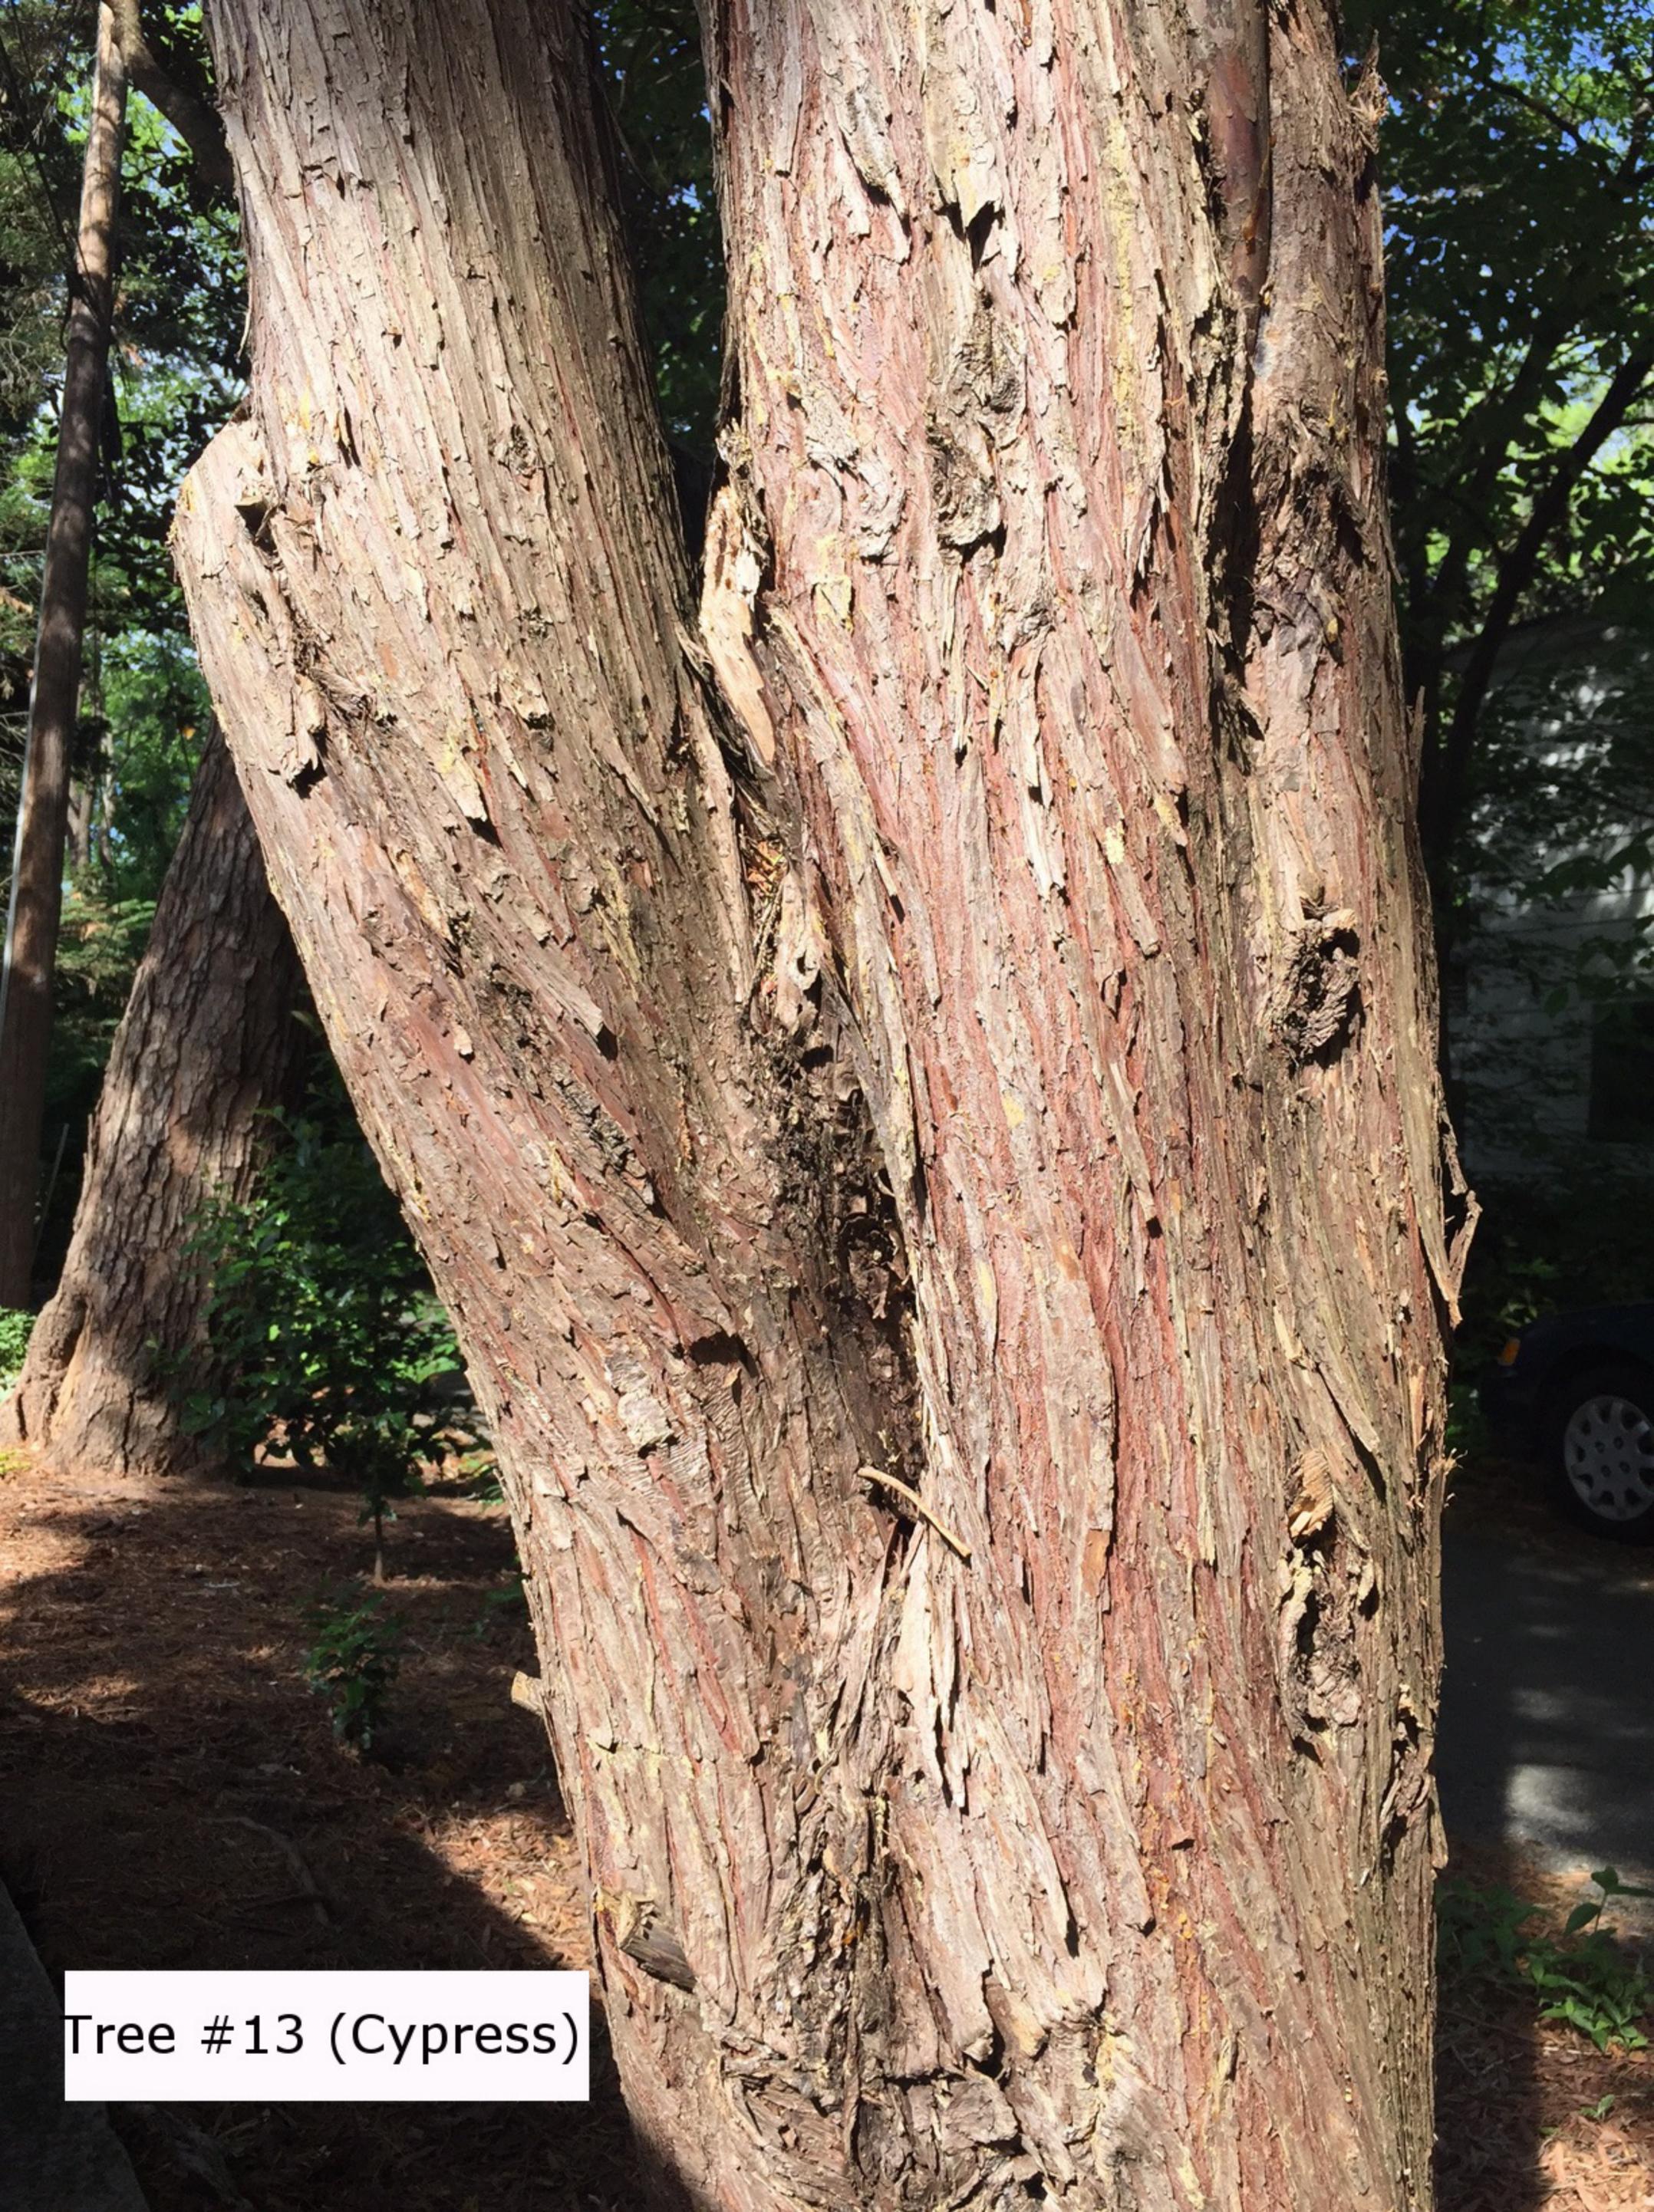
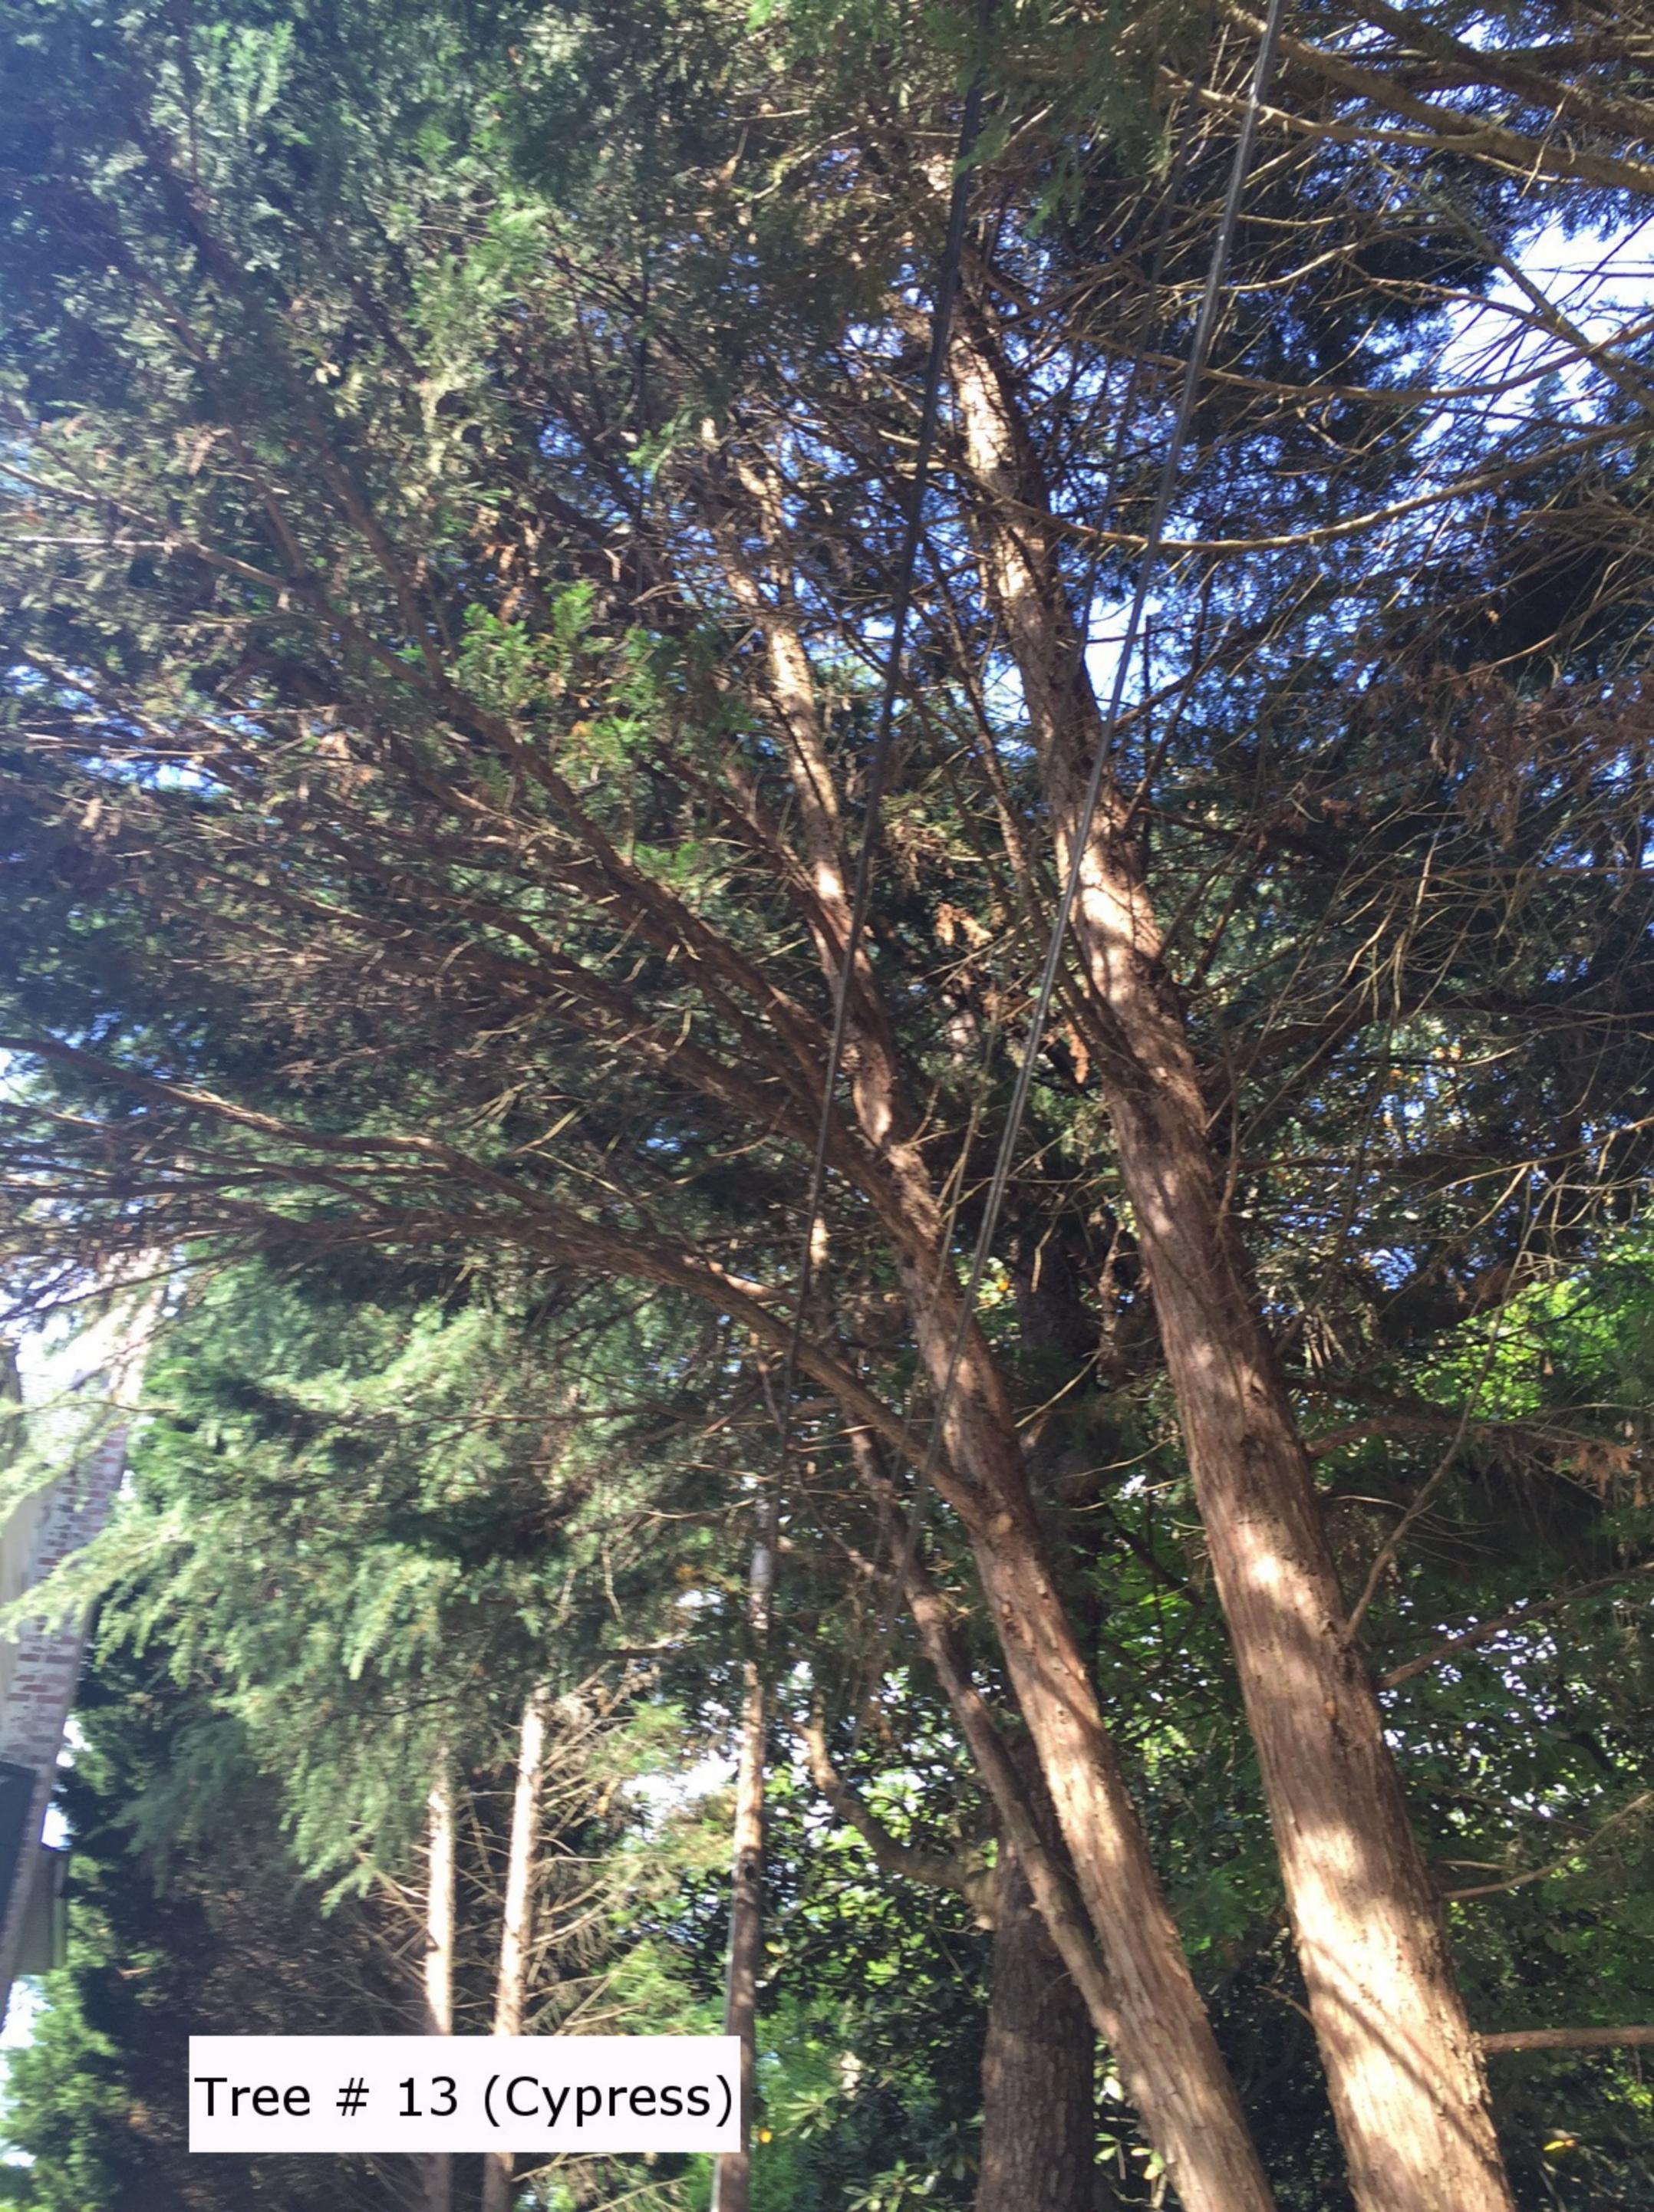
Tree #13 (Cypress)

This tree has out grown its location. This tree is foliage heavy to the side that the trunk is leaning. It is entangled in utility lines and more exposed to wind than trees number 2 and 3. I recommend removal. *Bill Leake*

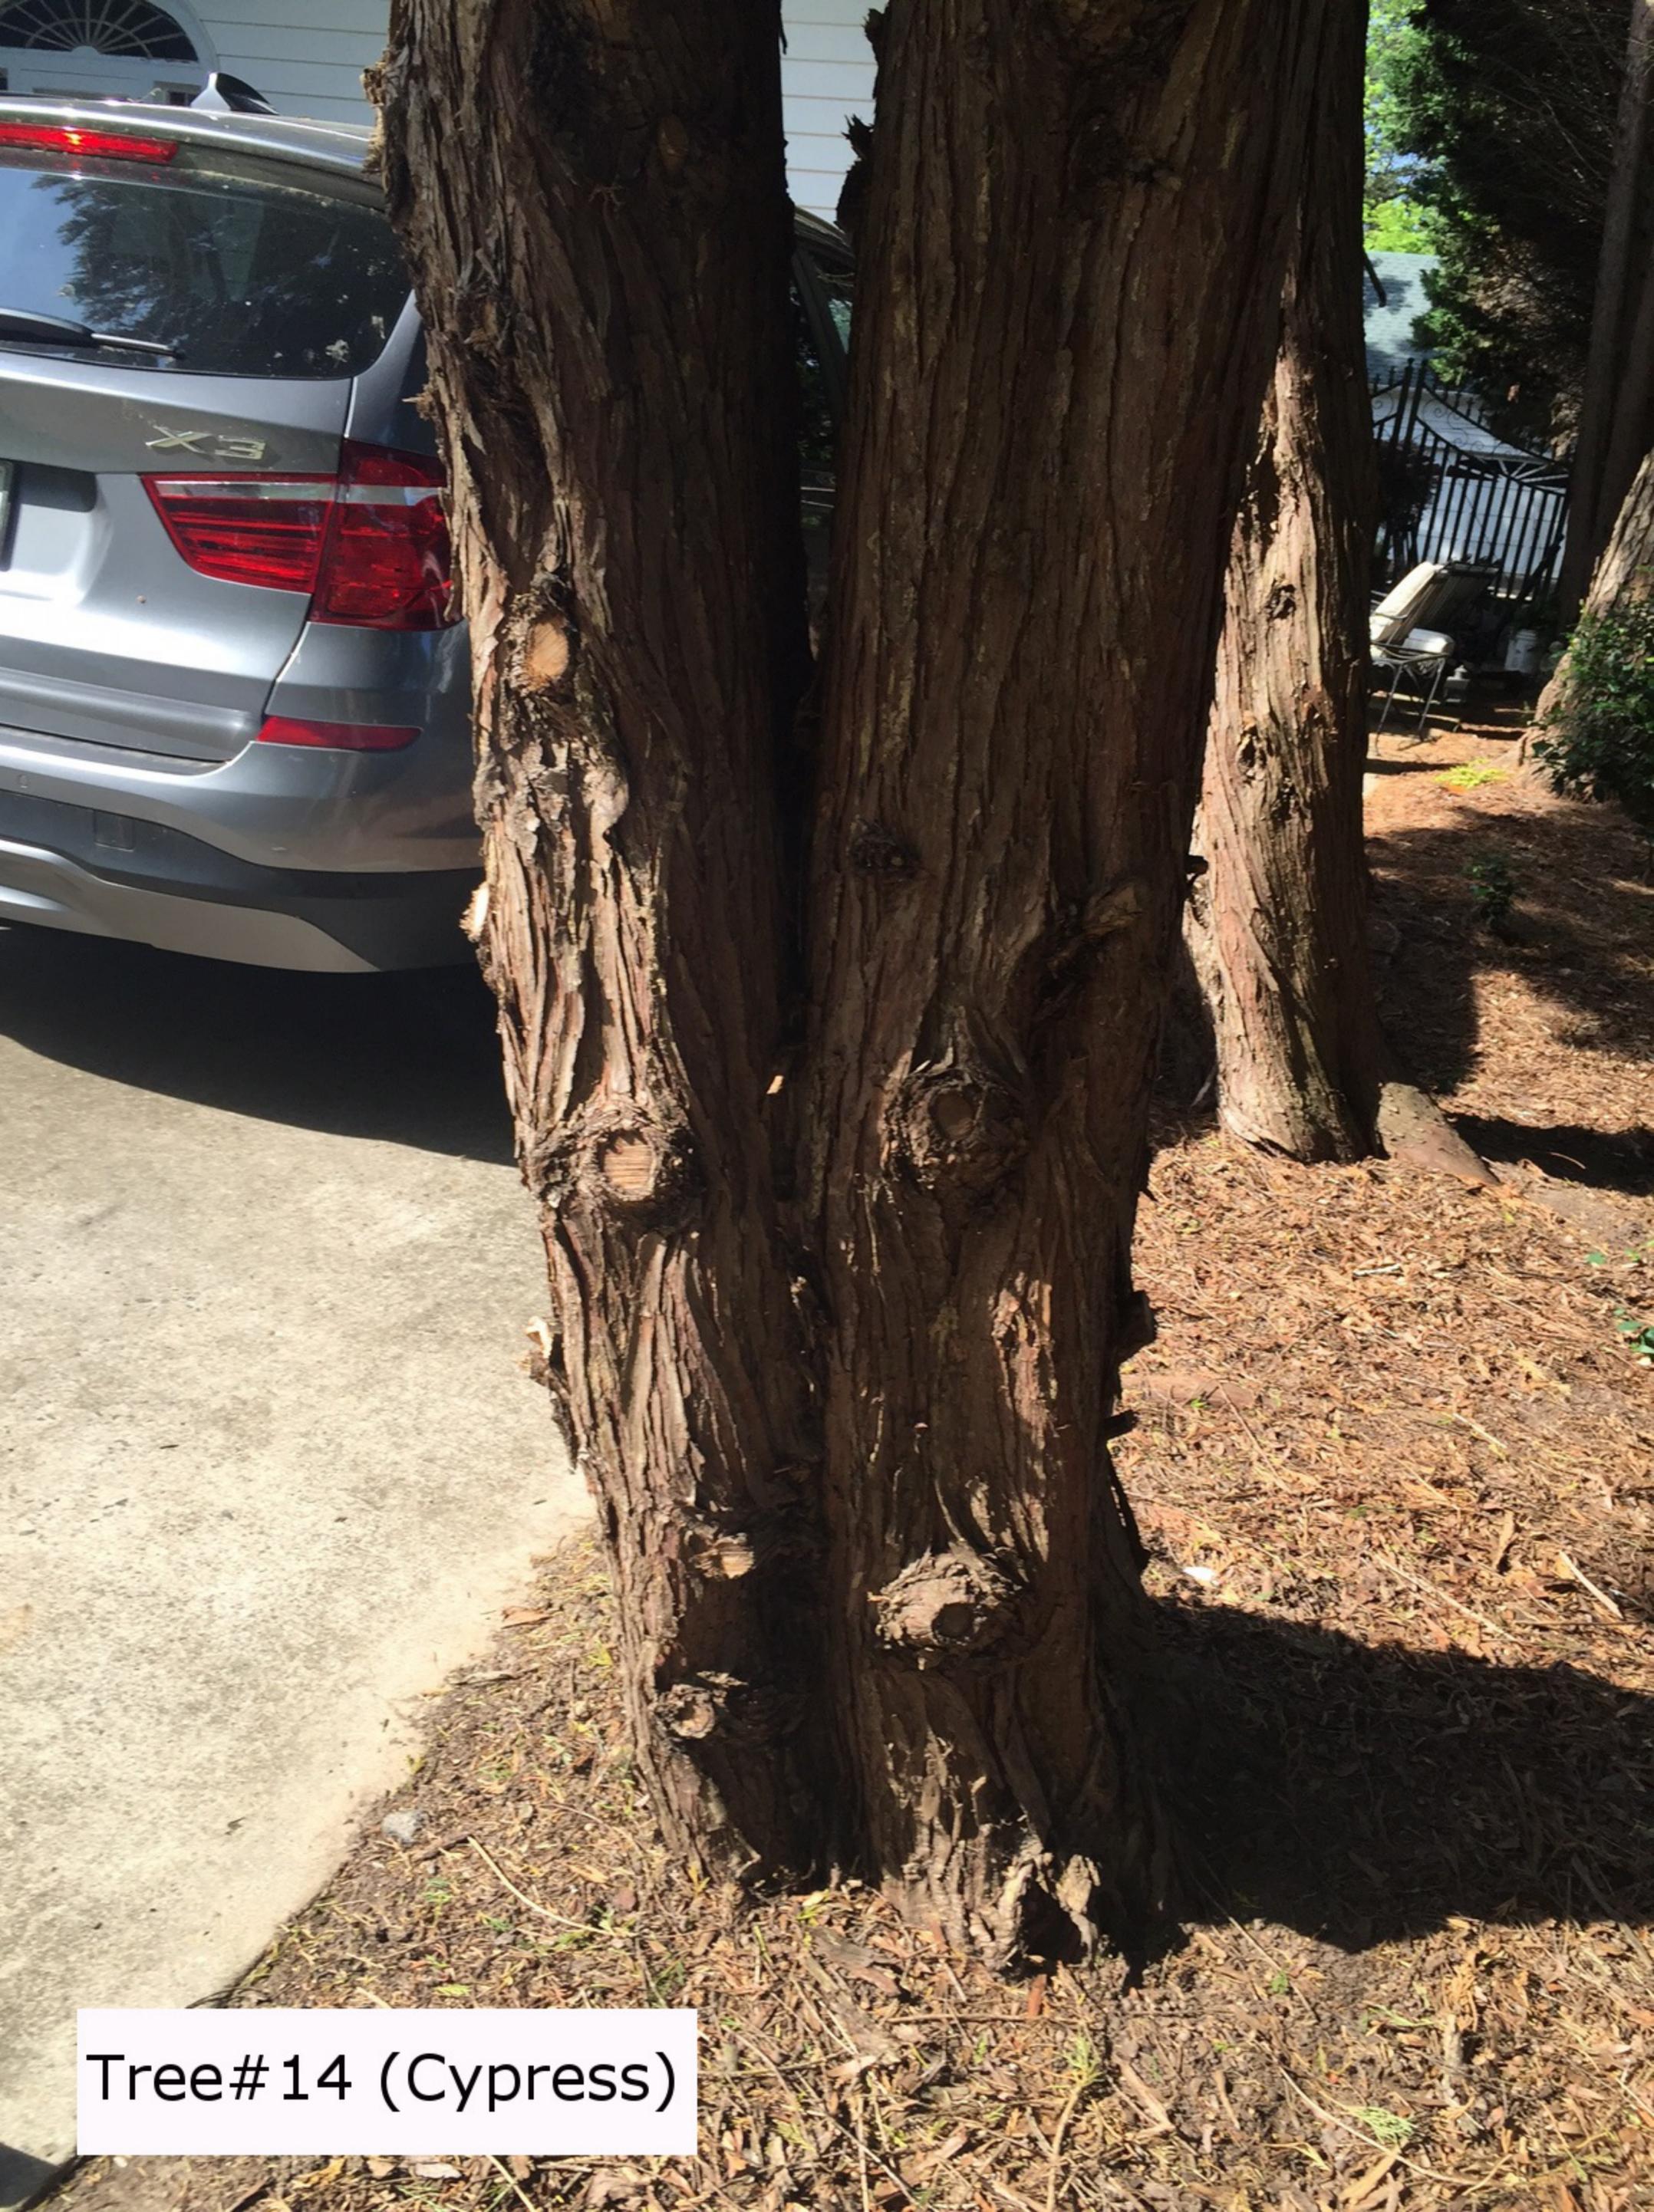
Tree# 14 (Cypress)

This tree has out grown its location. This tree is foliage heavy to the side that the co-dominate trunks are leaning. It is entangled in utility lines and more exposed to wind than trees number 2 and 3. *Bill Leake*
