HISTORIC PRESERVATION COMMISSION MEETING

Wednesday, June 8th, 2016 at 7:00 p.m.
Municipal Building, 35 Cabarrus Avenue, West

Certificate of Appropriateness Request : H-12-16

Staff Report prepared by: Starla A. Rogers, Sr. Planner

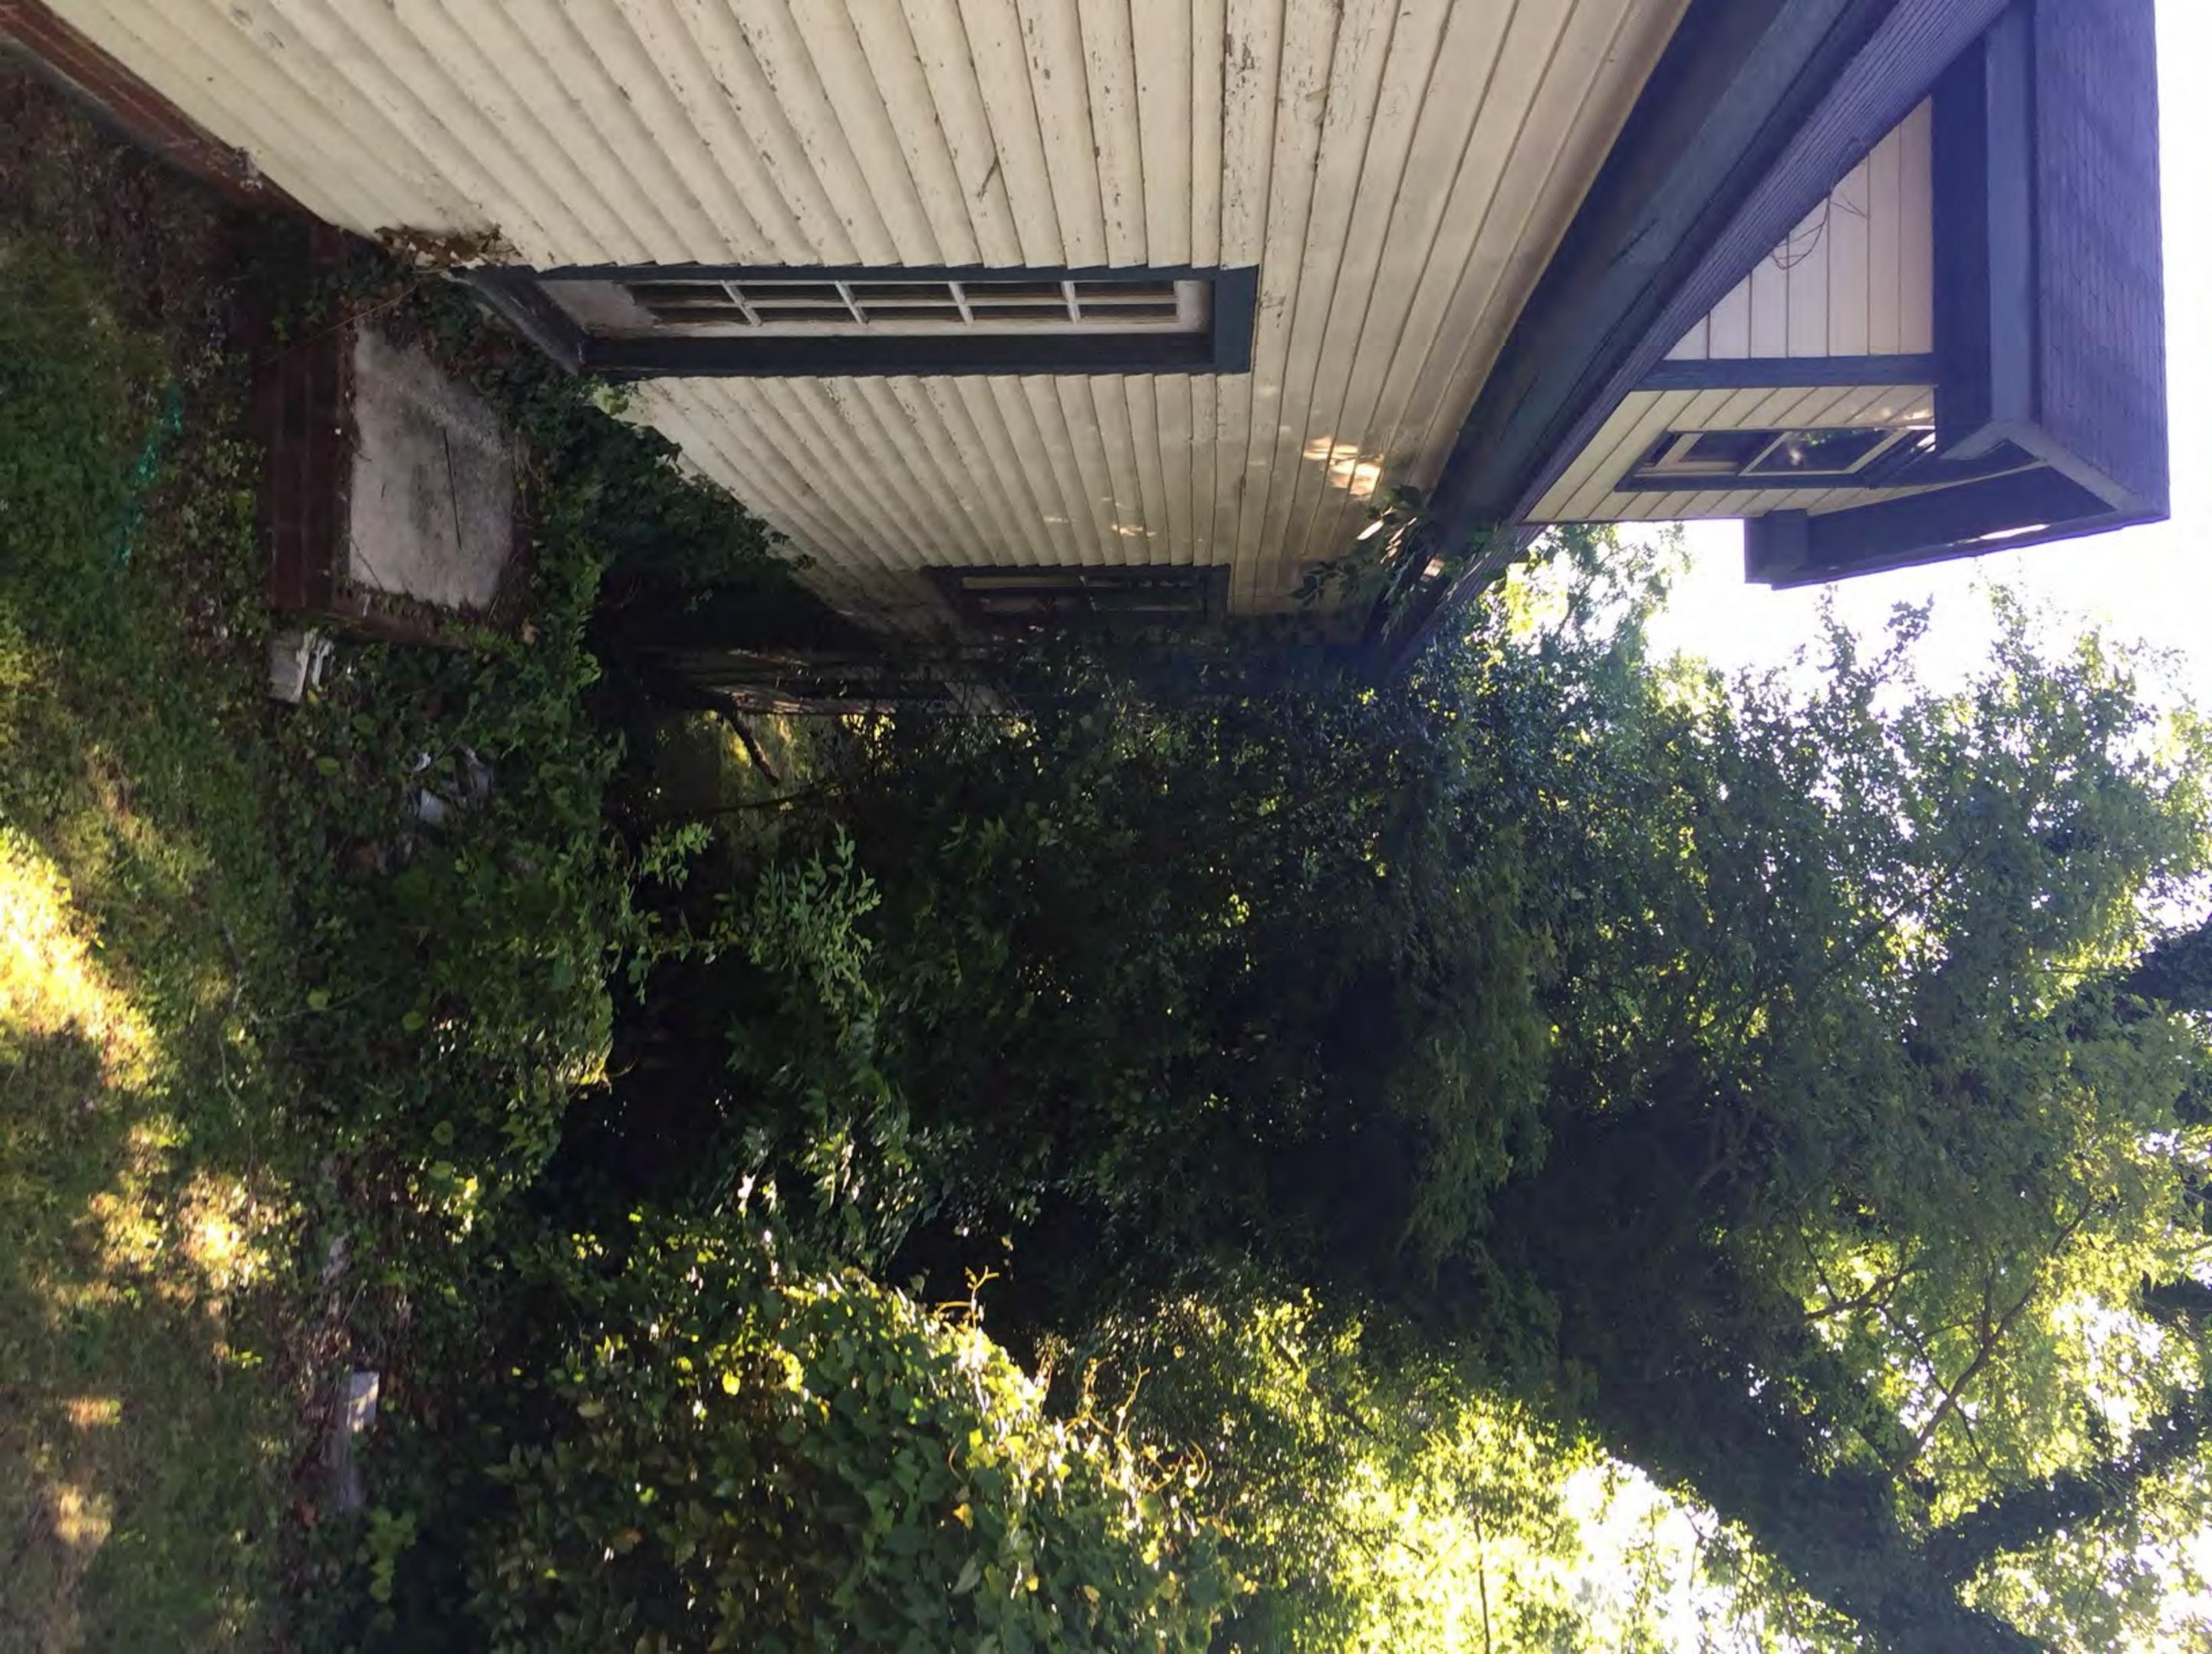
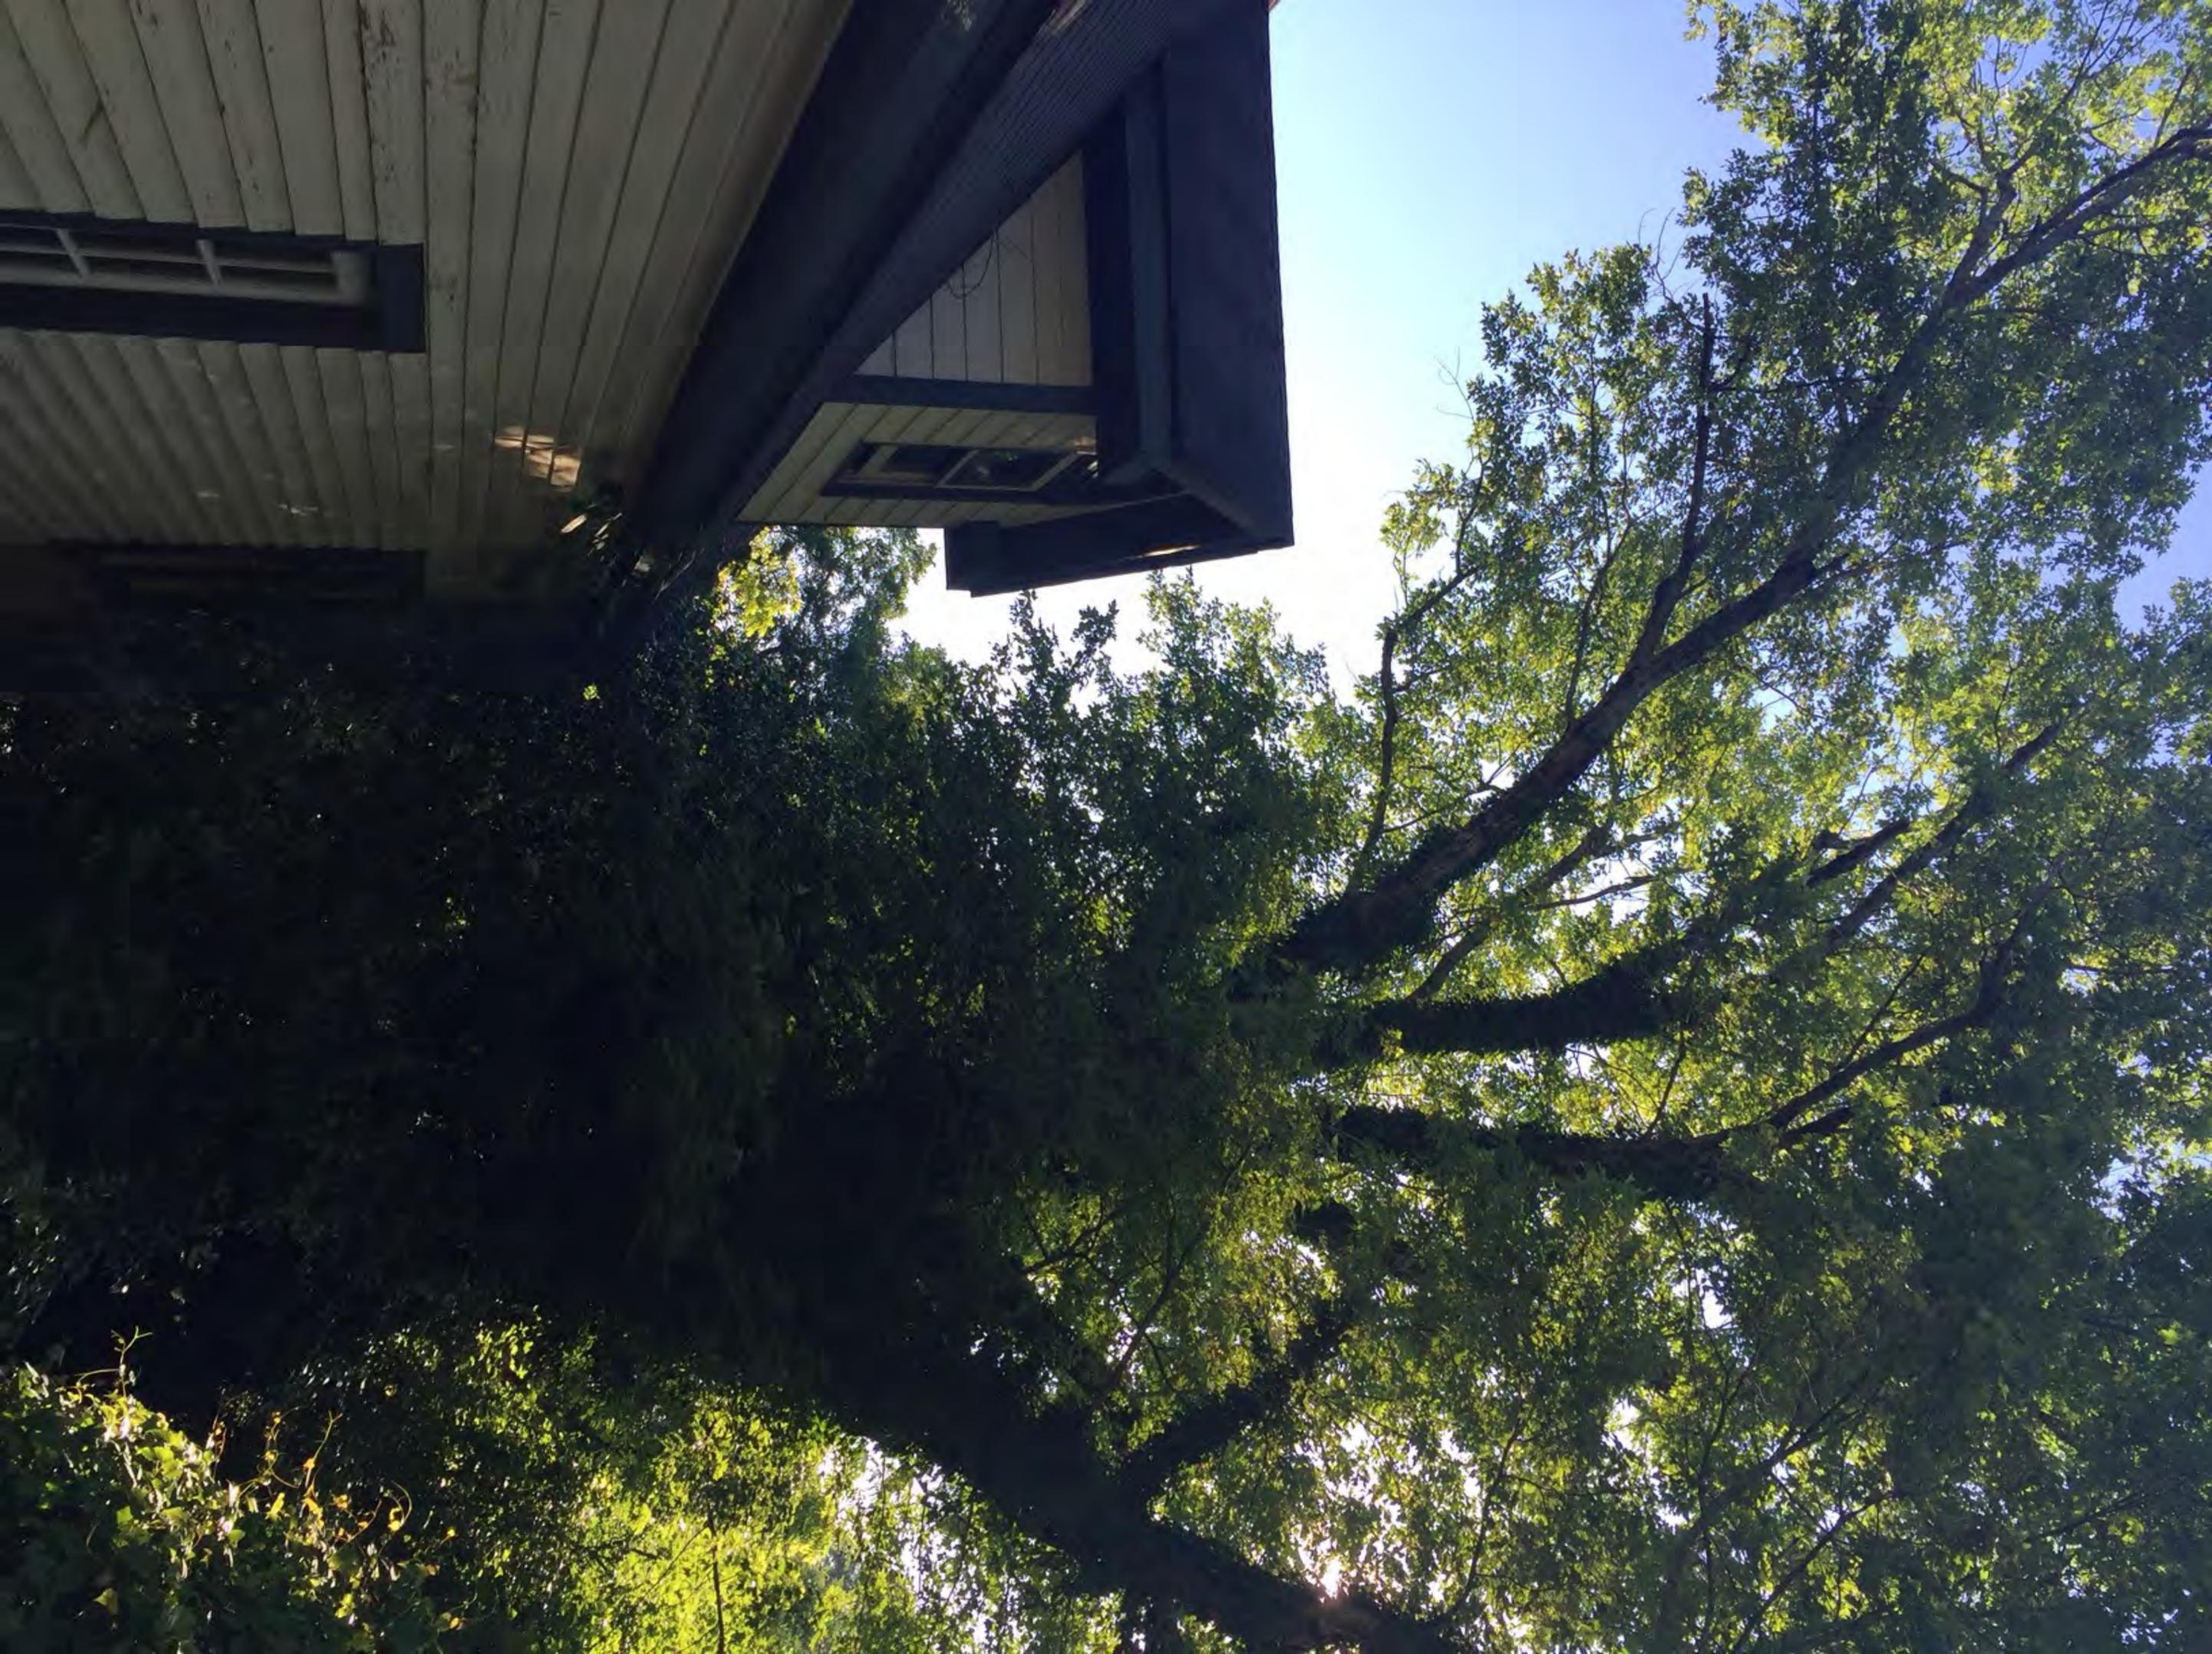
The described demolition, grading and new construction will all impact the root system of this tree. The effects of this root damage could be minimal, causing slow decline in vigor. If a large percentage of supporting roots are severed, high winds, ice, or snow could cause the complete uprooting of this tree. Removal should be considered if demolition is allowed.
