# **ASBESTOS ABATEMENT DESIGN SPECIFICATIONS**

**ABATEMENT OF SELECTED ACM  
FLOOR TILE & ASSOCIATED MASTIC ( $\approx$  1,970 SQUARE FEET)  
THERMAL SYSTEM INSULATION ( $\approx$  35 MUDDERED JOINTS & 54 LINEAR FEET)  
WINDOW GLAZING ( $\approx$  36 WINDOW UNITS)**

**HARTSELL RECREATION CENTER  
60 HARTSELL SCHOOL ROAD  
CONCORD, NORTH CAROLINA**

**ACES PROJECT No. 2016 – 06 – 050**

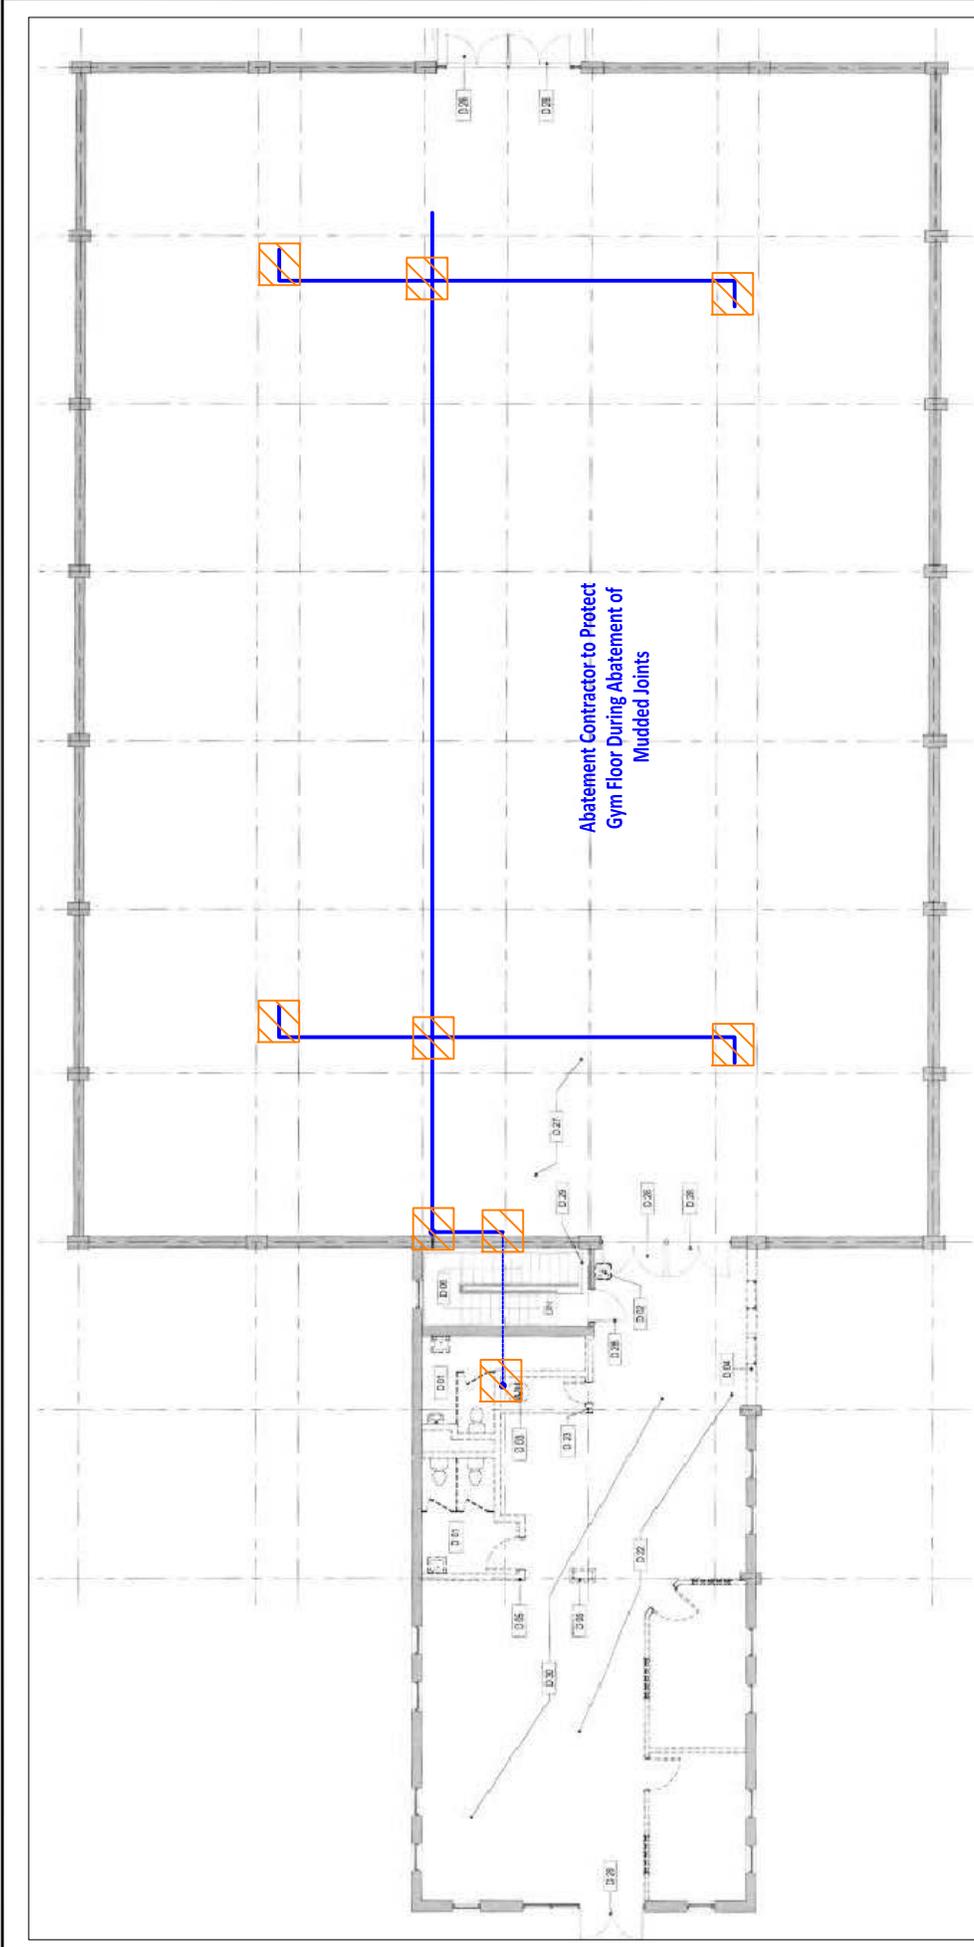
FIGURE  
**4**

Abatement Contractor to Protect Gym Floor During Abatement of Mudded Joints

For the abatement of mudded joints in the gymnasium area on the upper level, contractor shall provide a satisfactory means to protect the existing gym from damage. Any damage to the floor and subsequent repairs to the damaged floors will be the responsibility of the contractor.

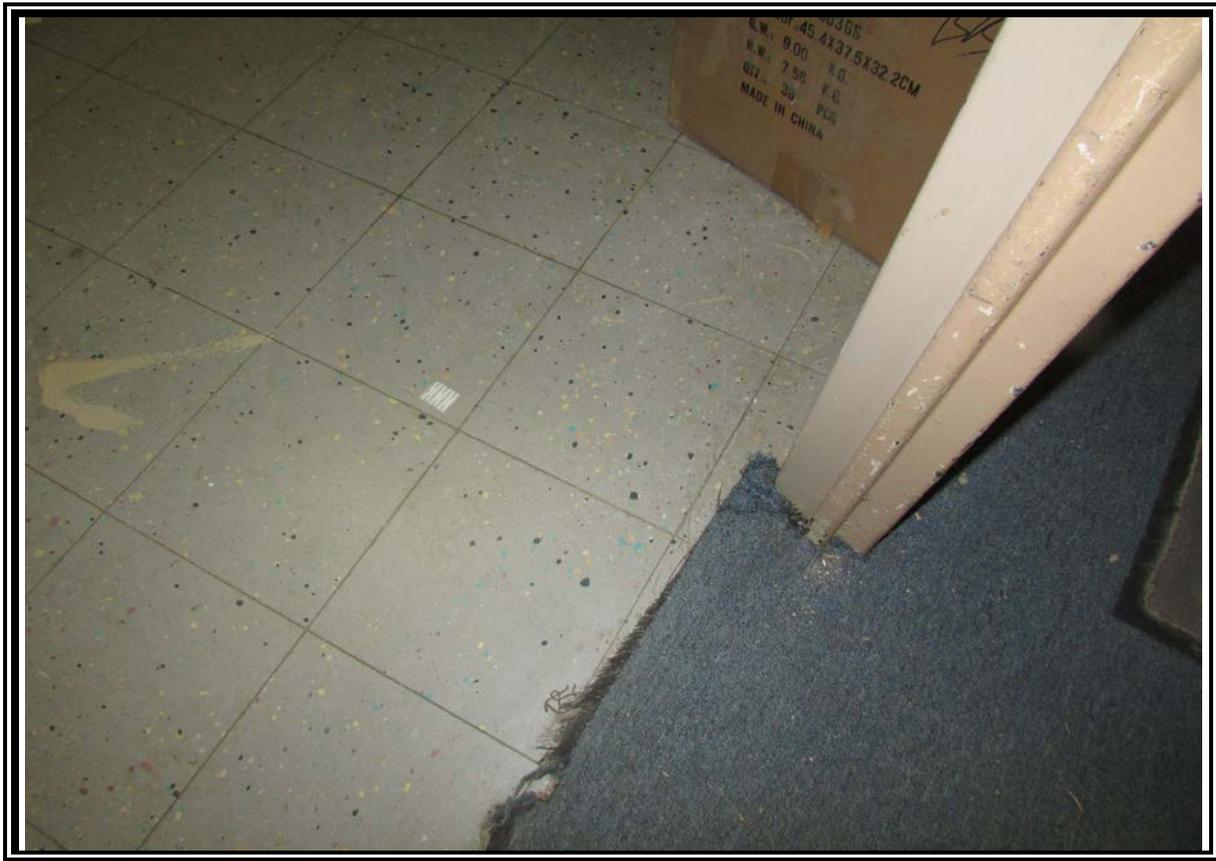
1. Asbestos containing material (9" x 9" floor tile & associated mastic) identified

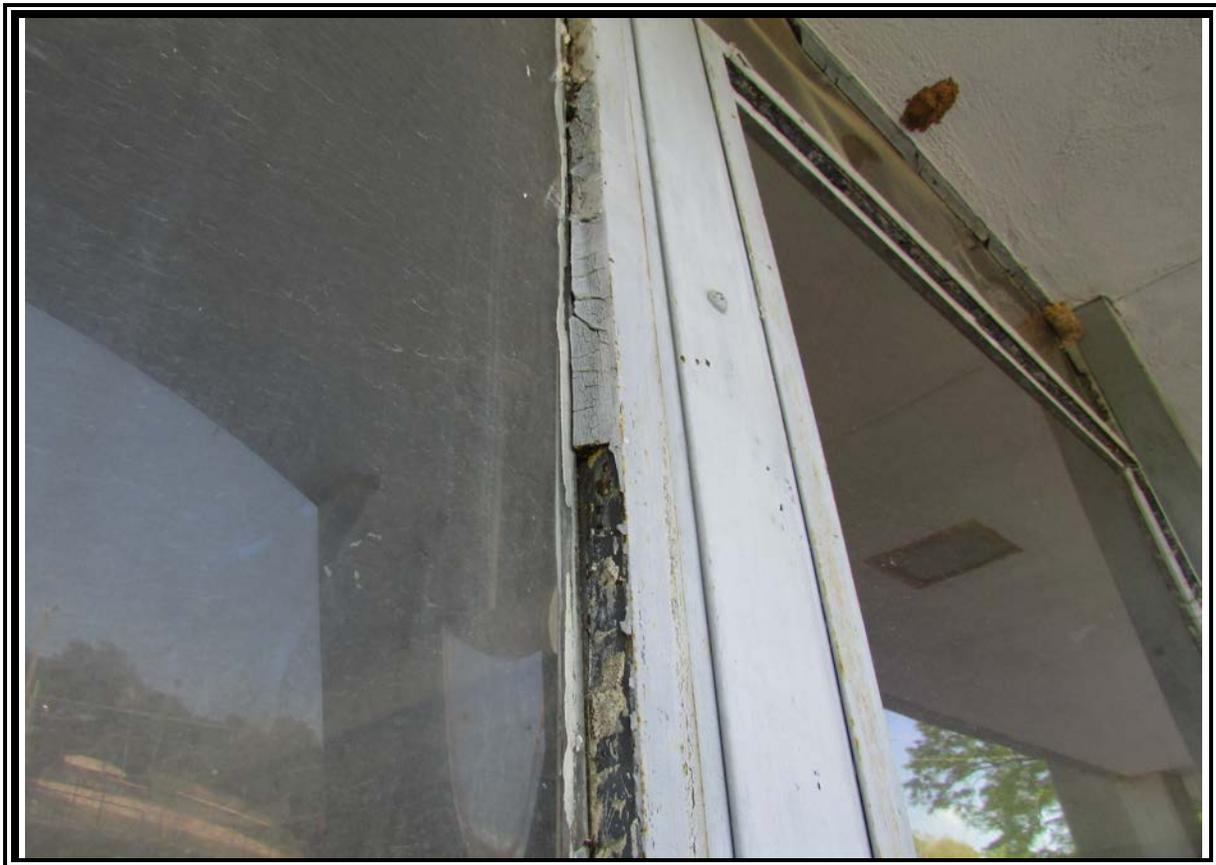
2. Asbestos containing material (window glazing) identified

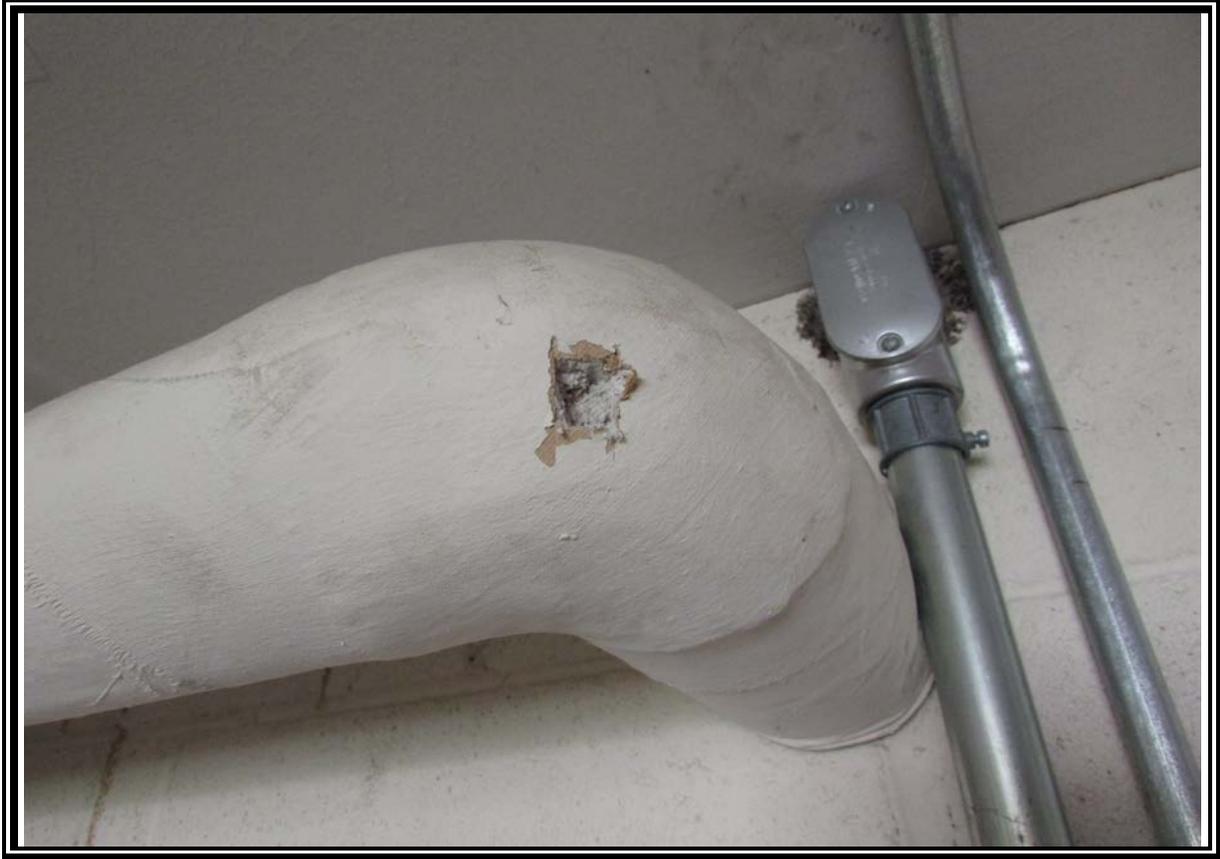
3. Asbestos containing material (TSI mudded joints) identified

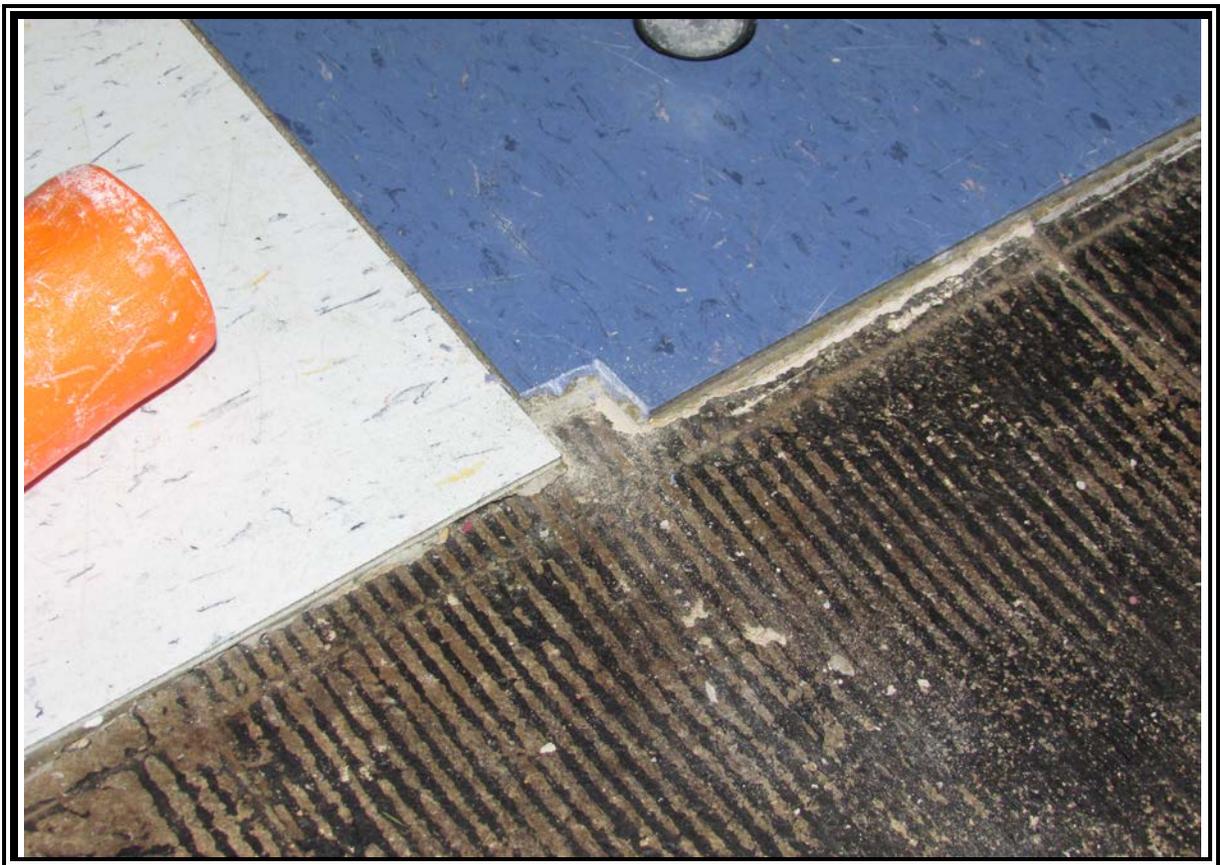
4. Asbestos containing material (bottom layer of floor tile and mastic) identified

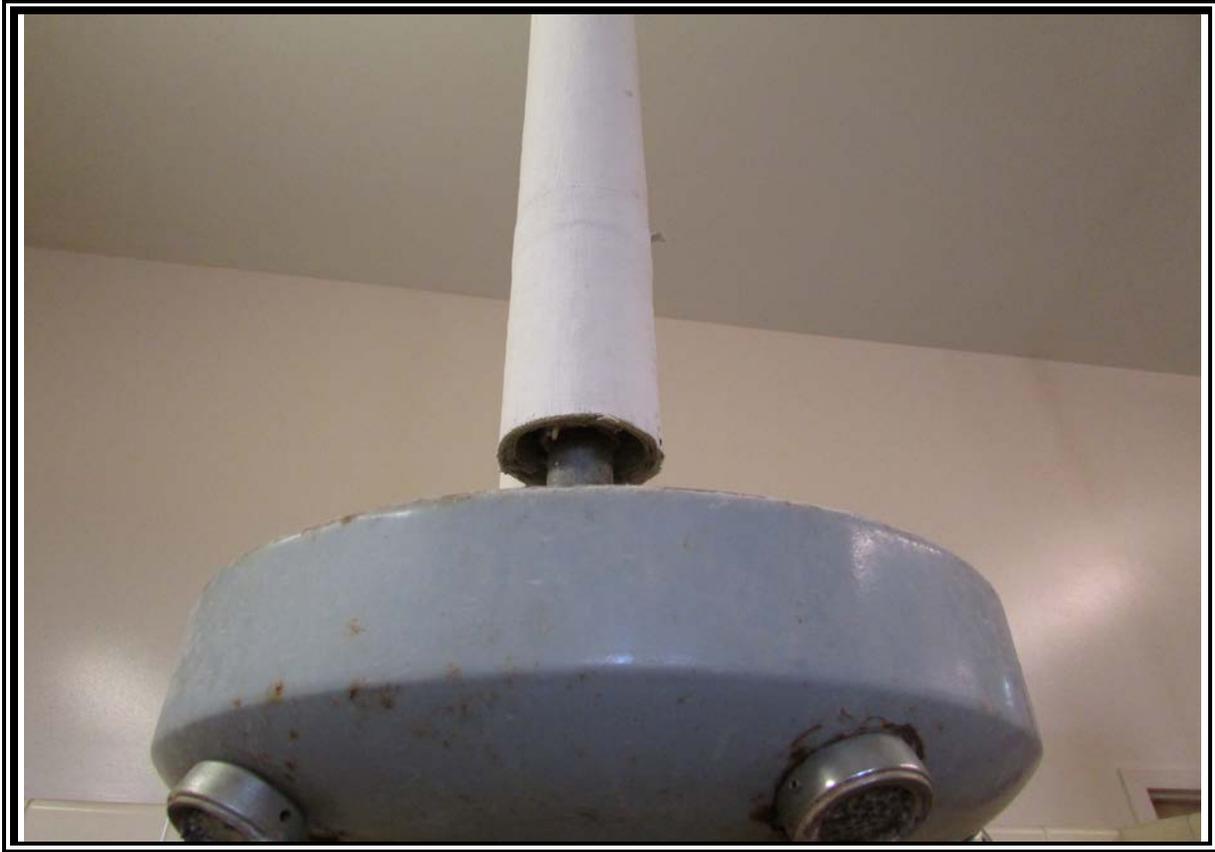
5. Asbestos containing material (TSI wrap) identified

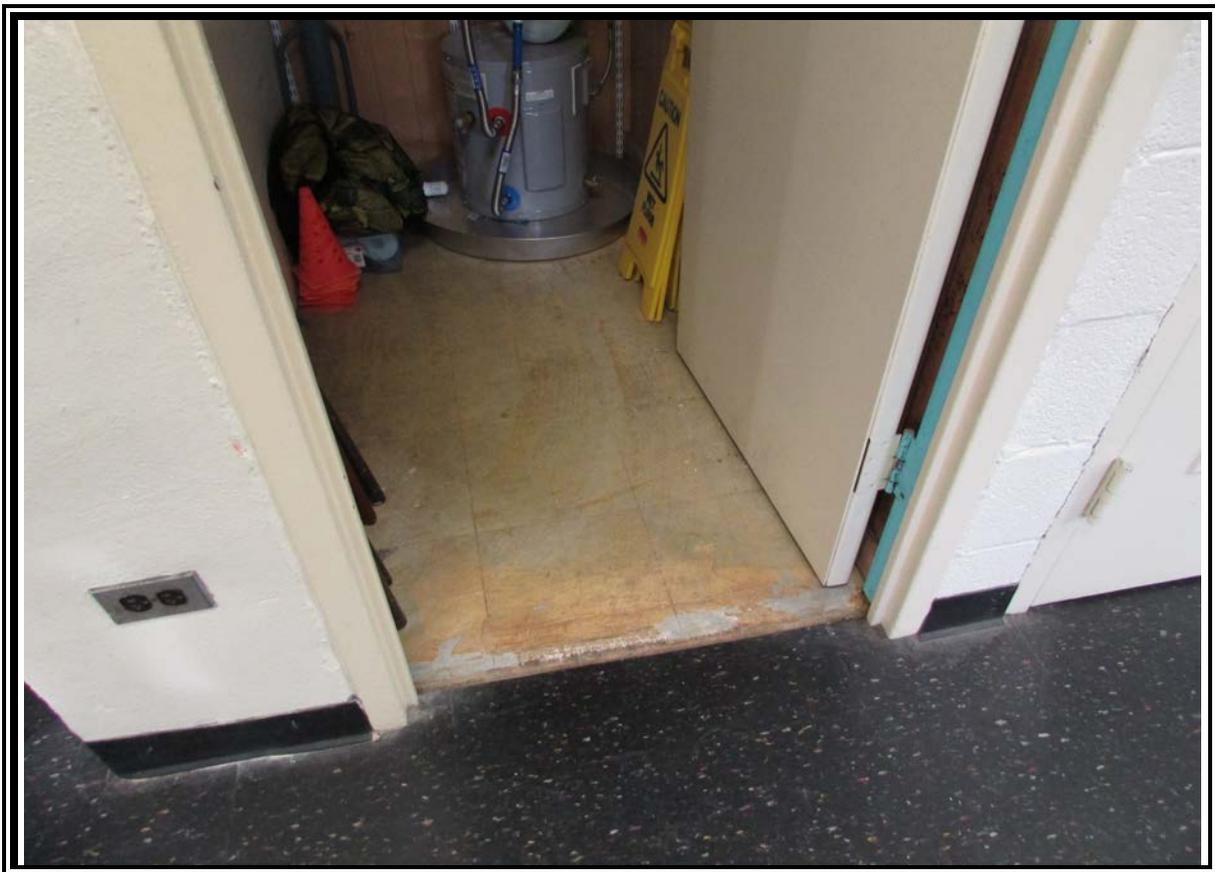
6. Asbestos containing material (mastic associated with tile in custodial closet) identified

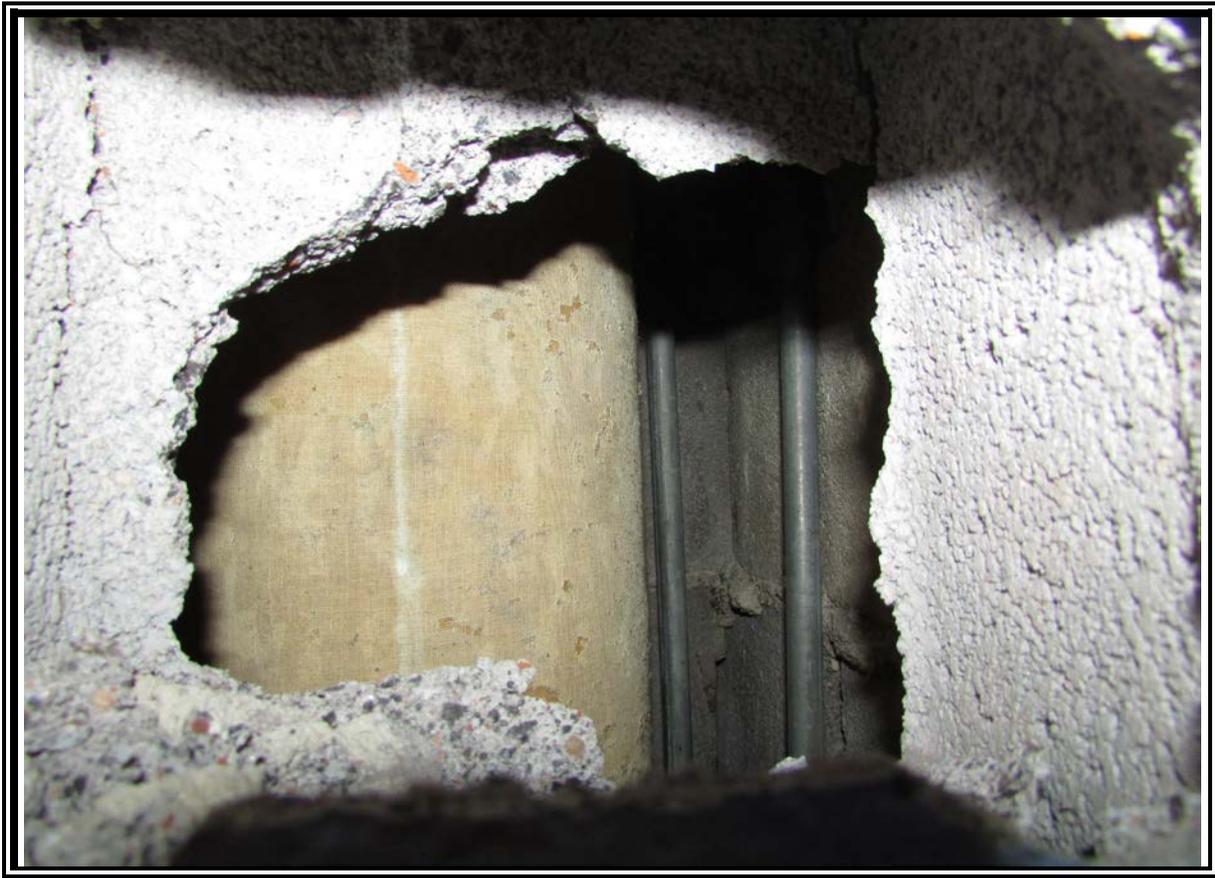
7. Fiberglass insulation noted on piping behind wall in men's restroom on the upper level

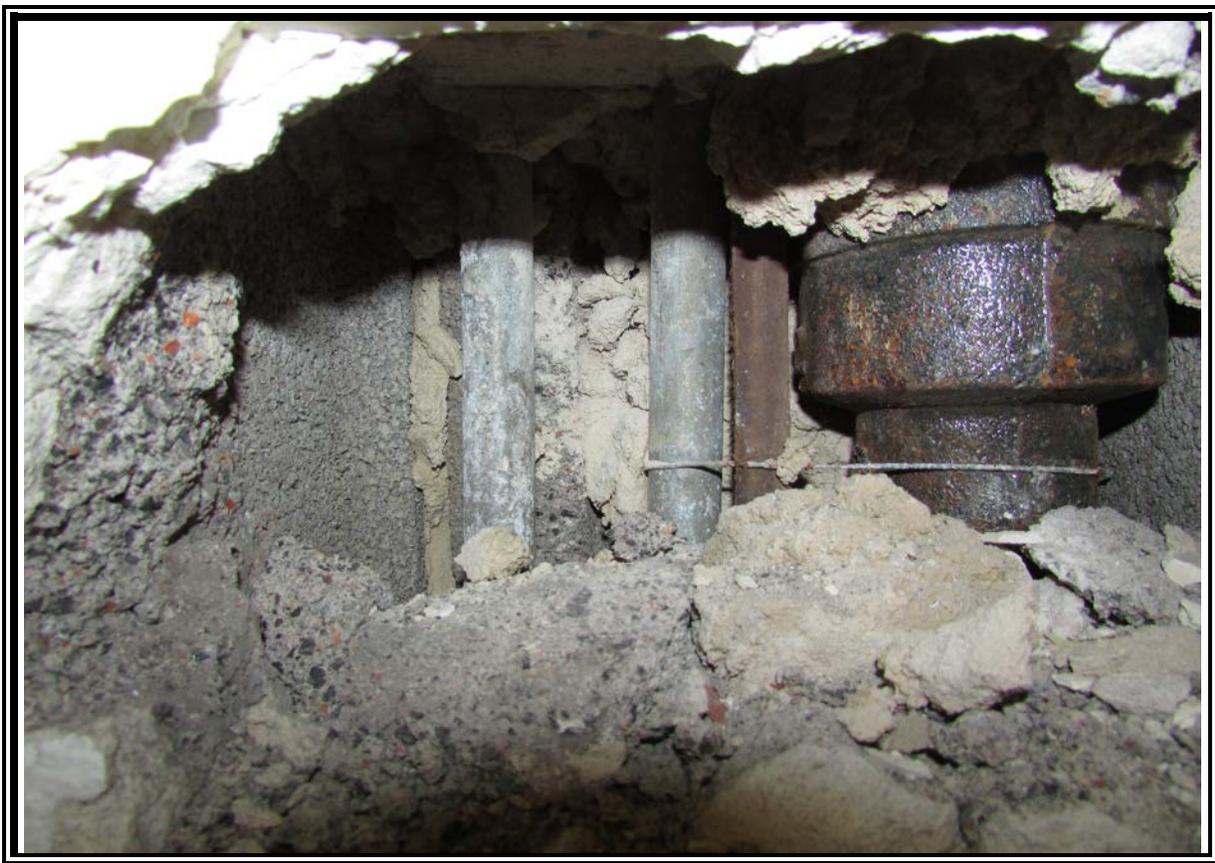
8. Un-insulated piping in walls of former shower areas on the lower level

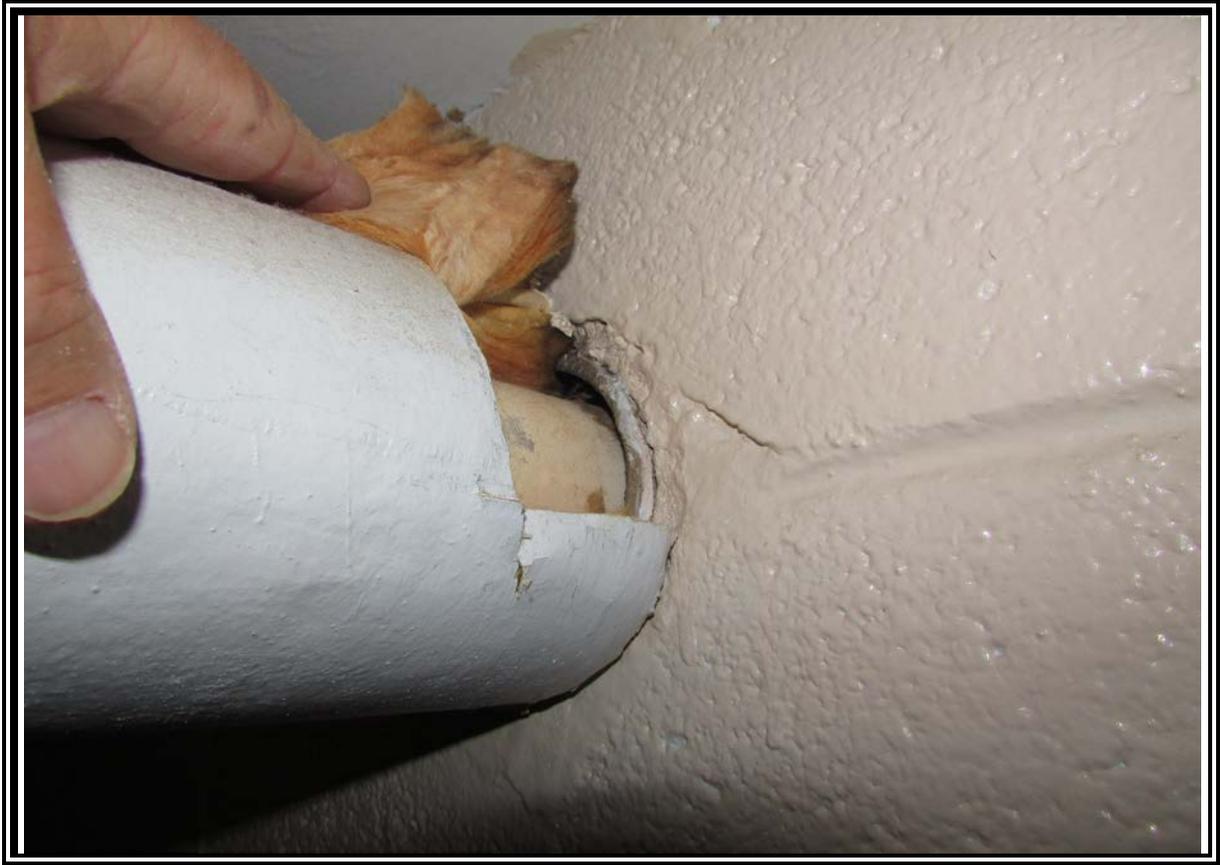
9. Un-insulated piping going through wall on the lower level

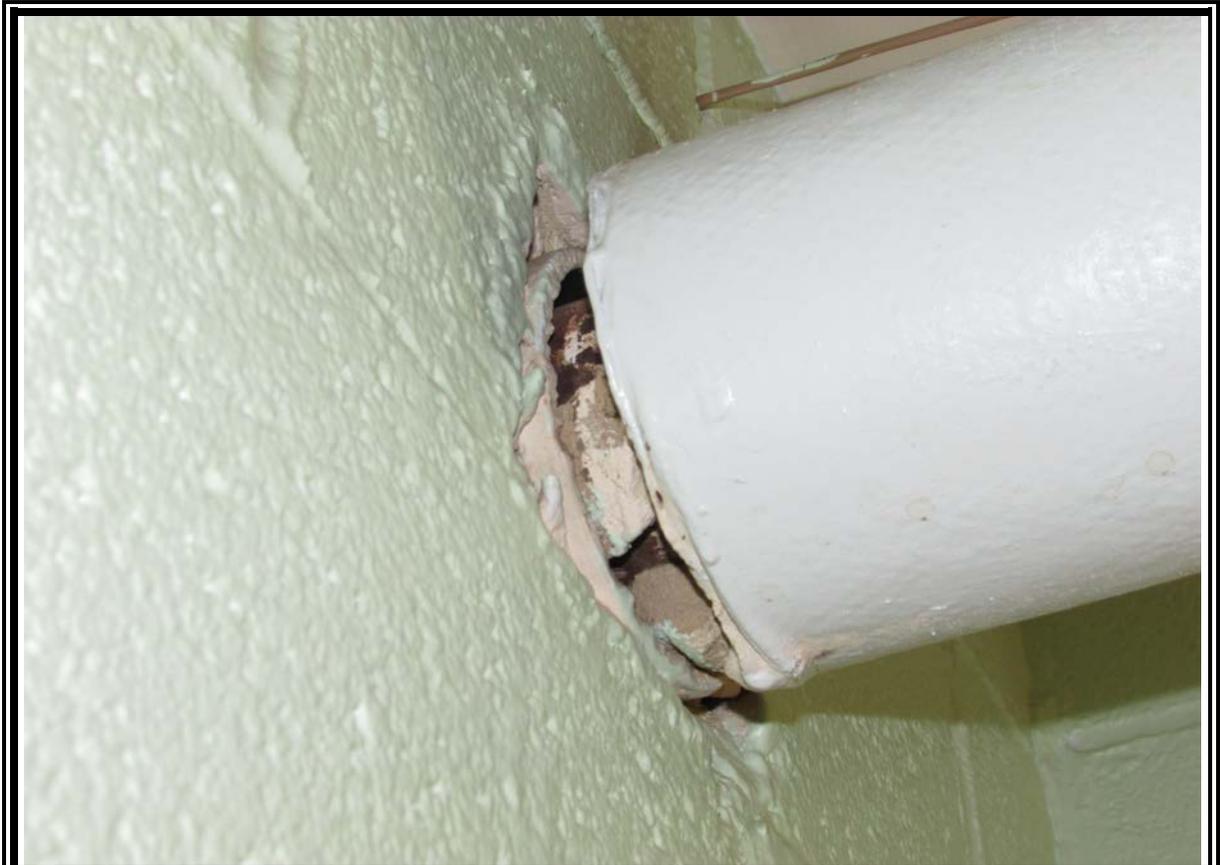
10. Un-insulated piping going through wall on the lower level

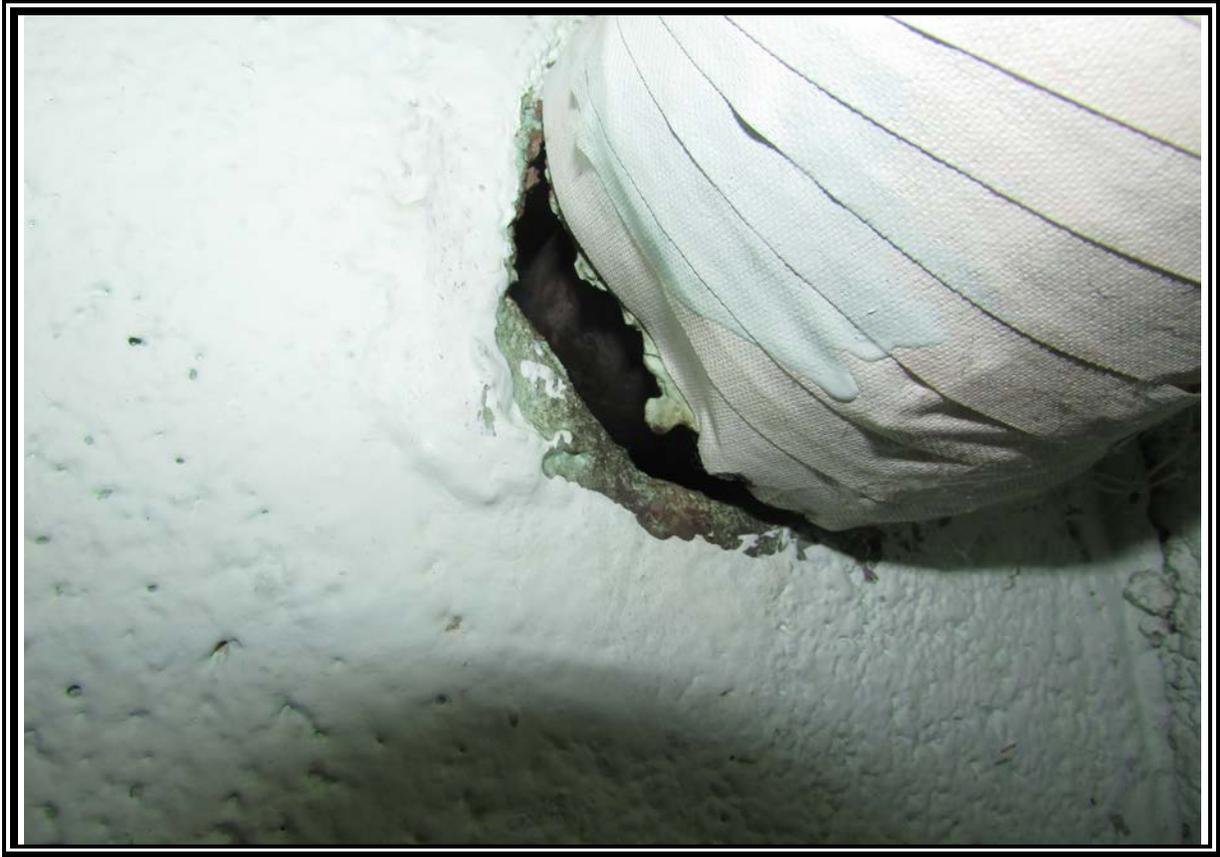
11. Un-insulated piping going through wall on the lower level

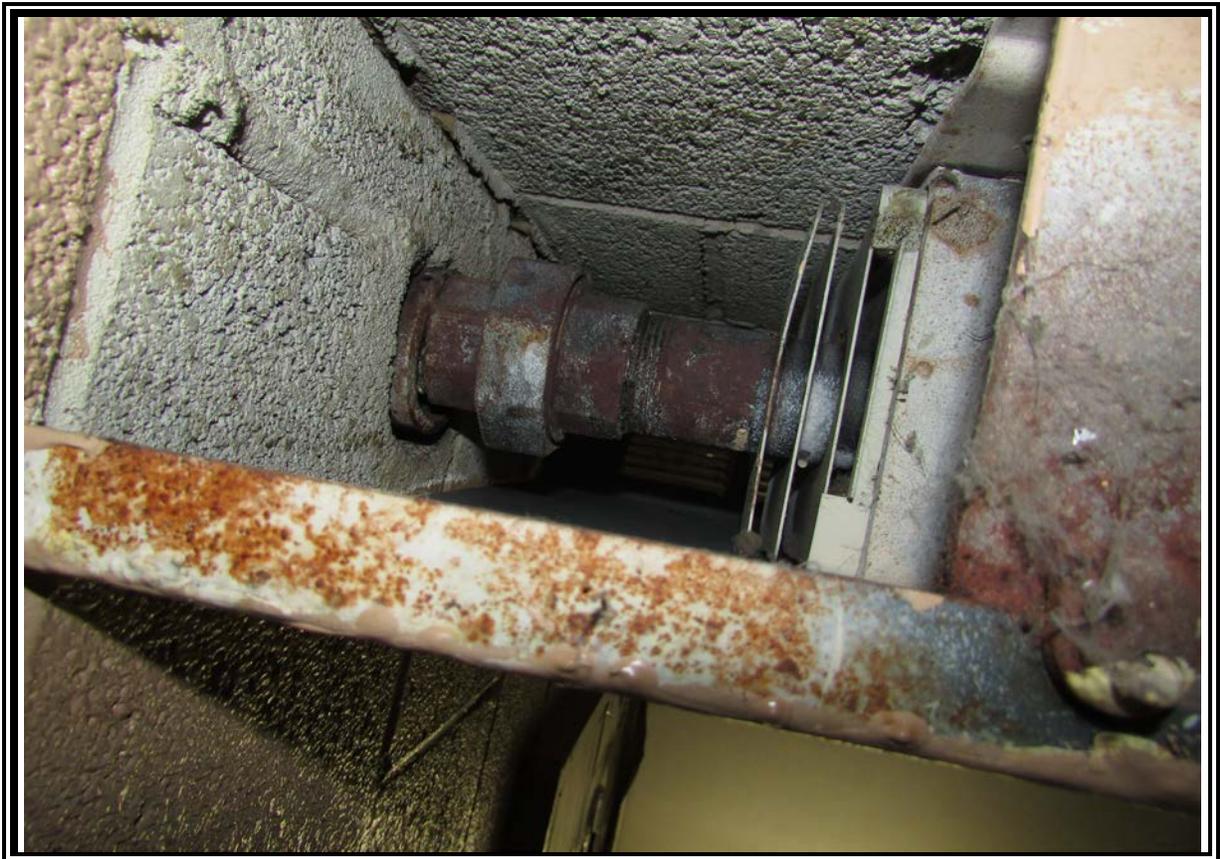
12. Un-insulated piping feeding radiator on the lower level
